Use of Guided Long Wave
Ultrasonic Inspection for Anomaly
Locating and Use of Composite
Repair Materials

12" x 10" M-2 Oil Pipeline

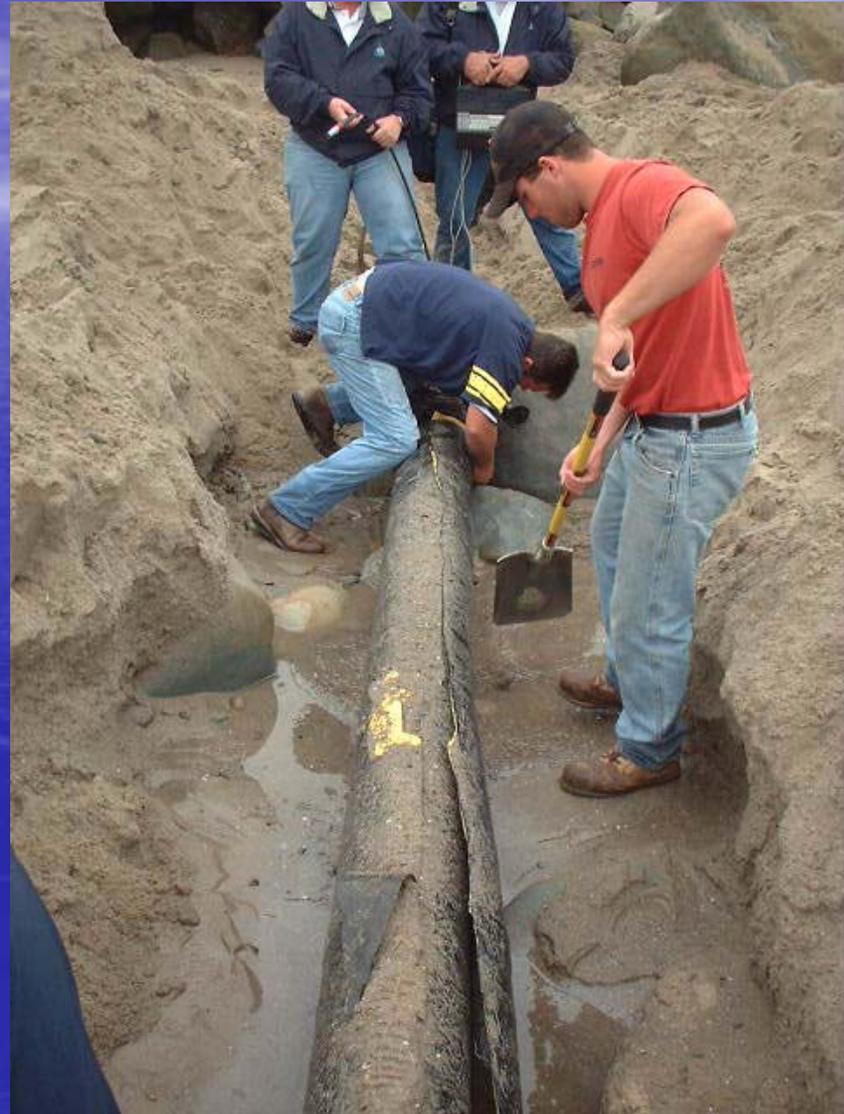
**Shot – 89971
(Collar Location)**

This shot was made on the cliff side of the grout bag with the positive direction toward the ocean.

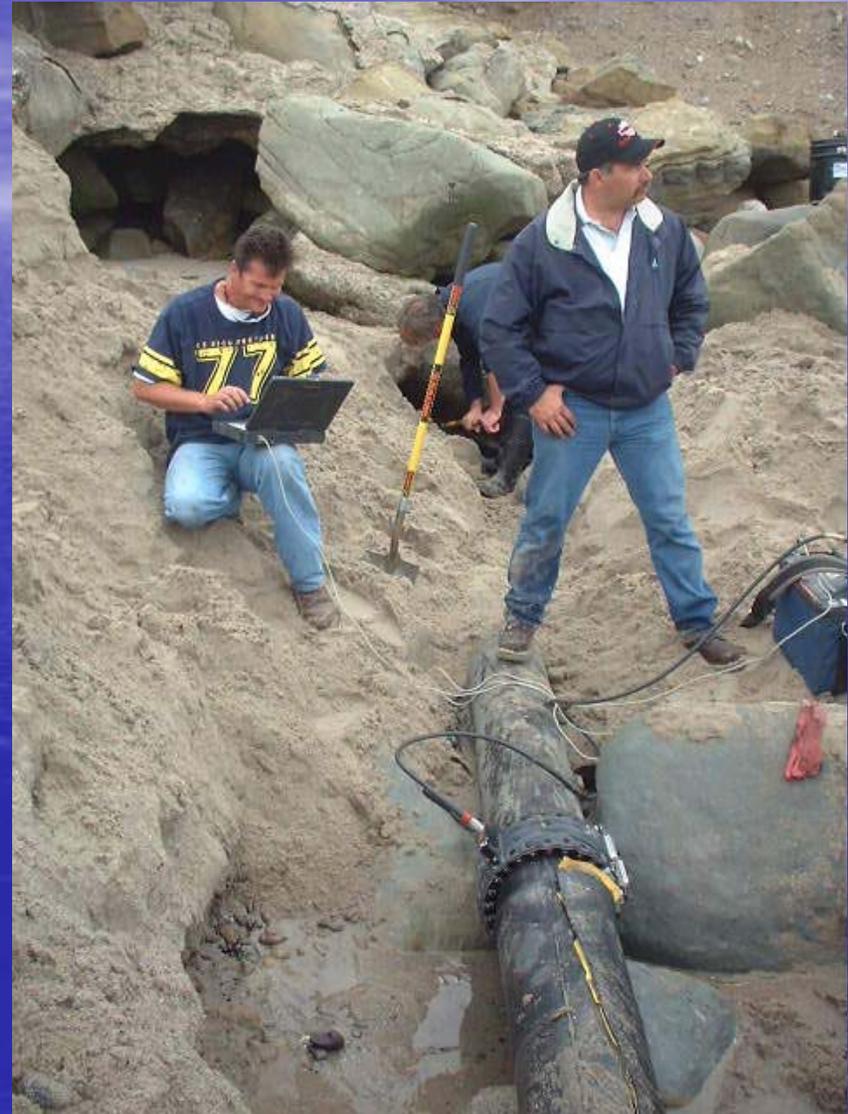
**Shot – 89977
(Collar Location)**

This shot was made at the cliff with the positive direction toward the cliff.

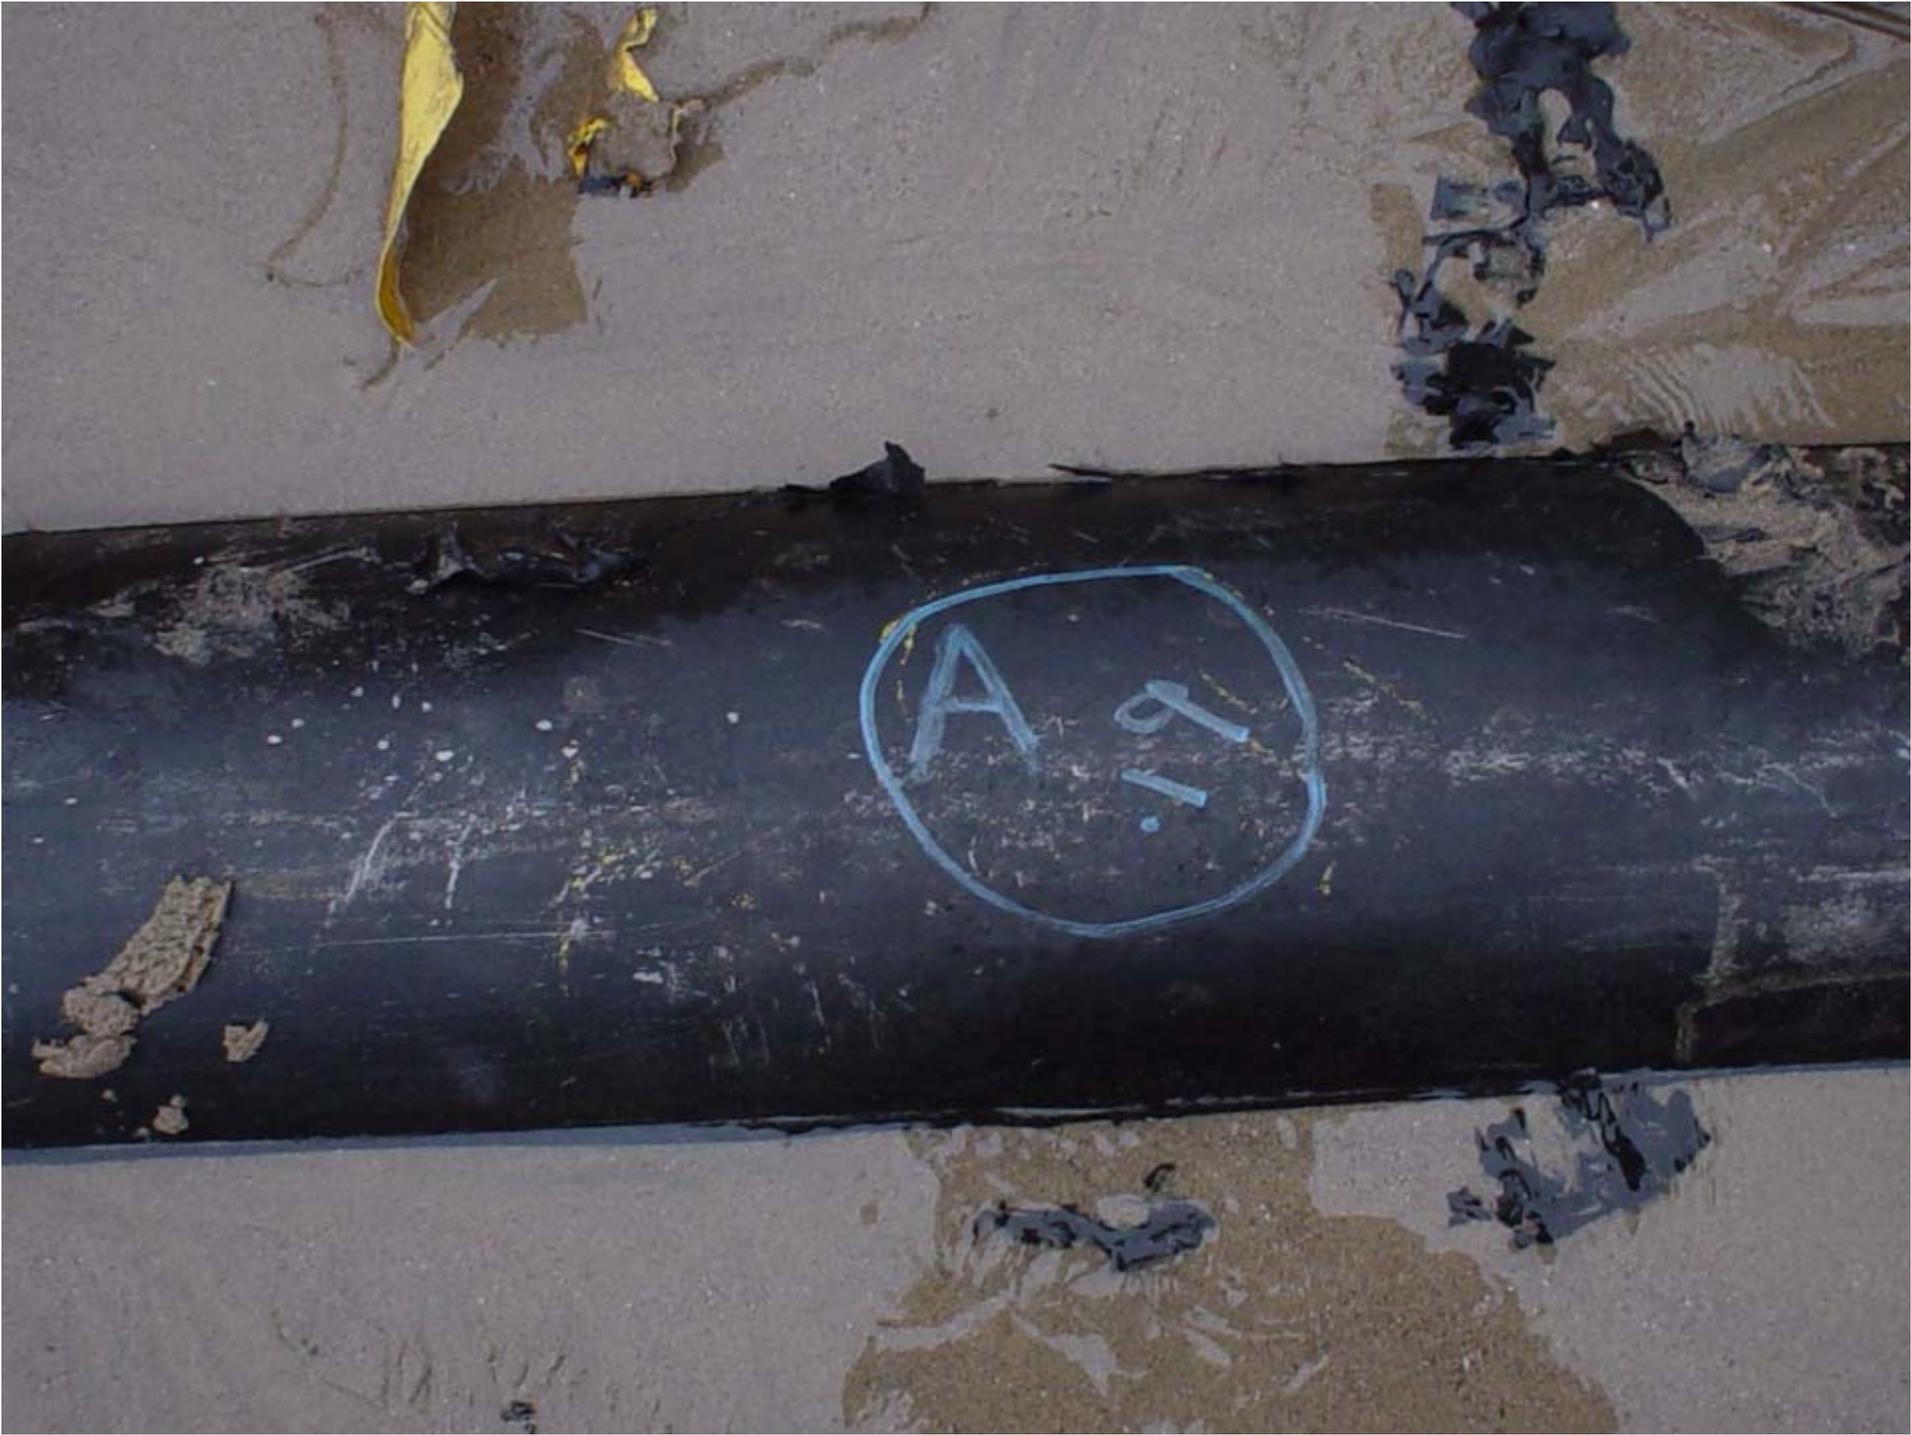
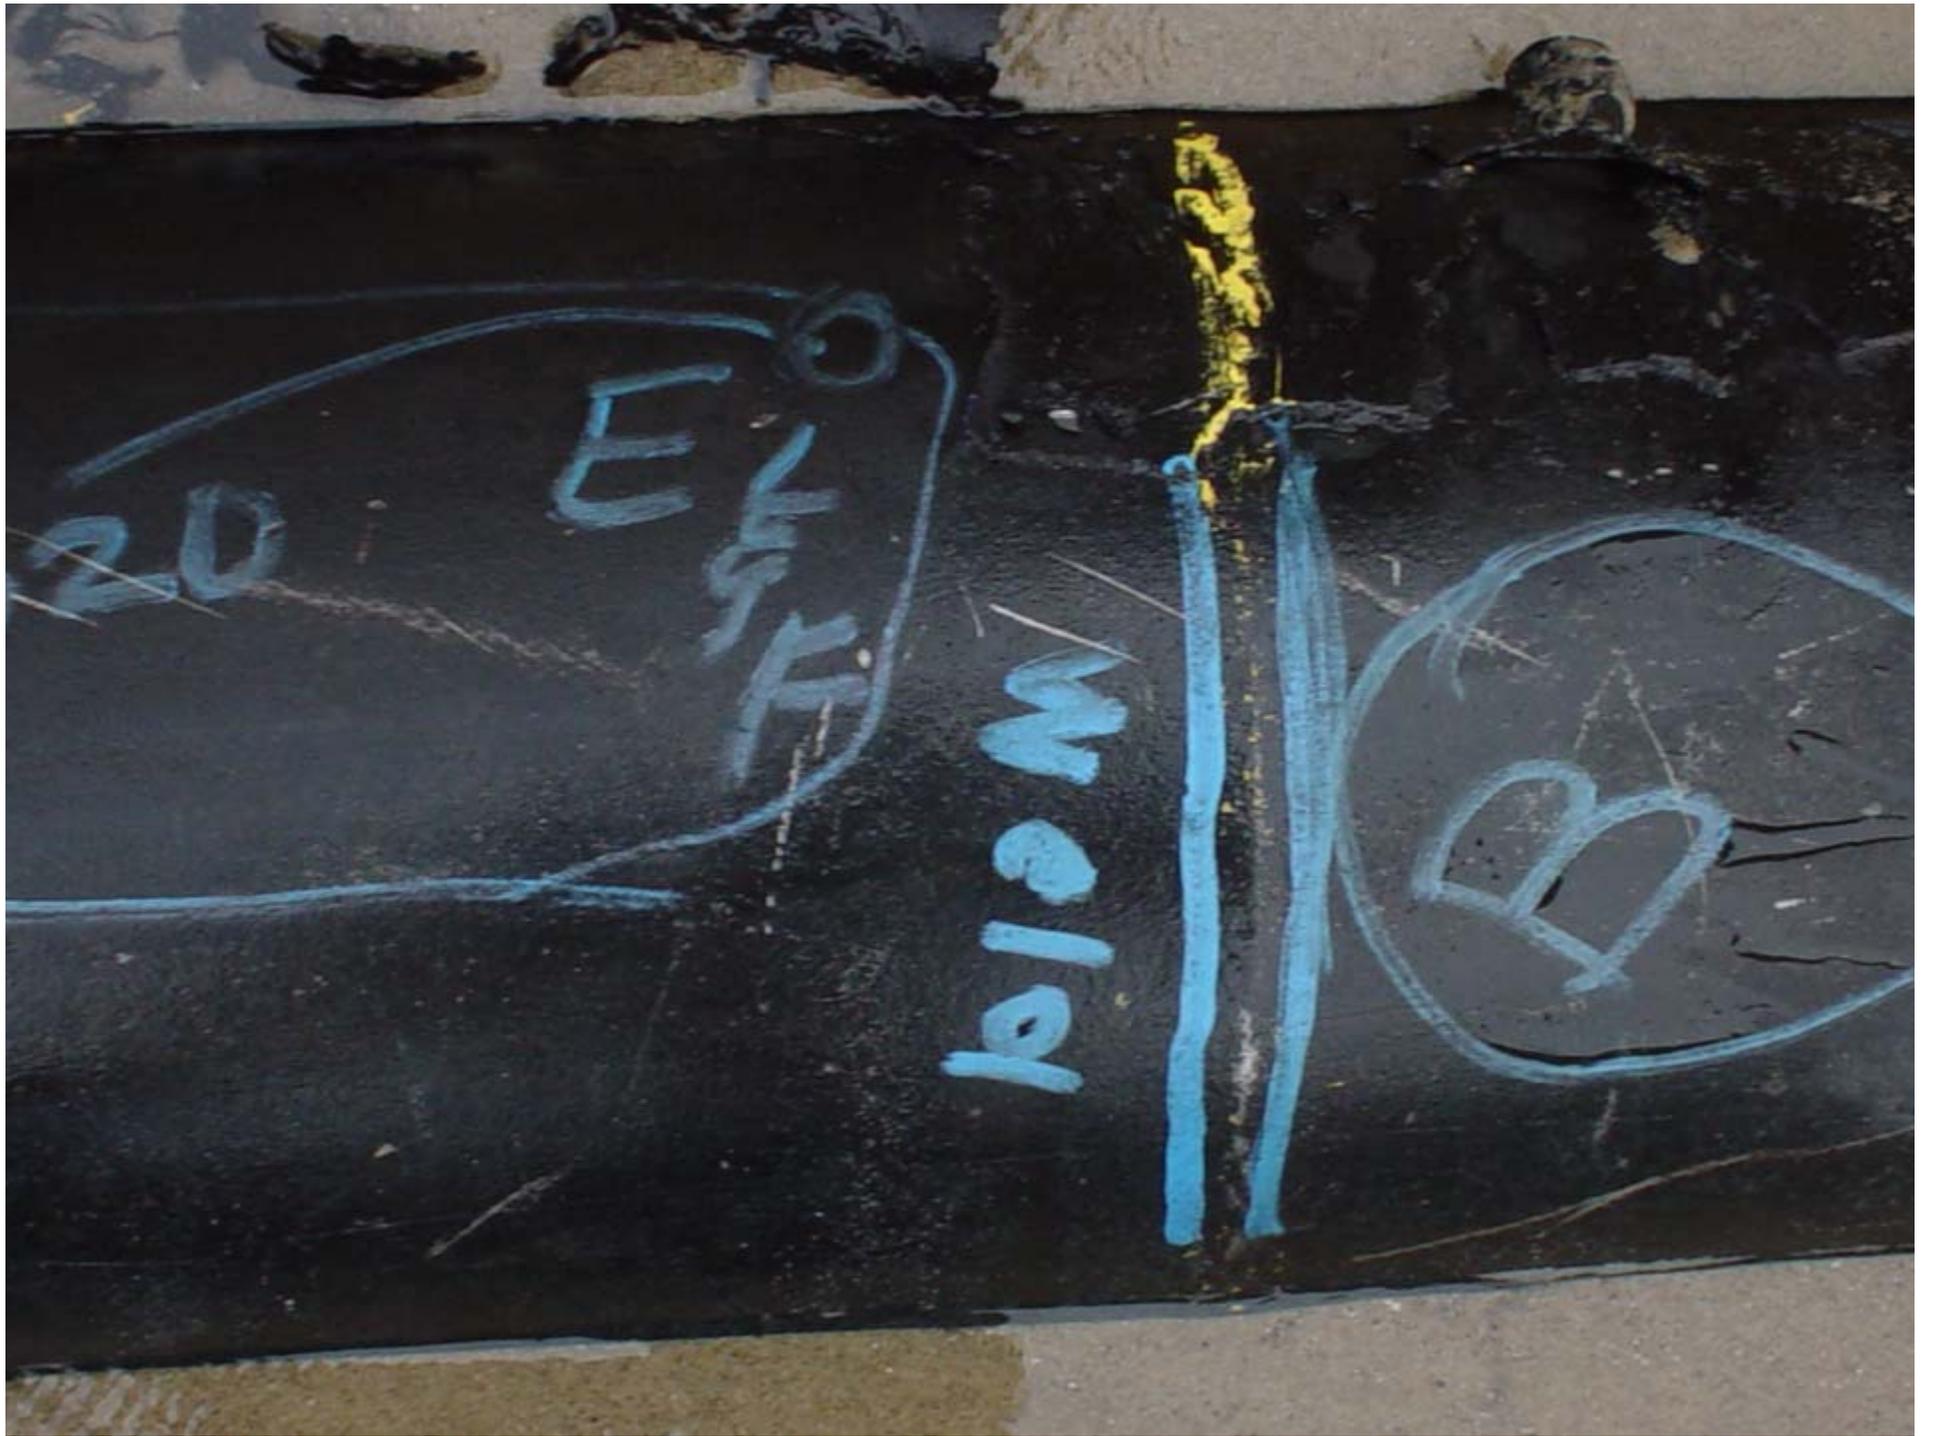
- Located two anomalies – external scouring of pipe

- Guided Wave Ultrasonic Inspection – June 21, 2004
 - Found 0.155" WT (58.6% loss) and 0.204" WT (45.6% loss)
 - Defects located within 45" of each other
 - About 12' total pipe exposed to scour
 - Subjected to RSTRENG analysis, determined true MAOP was 1188 psi, well above 740 psi

- Armor Plate System Selected
 - 4-layer wrap found to restore full hoop stress
 - 2-layer wrap added for scour protection and missing coating
- Contingency Planning Included Welded Sleeves as Back-Up

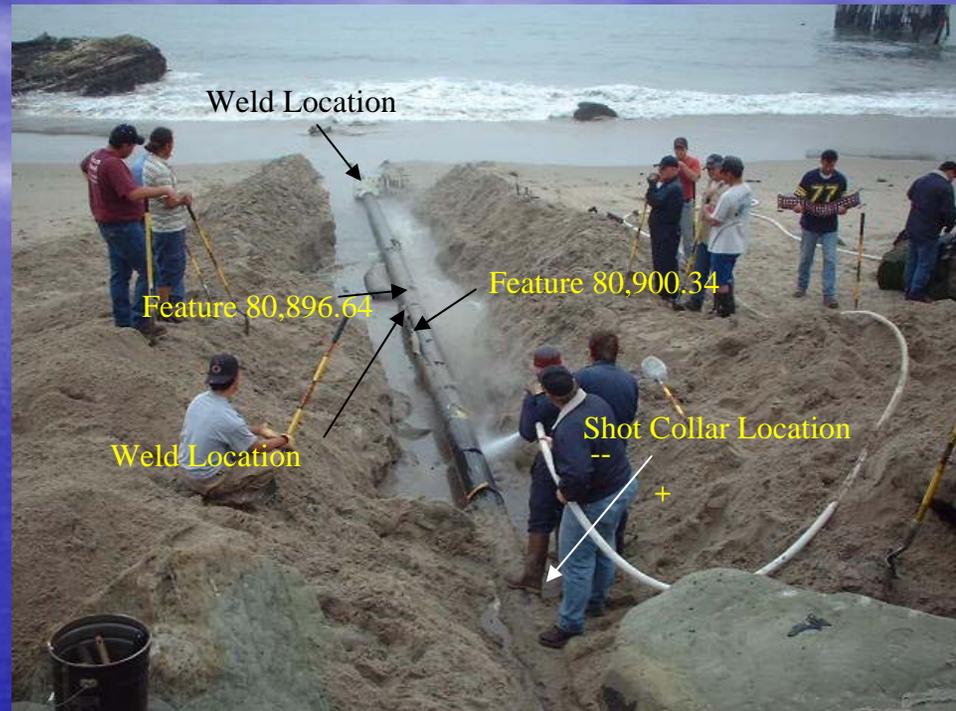
Shot – 89977 (Corrosion Location)

Feature locations were B-Scan inspected on 6-21-2004. Over 50% wall loss found at this location. This feature was found with the Smart Pig at the 80,900.34' location.

See attached B-Scan Details of this inspection

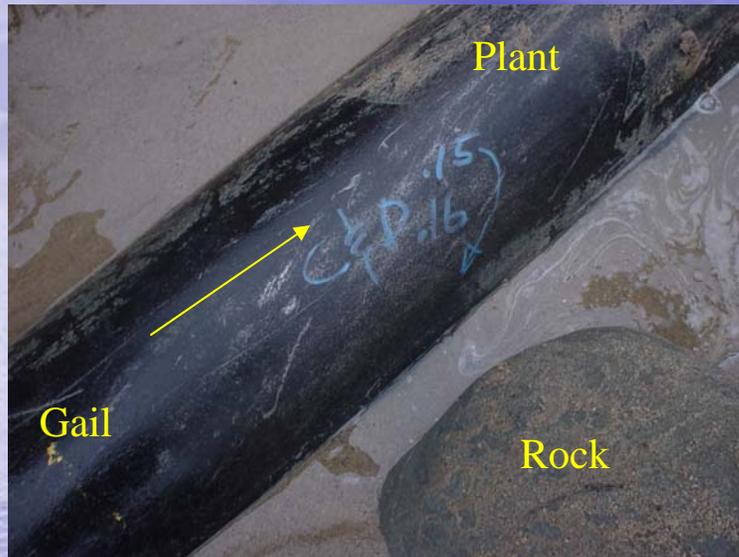
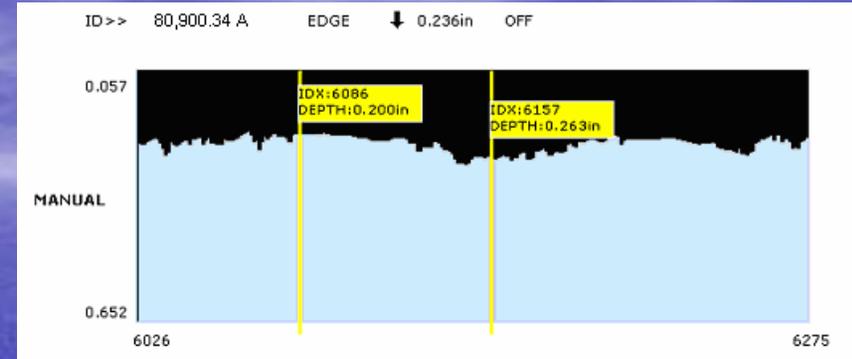
Scan – Feature 80,900.34

The remaining thickness in this area ranged from .200" to .263"

The top half of the piping was scanned to reveal a remaining thickness ranging from .200" to .263" from a nominal thickness of .375"

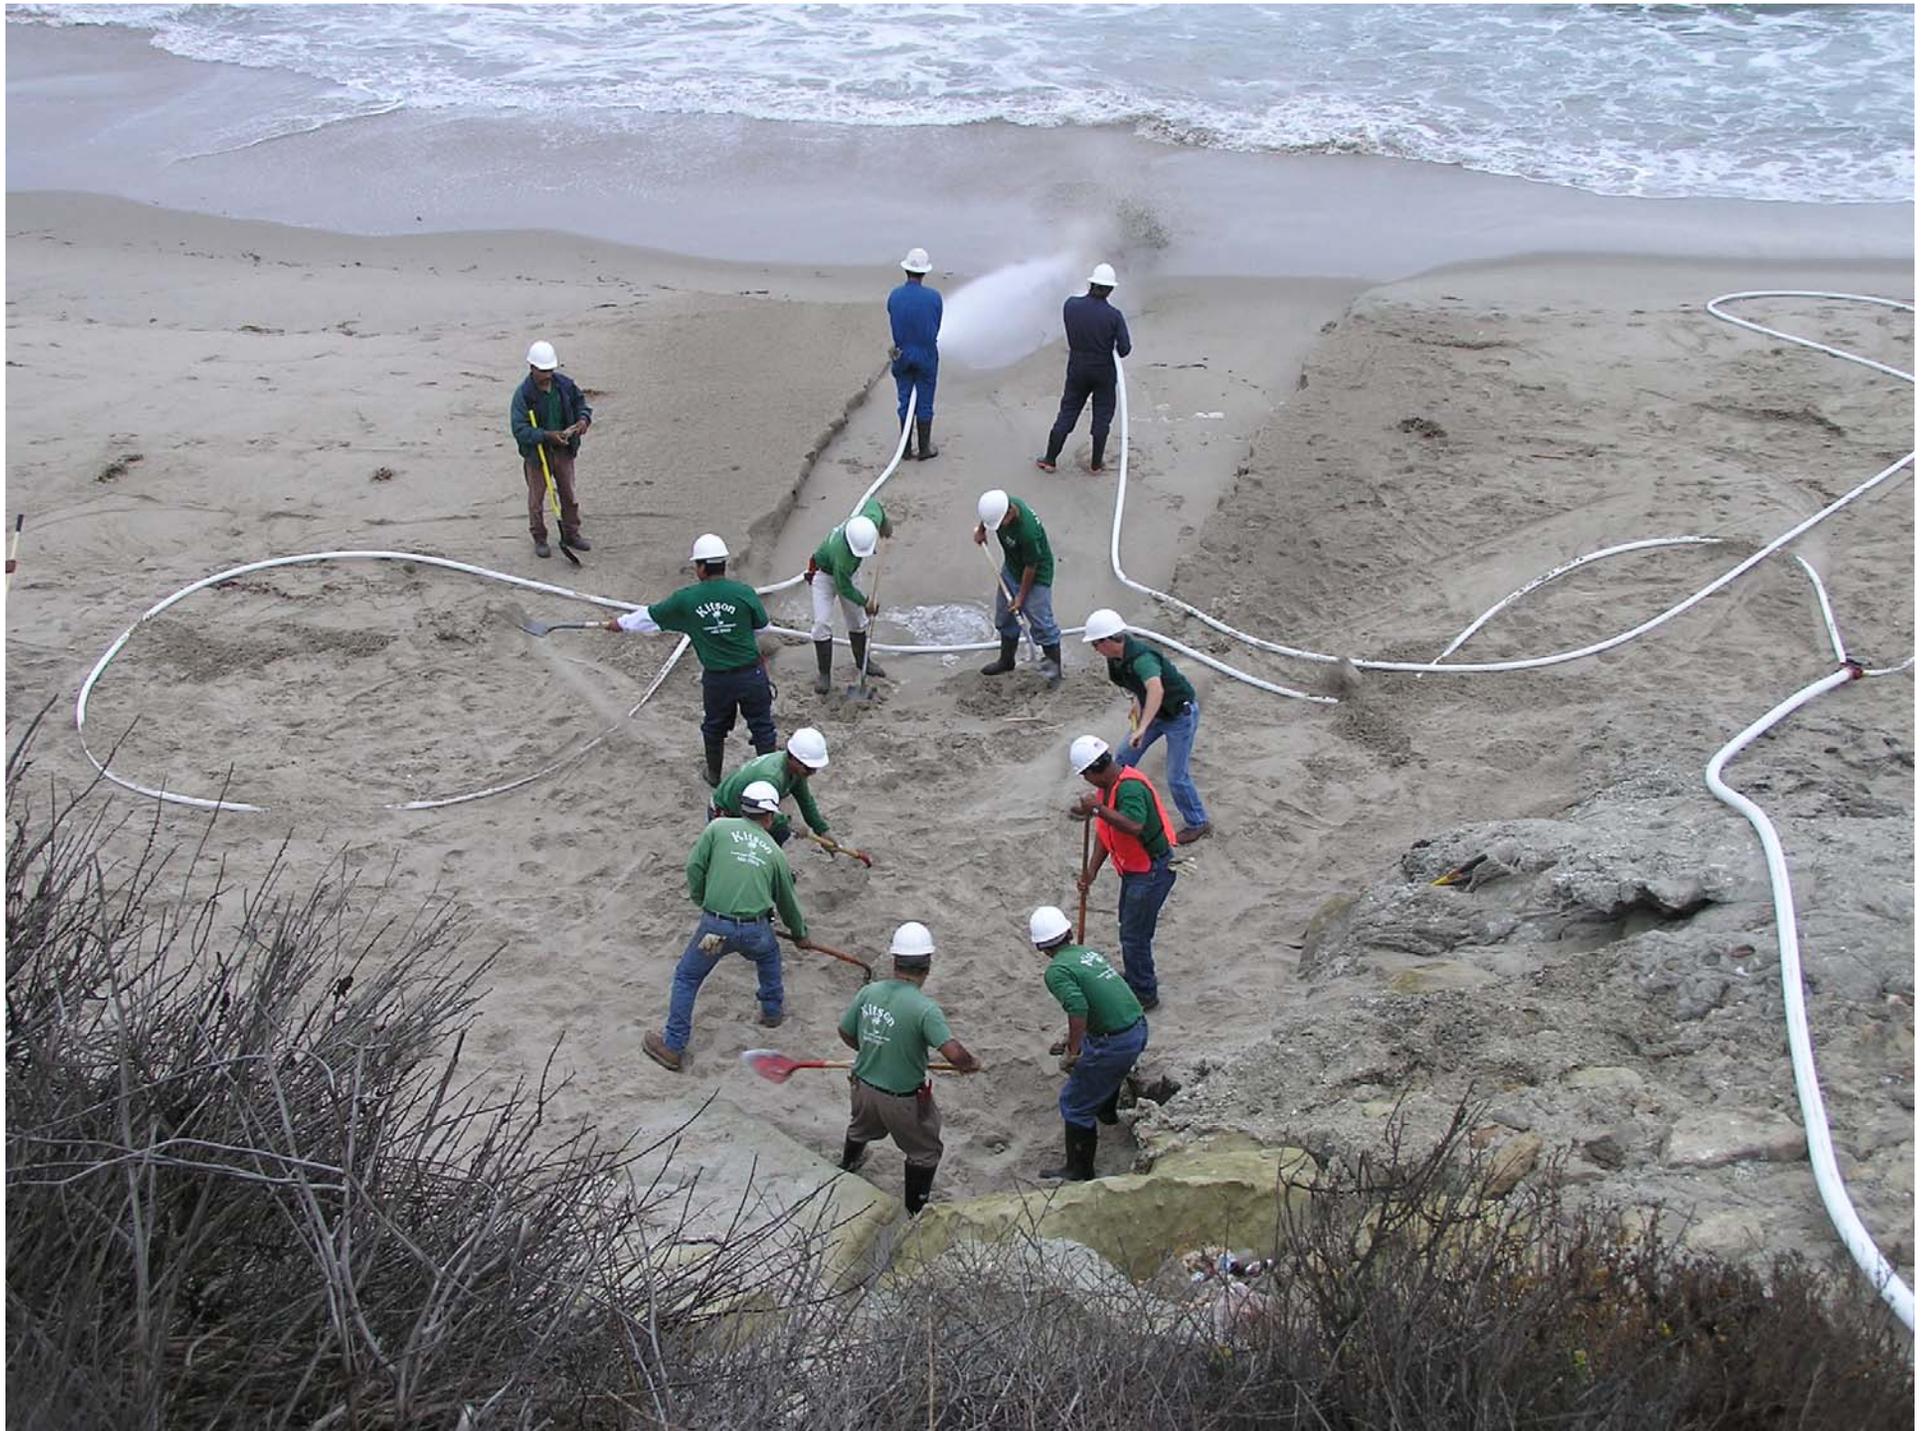
- October 14, 2004 (Day 3)
 - Pipe Exposed
 - Defects confirmed using hand held UT tool
 - Wrap applied along 17' length
