# HAITI EARTHQUAKE

## ASCE/TCLEE RECONNAISSANCE PROJECT

# Haiti Earthquake Reconnaissance

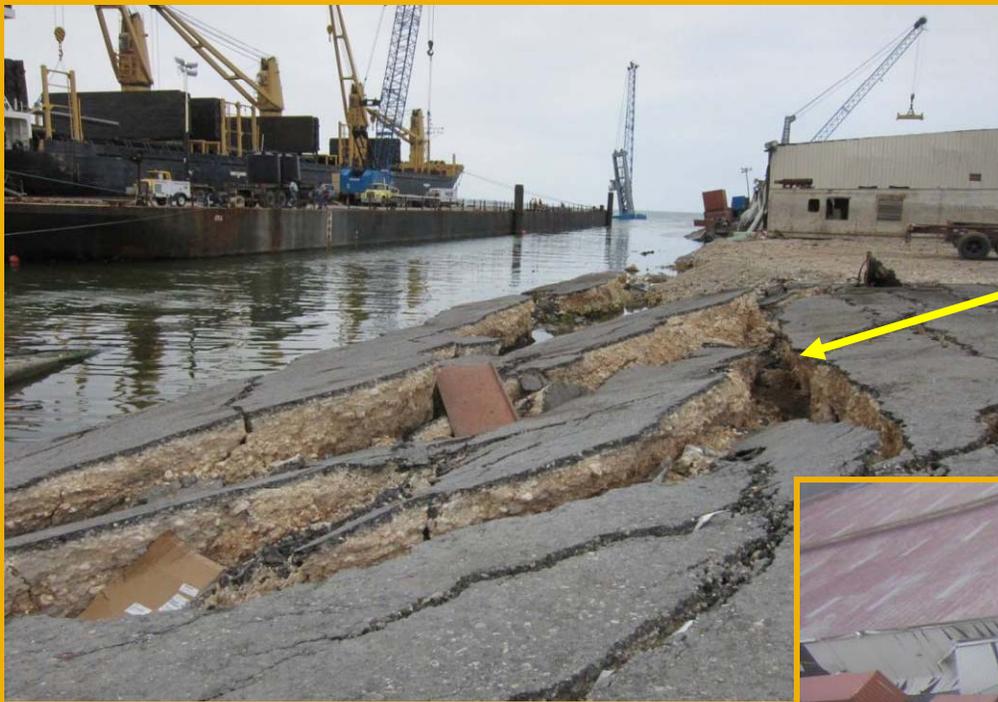
Very Large Lateral Spreading

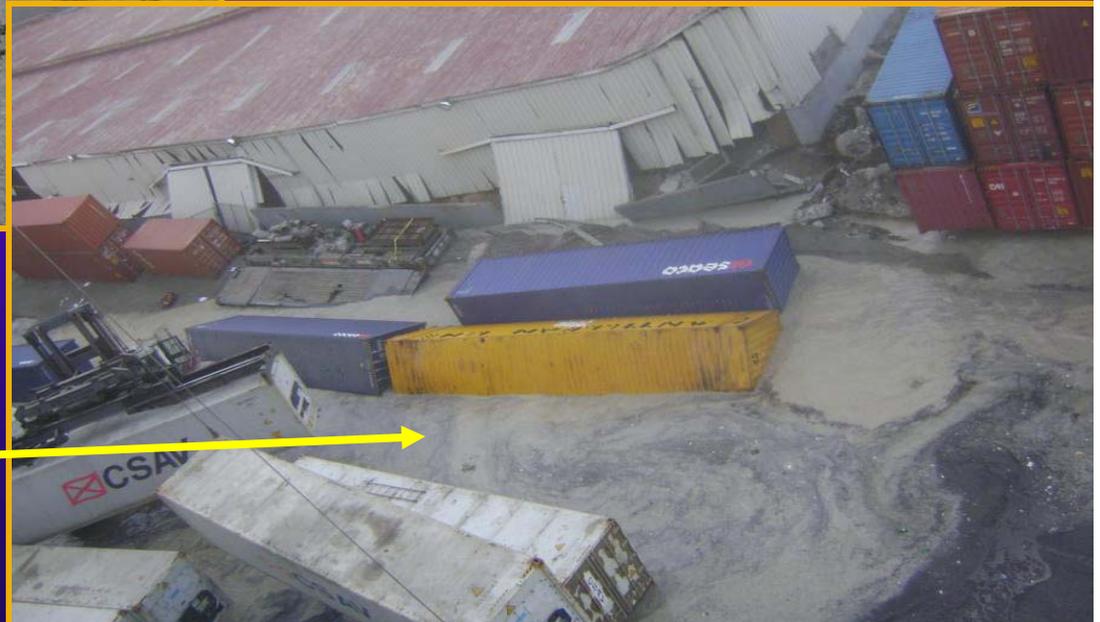
Liquefaction & Translation of Wharf

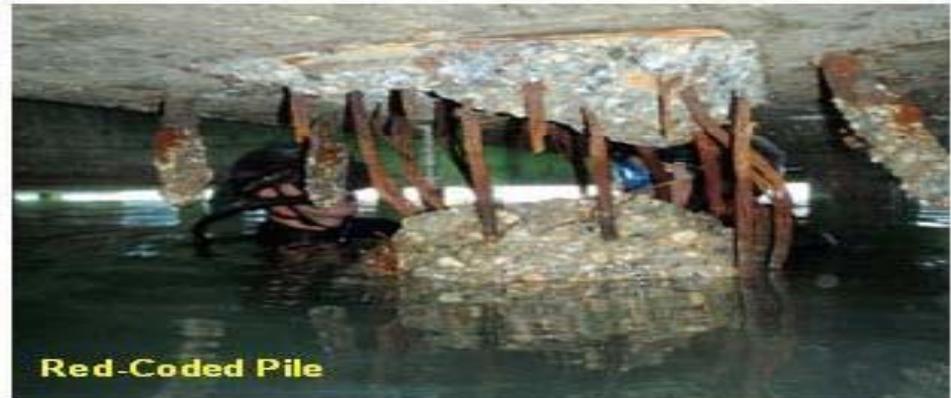
Red-Coded Pile

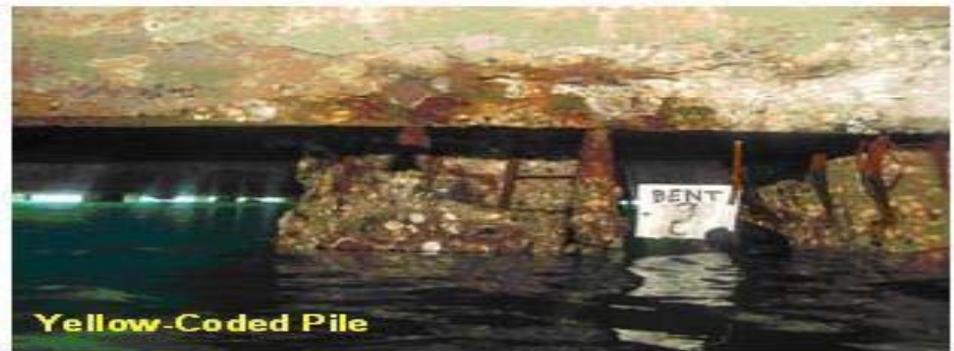
Yellow-Coded Pile

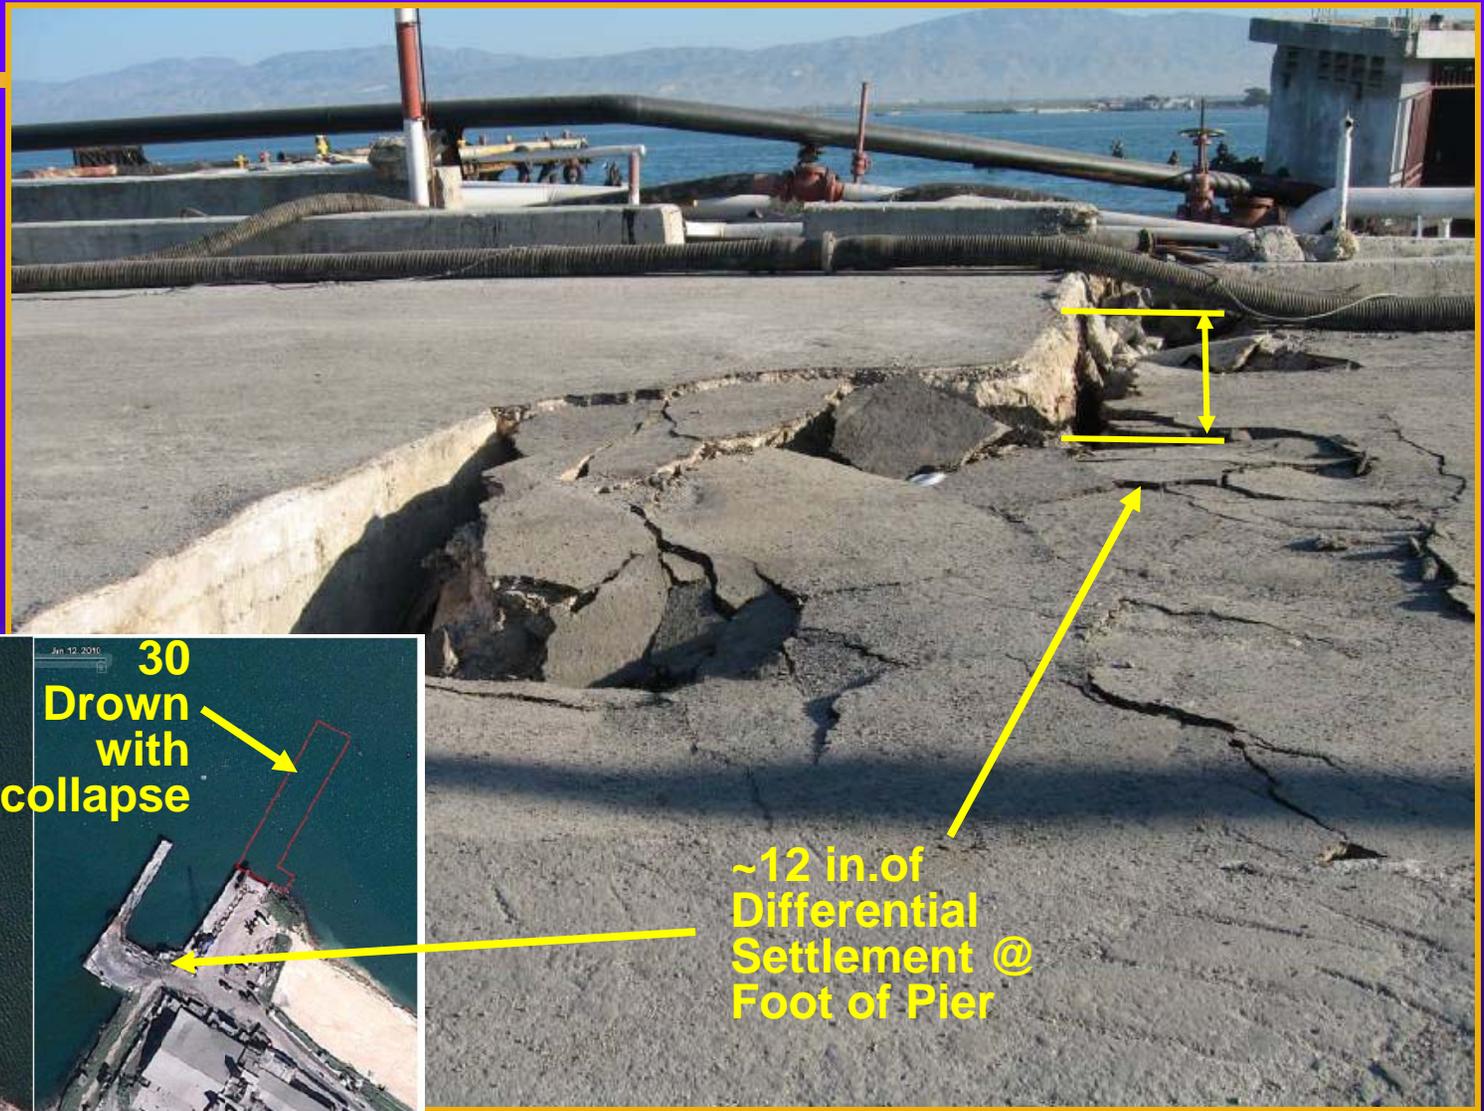
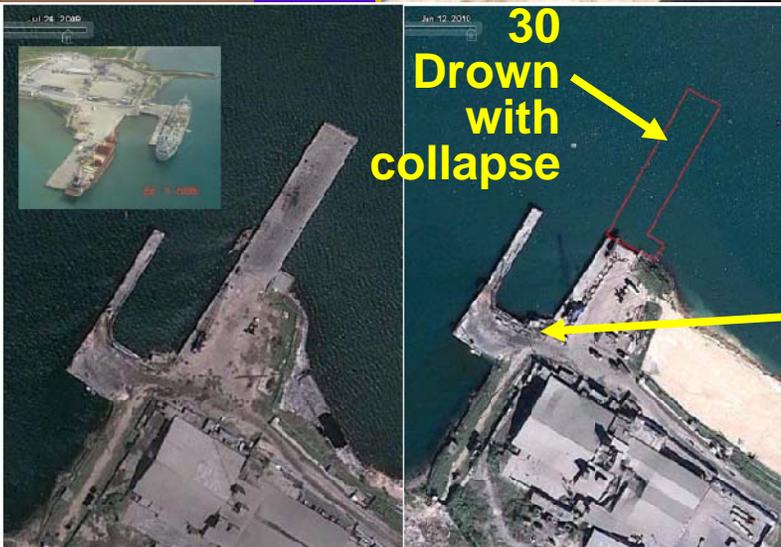
30  
Drown  
with  
collapse

~12 in. of  
Differential  
Settlement @  
Foot of Pier

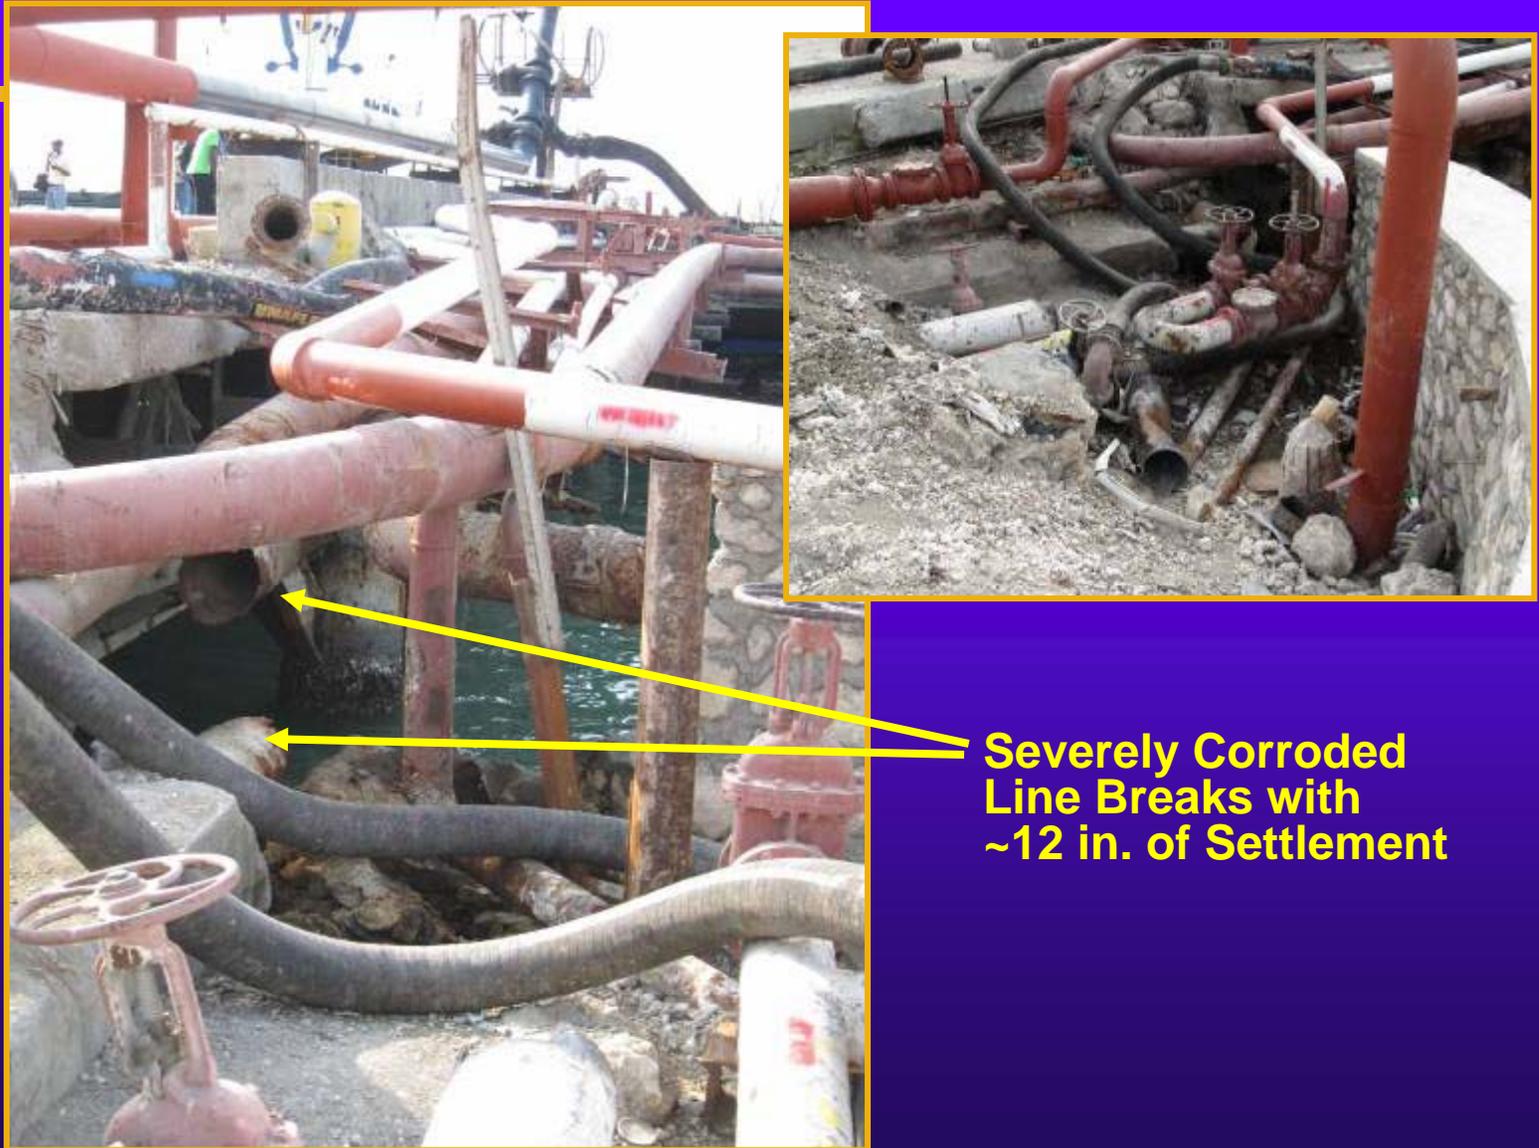
**Severely Corroded  
Line Breaks with  
~12 in. of Settlement**

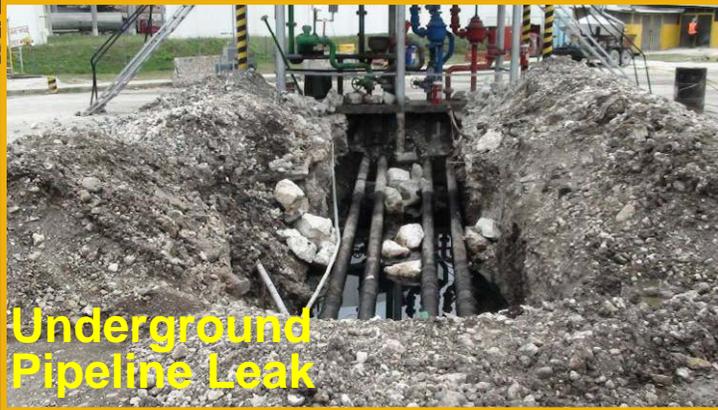
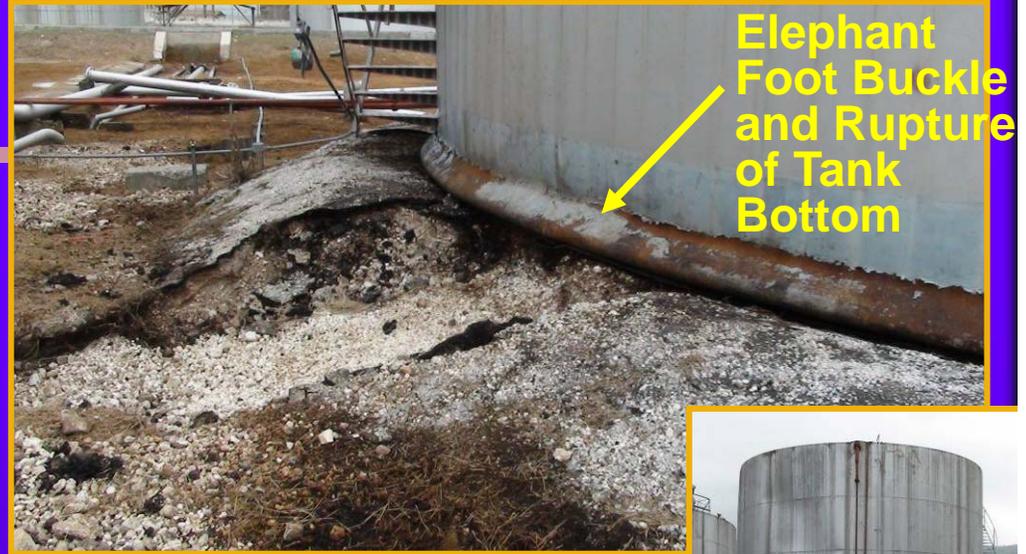
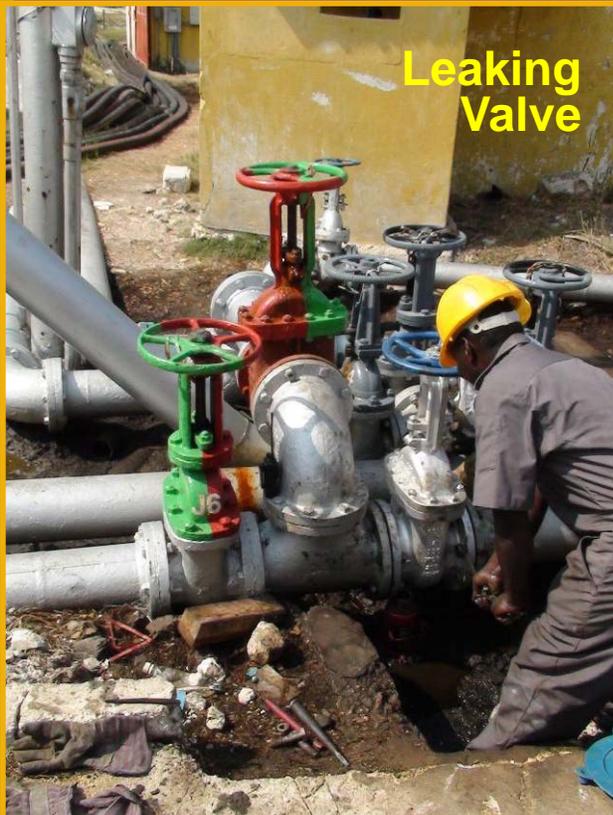
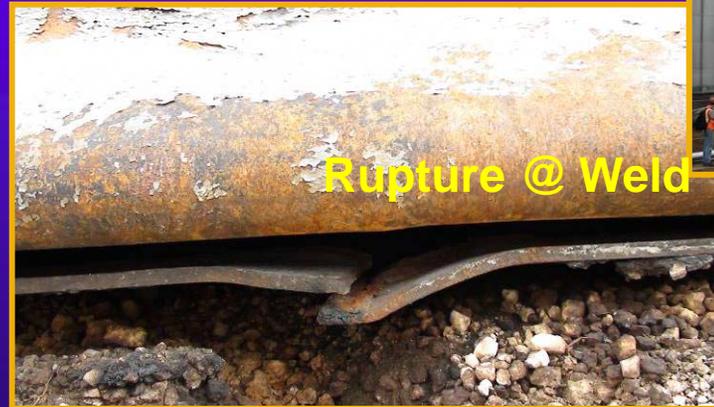
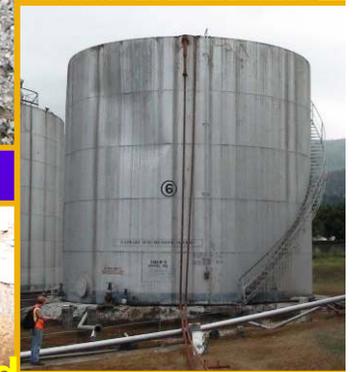
- ◆ Full, unanchored tank rocked, buckled

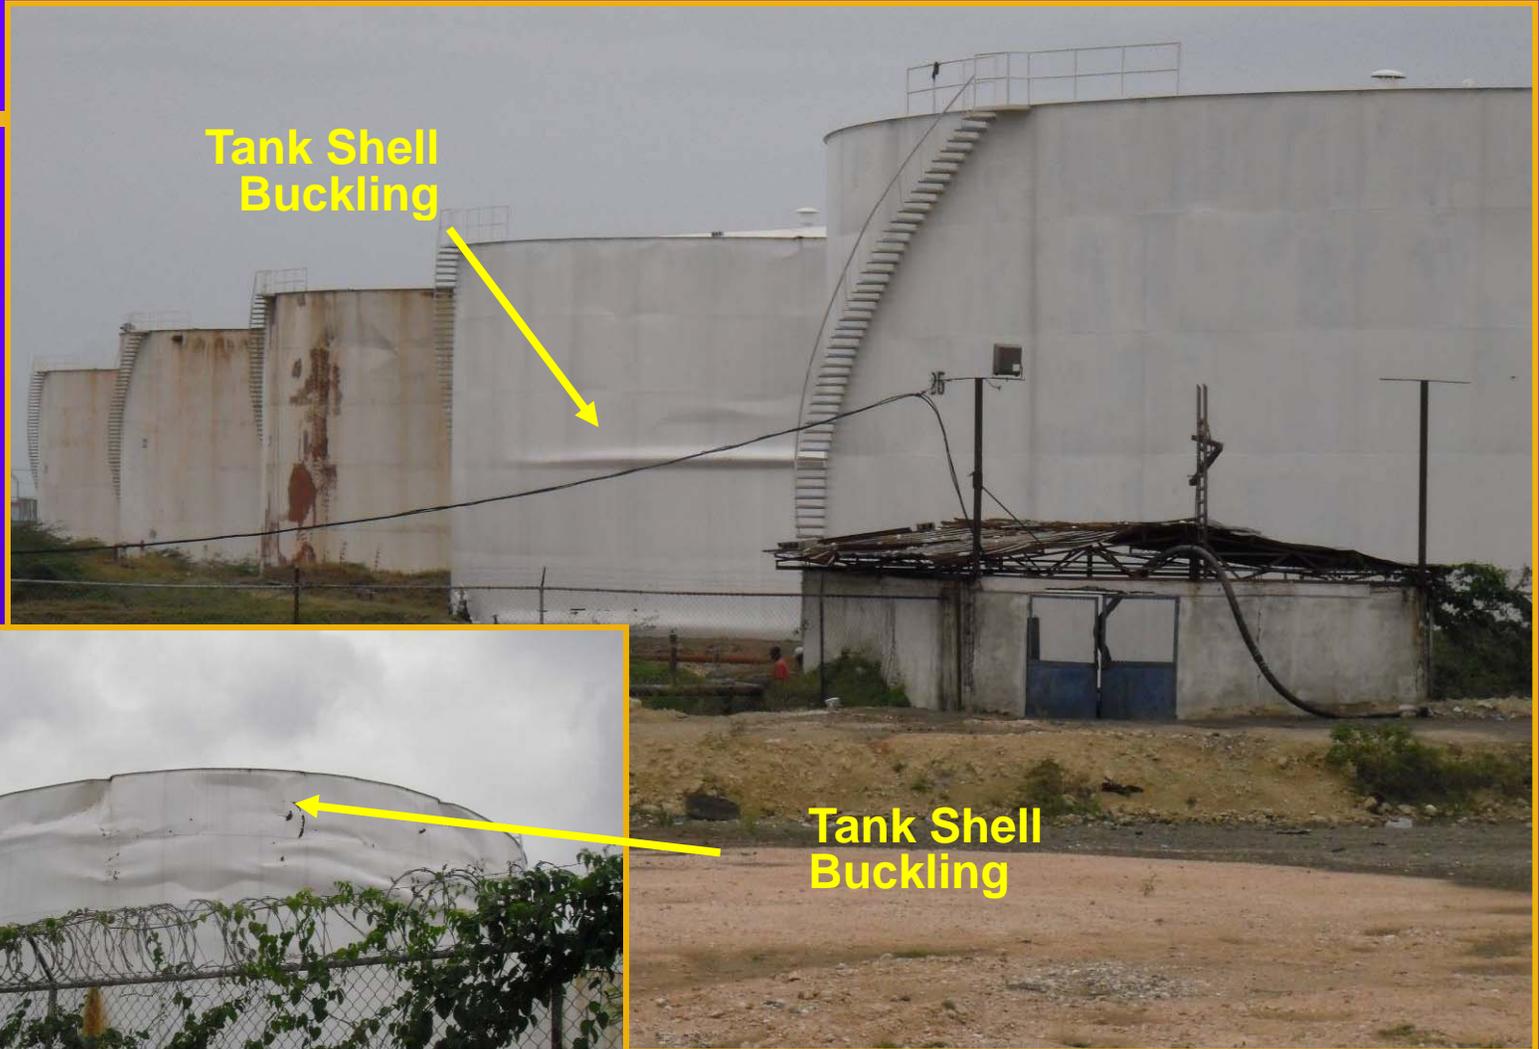
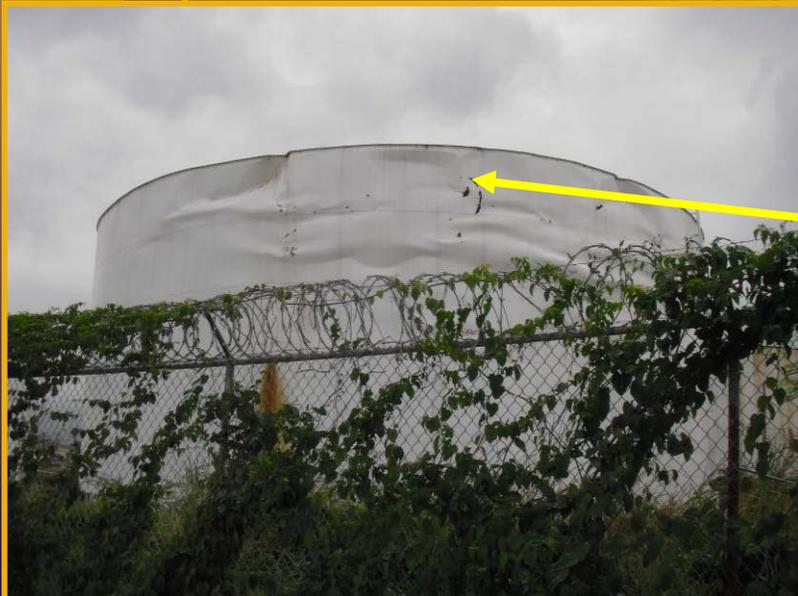
Tank Shell Buckling

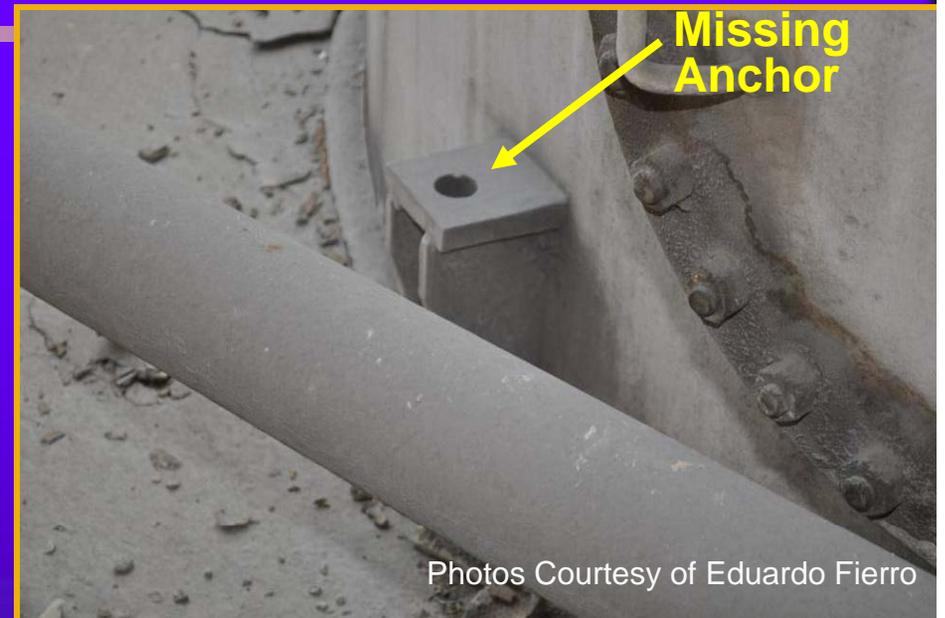
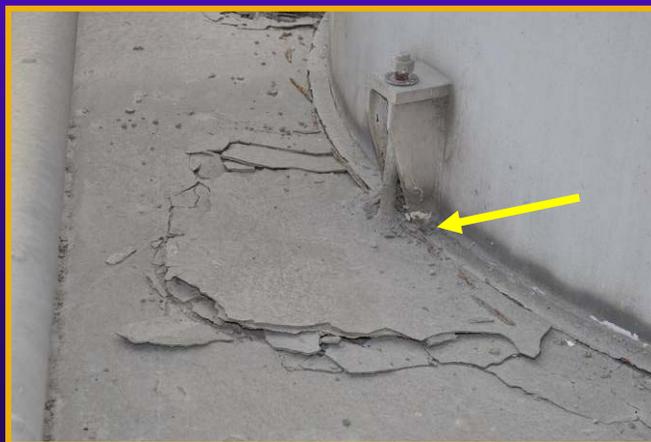
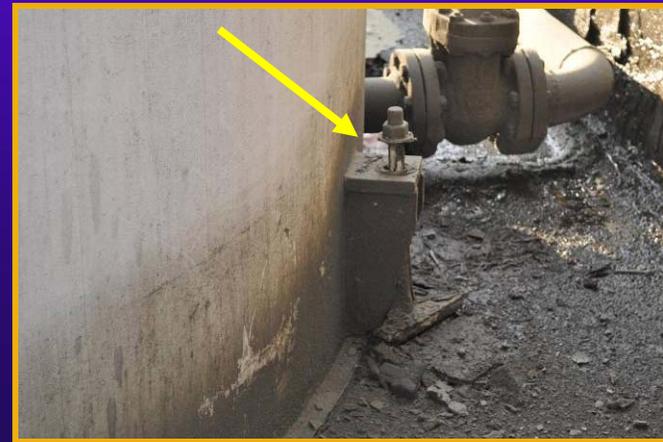
- ◆ 15,000 gal. Diesel Tank
  - ◆ Partially Anchored (4 of 8 installed)
  - ◆ Anchor Uplift
  - ◆ Anchor Pullout
- ◆ Some anchorage better than nothing
