*Resource Name or # (Assigned by recorder) 32852 and 32865 County Road 17

*Resource Name or #: Herman Richter House

B1. Historic Name: Herman Richter House
B2. Common Name: Twyla Thompson House
B3. Original Use: Residence B4. Present Use: Residence

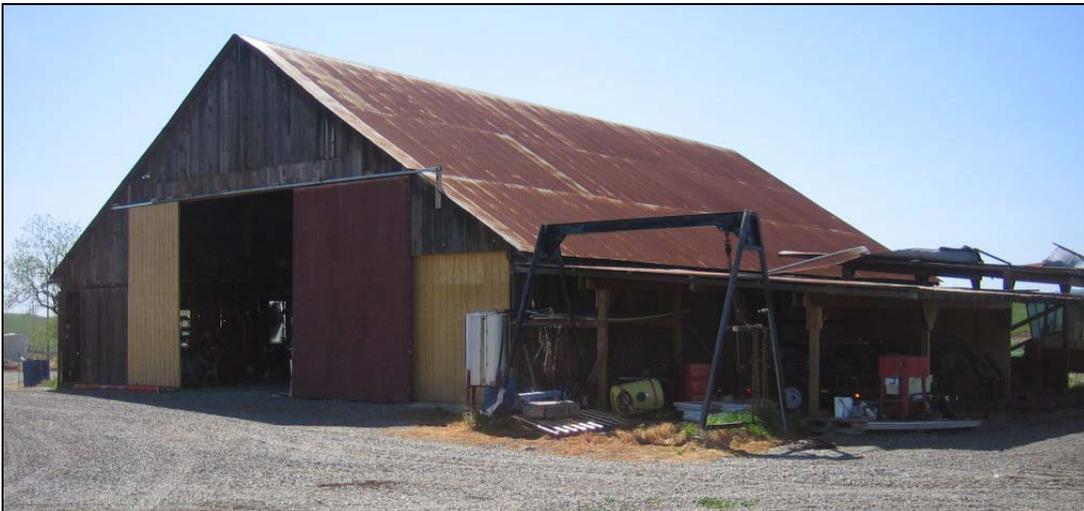
Farm Building #2 is northwest of Farm Building No. 1 and measures approximately 81 feet long x 56 feet wide, excluding the shed-roof projection on the north elevation. The barn was built in 1881 and appears to be the oldest building on the property. It exhibits two-stories and a wide expanse roofline. The moderate pitched front-gabled roof is sheathed with corrugated iron panels. The barn has a concrete foundation with a dirt floor, although concrete slabs cover sections of the floor. The timber-framed barn is sided with vertical wood planks on all, but the west elevation, and displays both cut nails and round-headed nails. Corrugated metal siding covers the west elevation. The east façade of the building features a large sliding wood-plank door in the center with an overhead track equipped with pulleys. New wood panels (or T-1-11 plywood) replace wood planks at either side of the door. The west elevation displays a smaller corrugated metal sliding door with an overhead track and pulleys on the west end. There is evidence that there was once a large door at the center of the elevation, similar to the one on the façade, but the door was later replaced by corrugated metal siding. The north elevation features a shed-roof extended roofline that is supported by wood posts. The extension is open-sided and miscellaneous equipment is stored under it. The only windows on the barn are on the south elevation. There are four aluminum-framed 1:1 pane windows spaced across the side of the building. The recently repaired barn is presently used for storing farming equipment, although it is likely that it was once used for livestock and/or hay storage. The replacement of wood plank cladding with corrugated metal panels and the addition of aluminium sliders on the south elevation have affected the integrity of the building.

Overview of east façade and north elevation of hay/horse barn at Y-7, facing southwest; 03/21/2007; IMG_1473.

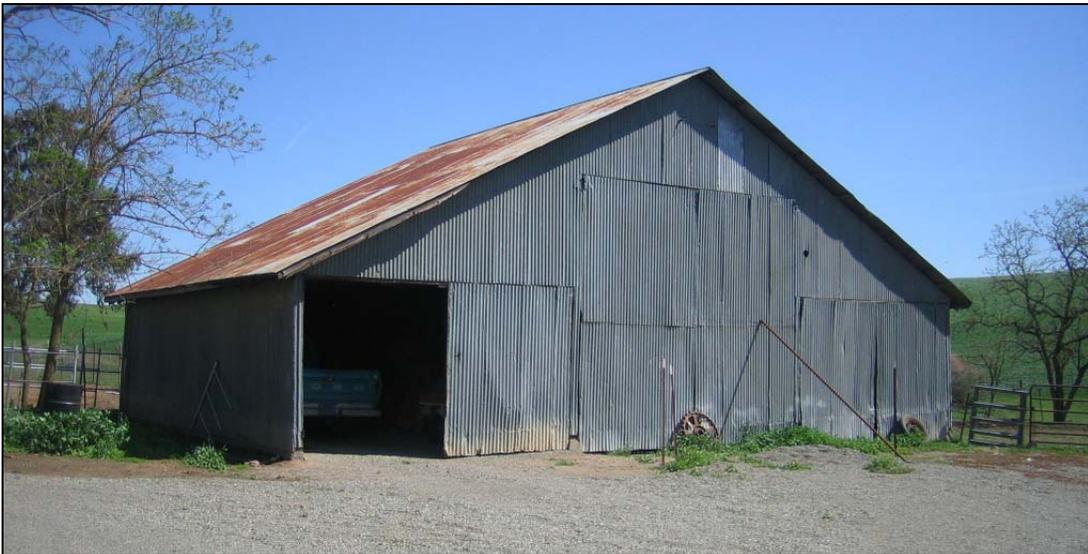
Farm Building No. 3 is east of Farm Building No. 2 and measures approximately 50 feet long x 32 feet wide. According to the owner, the barn was constructed in the 1940s. The barn is two-stories with a wide expanse roofline and moderate pitched front-gabled roof. It has timber-framing and the roof and exterior walls are clad with corrugated metal panels. The barn has a concrete foundation with a dirt floor. The west façade of the building features a swinging corrugated panel door on the north end, although fenestration is absent. The barn presently houses horses and/or other livestock. A fence abutting the building is used as a horse pen.

Overview of west façade and north elevation of the horse barn (Farm Building No. 3) at Y-7, facing southeast, 03/21/2007.

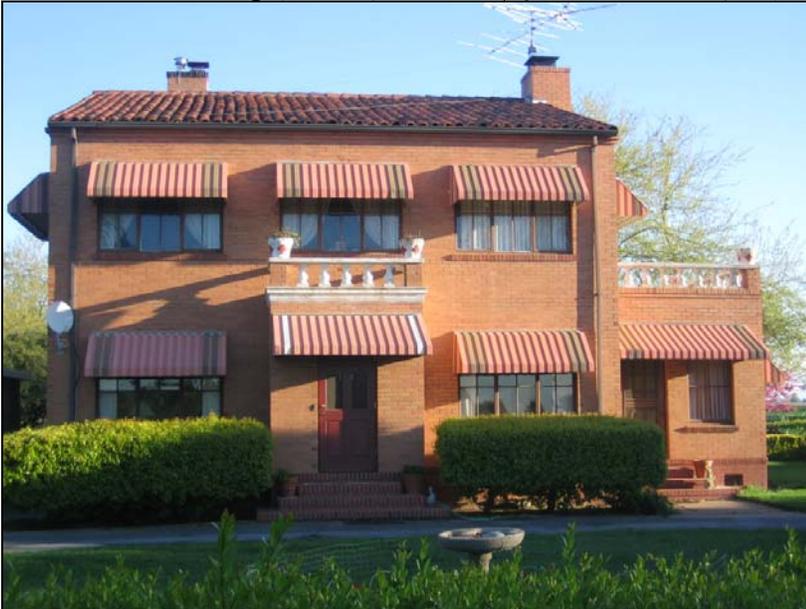
Building No. 1: Built in 1927, this residence is constructed of brick, and measures approximately 43 feet by 42 feet. The Mediterranean Revival-style house appears to have two floors and a basement. It has a ceramic tile roof and a brick foundation. The house also has two chimneys. The garden is well groomed and consists of a lawn with a bird bath, trimmed hedges and a grape vine fence, fruit trees, and a cork oak tree (*see Continuation Sheet, page 2*).

Northern overview of the southern façade of residence (Building No.1); 03/21/2007; CP003.

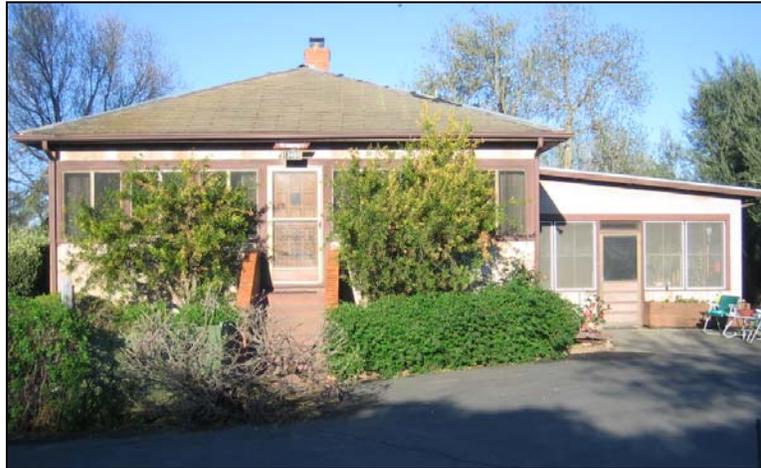
Building No. 2: This other older single-storied residence was, according to the owner, built between 1865 and 1875. The house still has its original foundations. The home was remodeled in 1949 and was originally two stories; it measures approximately 50 feet by 28 feet. The house has asbestos siding, one chimney, and a modern tar shingle roof. The house is surrounded by trees with a garden constructed of brick that has star-, clover-, circle- and square-shaped designs made of upside down beige stoneware bottles (circa. 1870).

Eastern façade of Building No.2, the older residence at HRI-4/114; 03/21/2007; CP018.

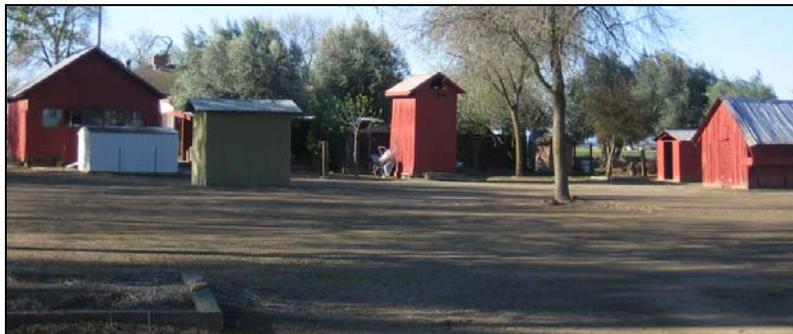
Southerly overview, from east to west, of three red historic buildings: the garage, the smoke house, and the bird house of HRI-4/114; 03/21/2007; CP032.

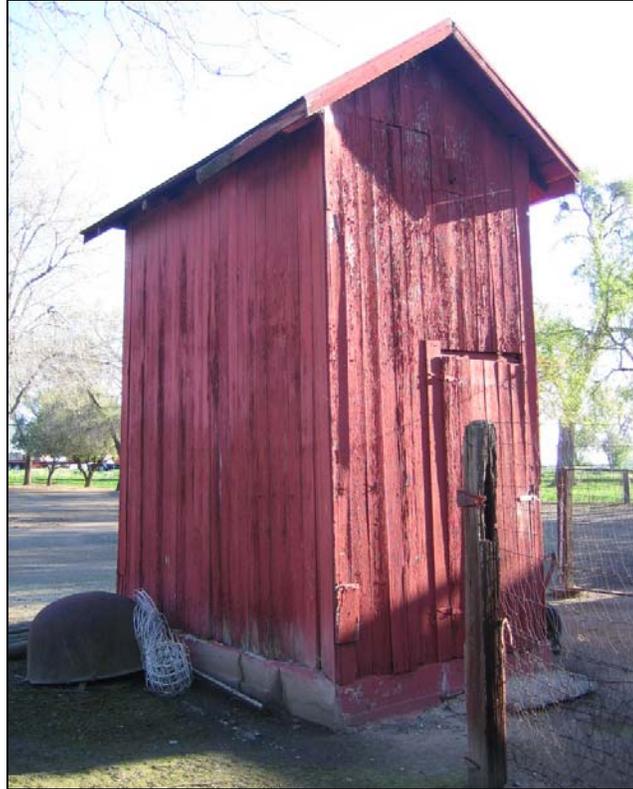
Building No. 4: This resource is a smoke house built in the 1880s. It is approximately 15 feet high with red painted vertical side boards and a roof consisting of tar paper shingles, and measures approximately 10 feet 8 inches by 6.5 feet. It also has a 1 foot high concrete slab foundation on top of an older brick footing. The floor is poured concrete. There is evidence of square nails on the building.

Northeasterly overview of the western elevation and southern façade of the smoke house (Building No. 4) at HRI-4/114; 03/21/2007; CP024.

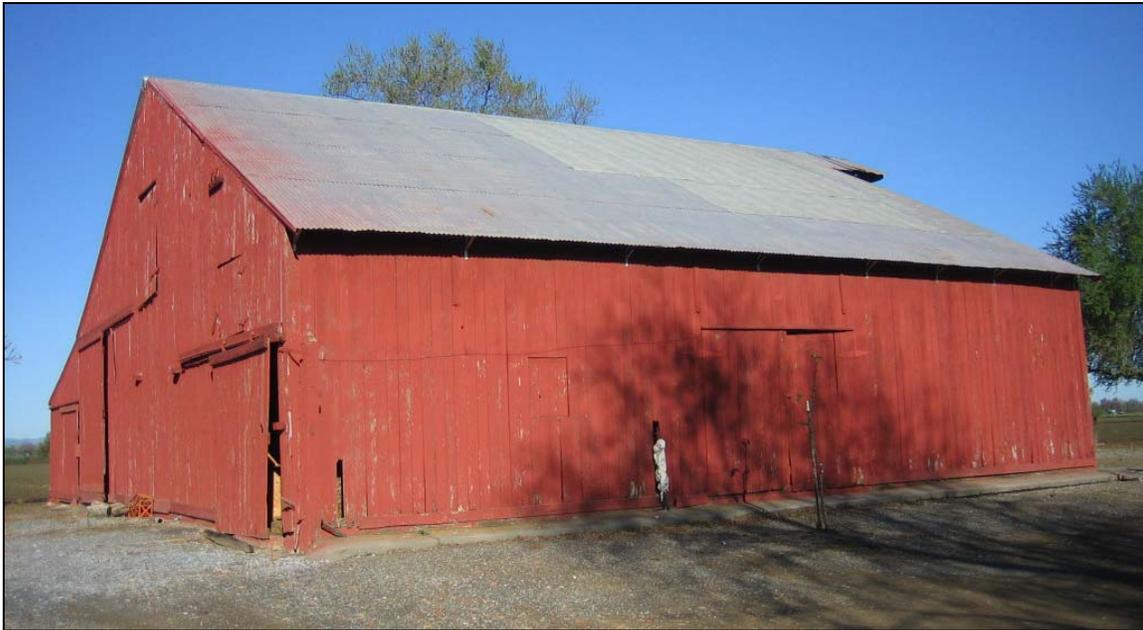
Building No. 6: This resource is a large barn built in the early 1900s. It is approximately 25 feet high has red painted wood board siding and an unpainted corrugated roof. The barn measures 68.5 feet by 50 feet. It also has six track doors (three on the south facade and three on the north facade) and a cement footing edge around the entire barn. The second story of the barn has wooden window openings. The barn also has square and modern nails.

Northwestern overview of the southern façade and eastern elevation of the barn (Building No. 6) at HRI4/114; 03/21/2007; CP028.

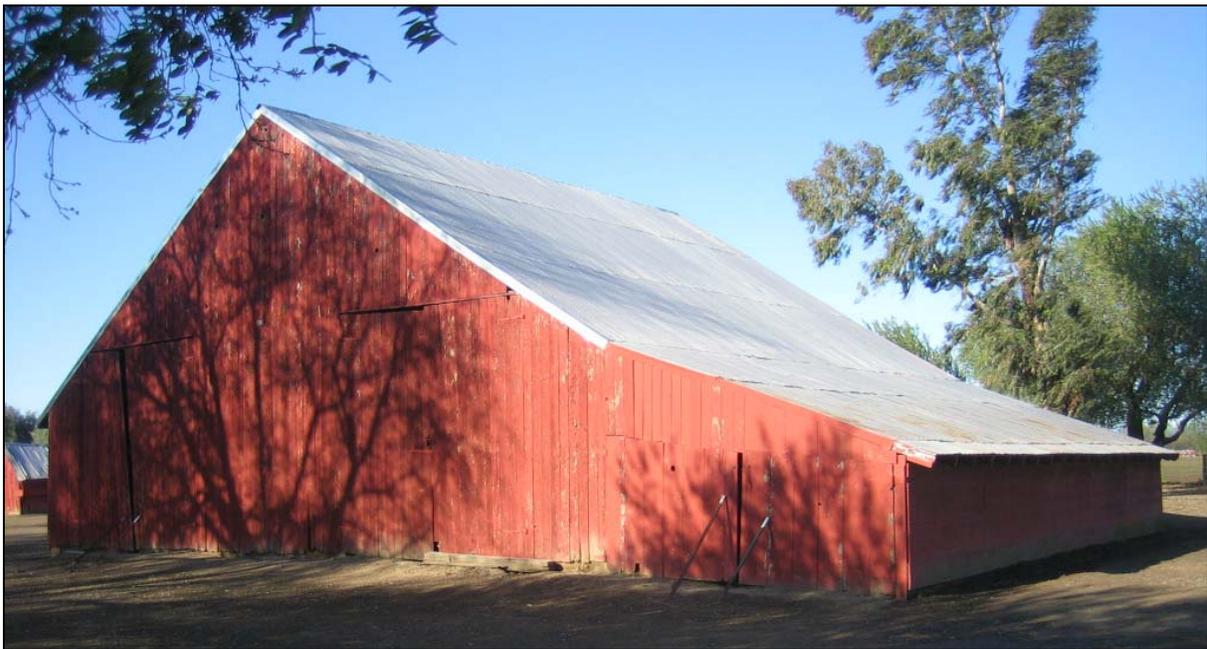
Building No. 7: This resource is a large wooden granary. It is sided with red painted wooden planking and appears to be approximately 25 feet high, and measures approximately 59 feet by 41 feet. The roof is relatively new and consists of unpainted corrugated metal. The foundation is made of brick and is four bricks high. The wooden siding of the granary has evidence of square and modern nails. This building also has four large doors.

Southwesterly overview of eastern façade and northern elevation of the granary (Building No. 7) at HRI-4/114; 03/21/2007; CP030.

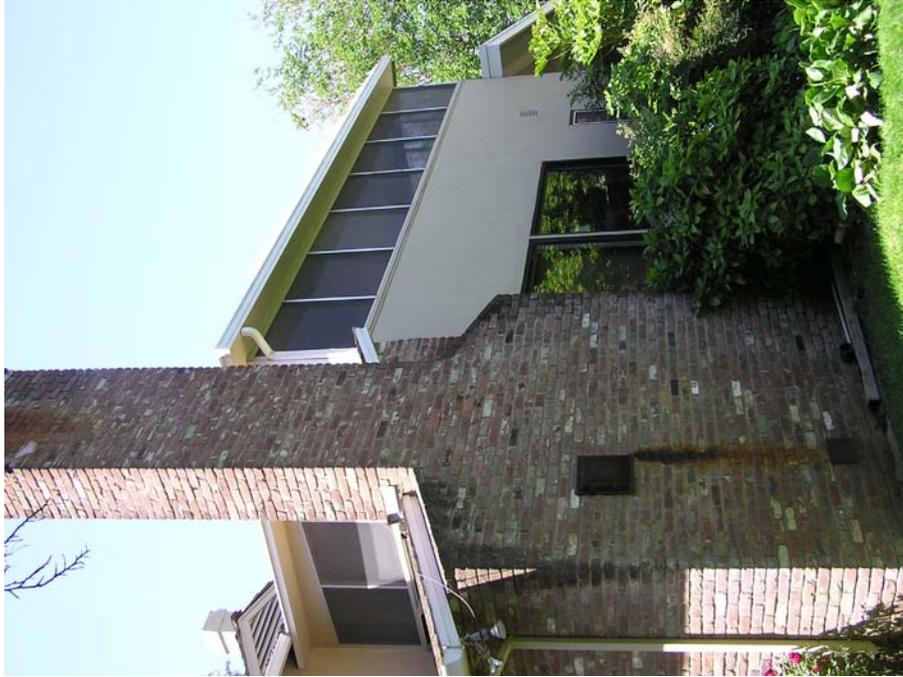
east end of the parcel. The house is on a brick foundation and has a hipped roof with overhanging eaves and a small gable-roof louver dormer on each side. A hipped roof wrap-around porch, supported by large square columns, is on the south and east. All roofs are covered with composition shingles. The house originally was clad with wood siding; it is now covered with stucco. A one-story gable-roofed two-car garage and office is attached to the west side of the house. While it is a free-standing building, the roof continues to the main house, creating a covered walkway. Two exterior brick chimneys are present. The east side chimney is covered with stucco. The north side chimney is part of a shed-roofed brick addition on the northeast corner of the house. The rear (north) of the house has been expanded with a flat-roofed addition.

View southwest of House 1, rear addition, May 10, 2007, 047.jpg

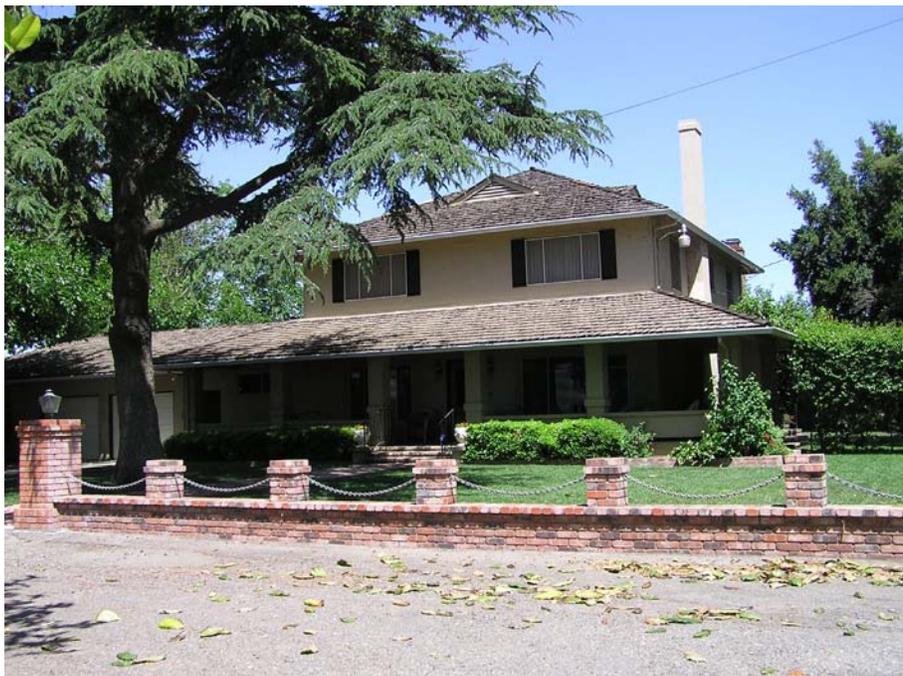
View northwest of House 1, May 10, 2007, 050.jpg

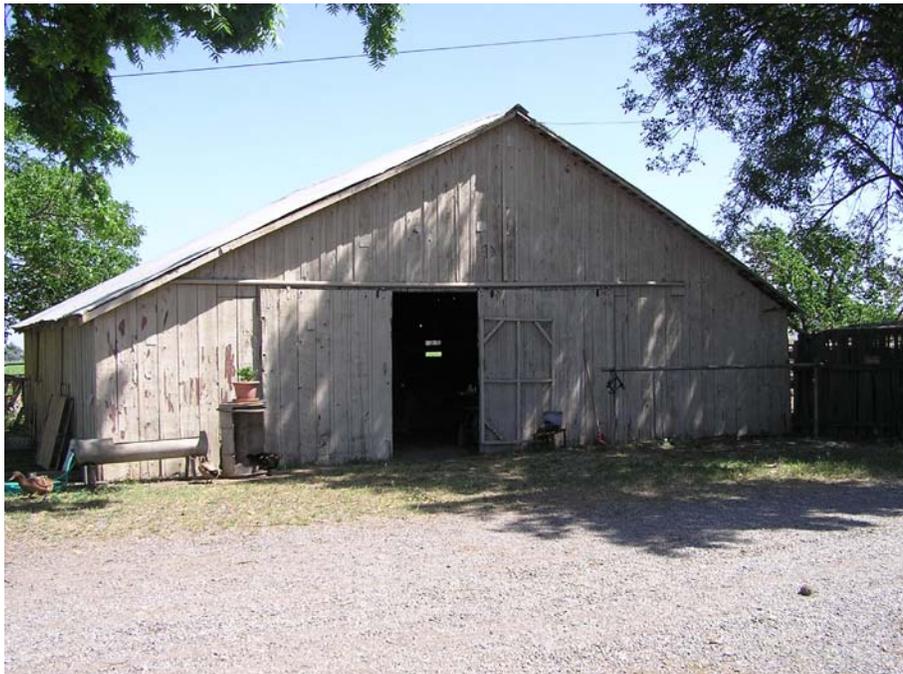
View northeast of barn, May 10, 2007, 018.jpg

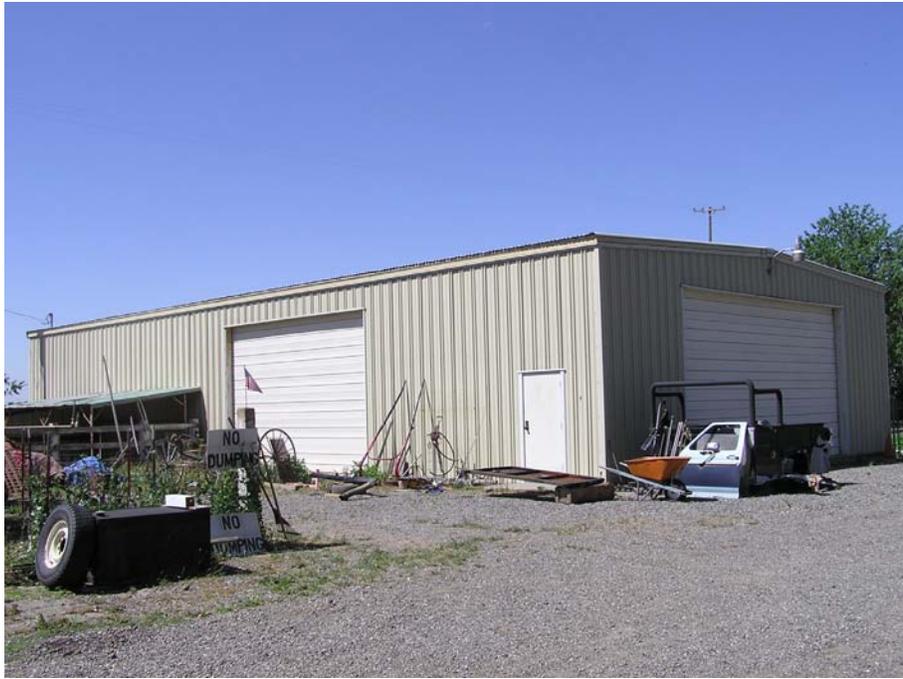
View southwest of warehouse, May 10, 2007, 014.jpg

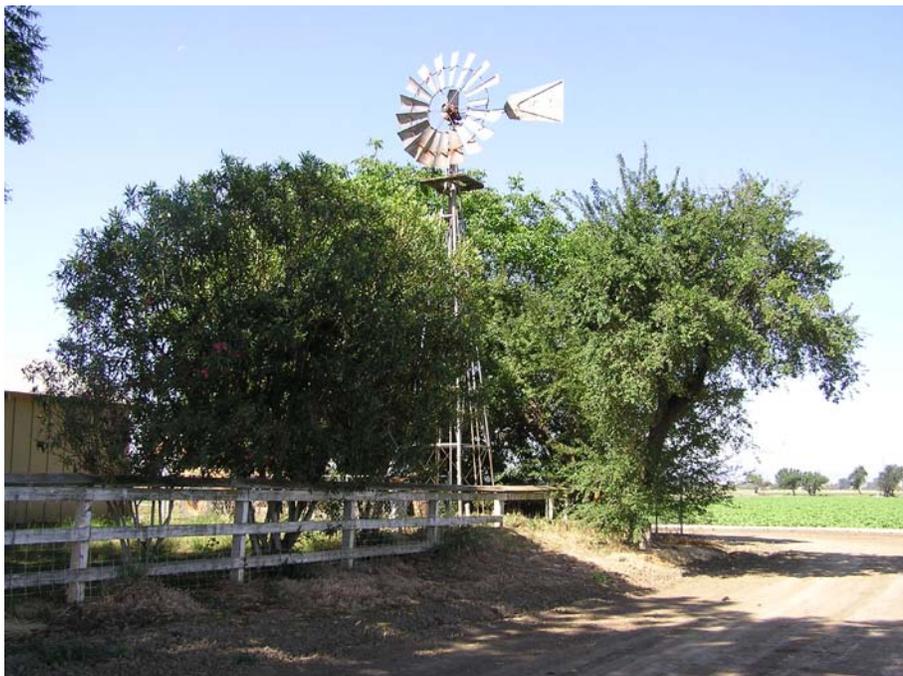
View southwest of windmill, May 10, 2007, 004.jpg

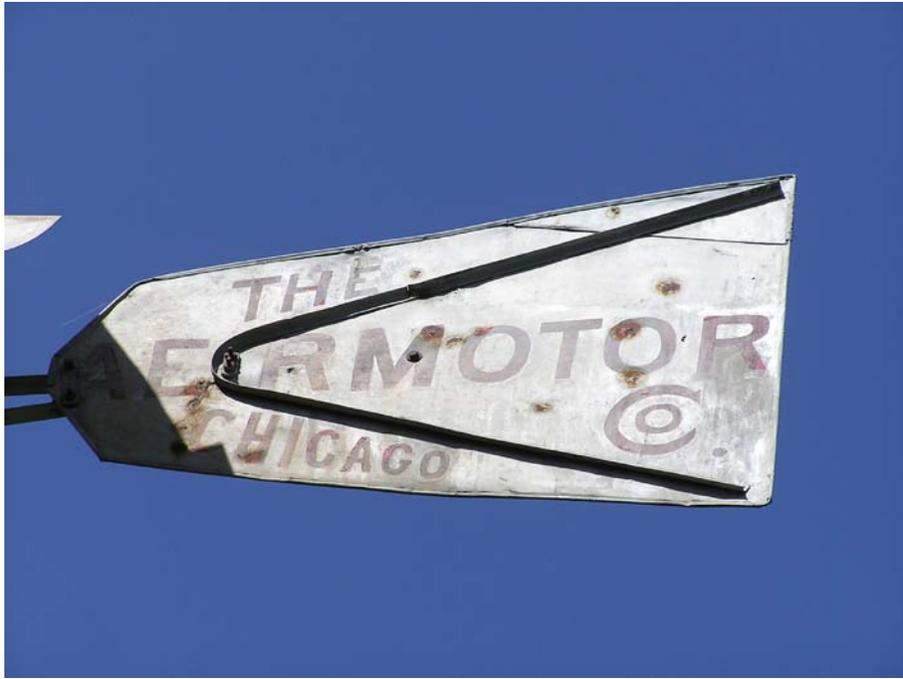
Detail of windmill blade, May 10, 2007, 007.jpg

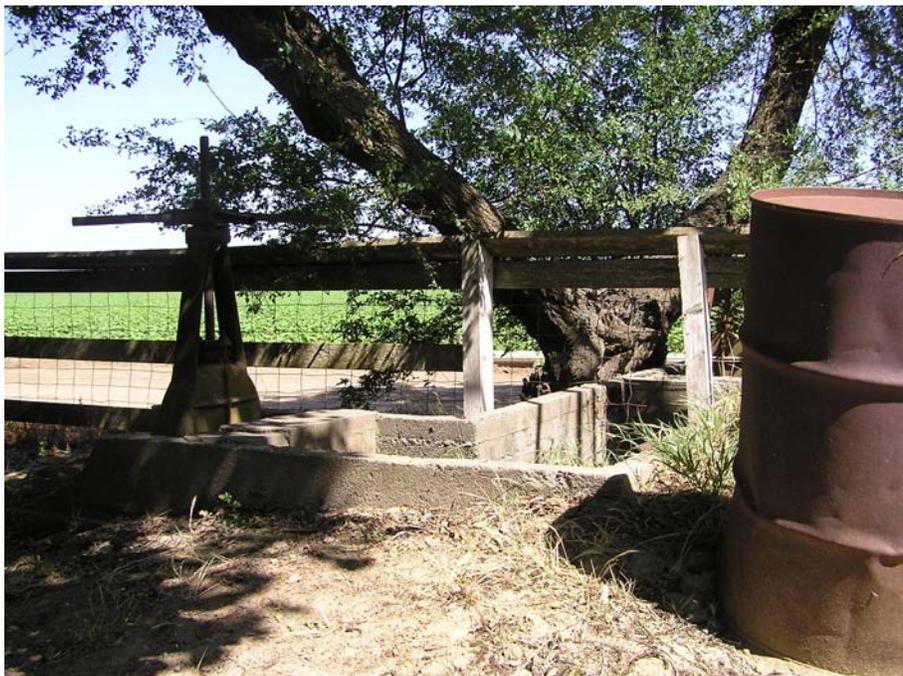
View north of wells near windmill, May 10, 2007, 008.jpg

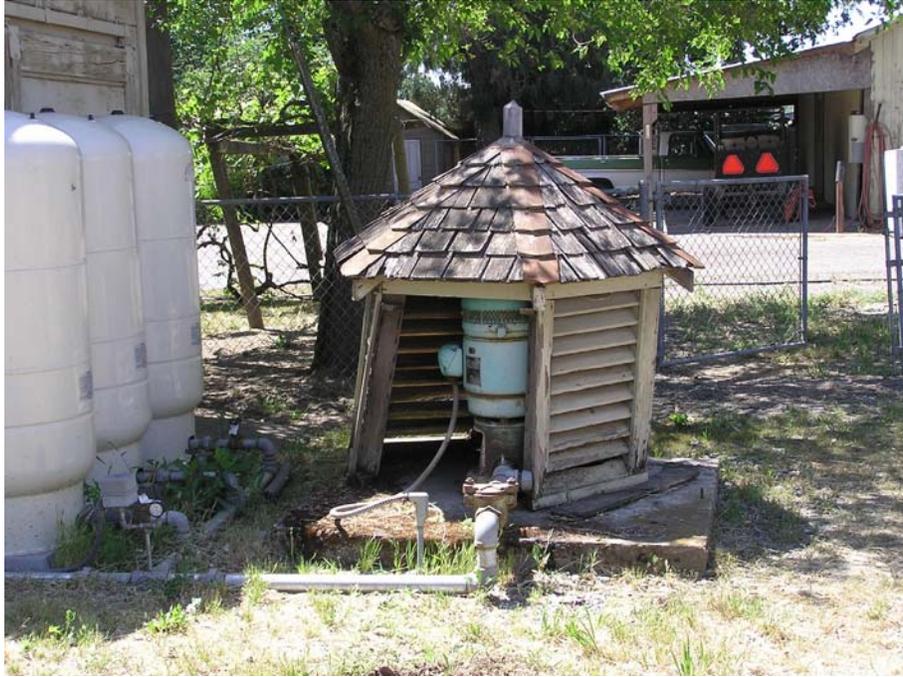
Another modern well, protected by a wood-slat structure with a five-sided cone-shaped roof, sits on a concrete foundation between the barn corral and Shed #2.

View south of modern well, May 10, 2007, 035.jpg

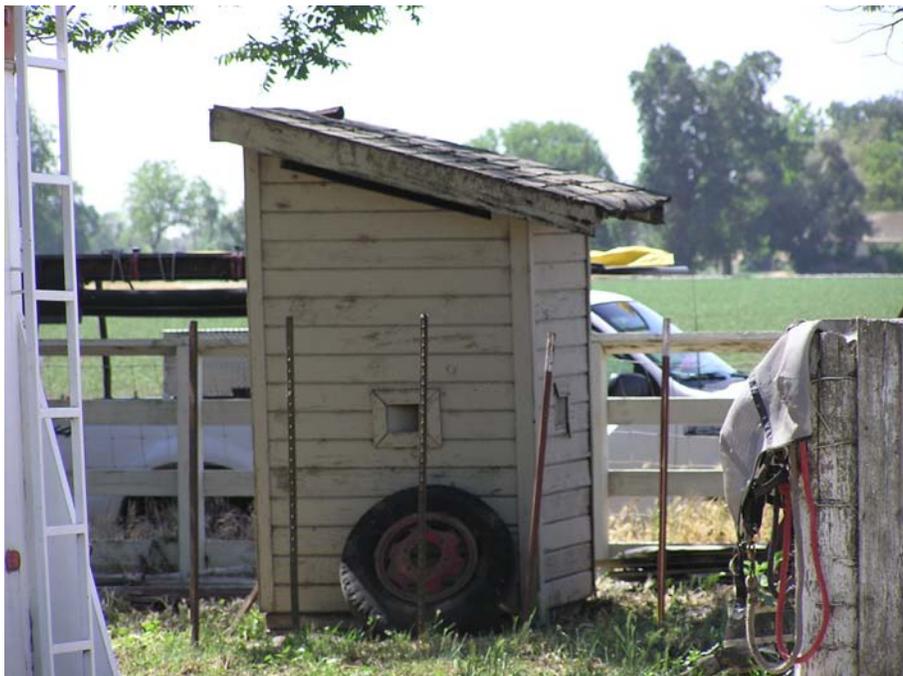
View south of privy, May 10, 2007, 016.jpg
