Implementation of Composite Repairs on Marine Pipelines

Osbaldo Chavez, Training Dept. Mgr., Technical Sales Rep.,
Clock Spring Company, L.P.

Chad Edinger, General Manager, NuStar Energy, West Region

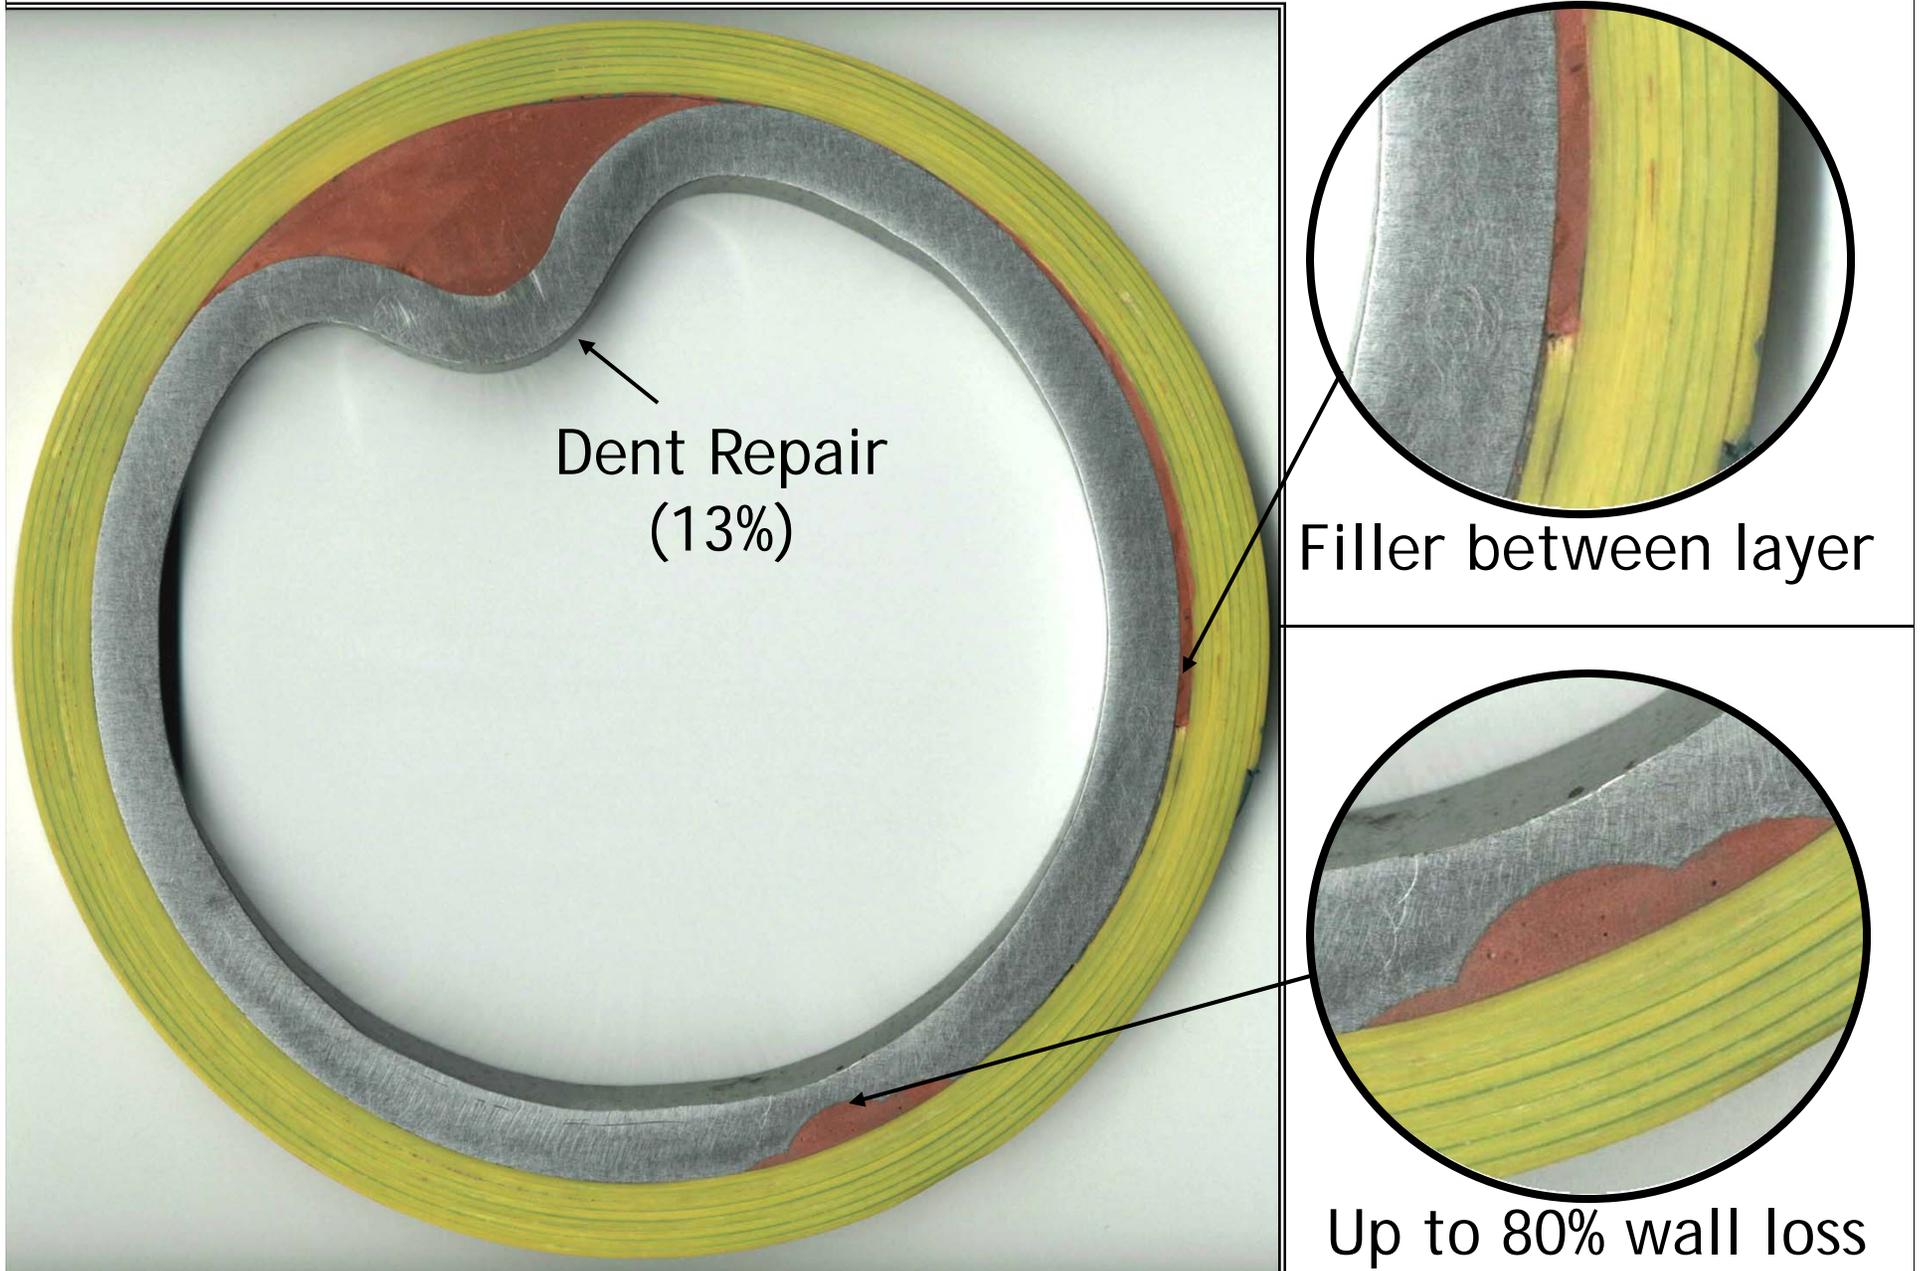
Clock Spring Cross Section (Repaired Dent and Corrosion)

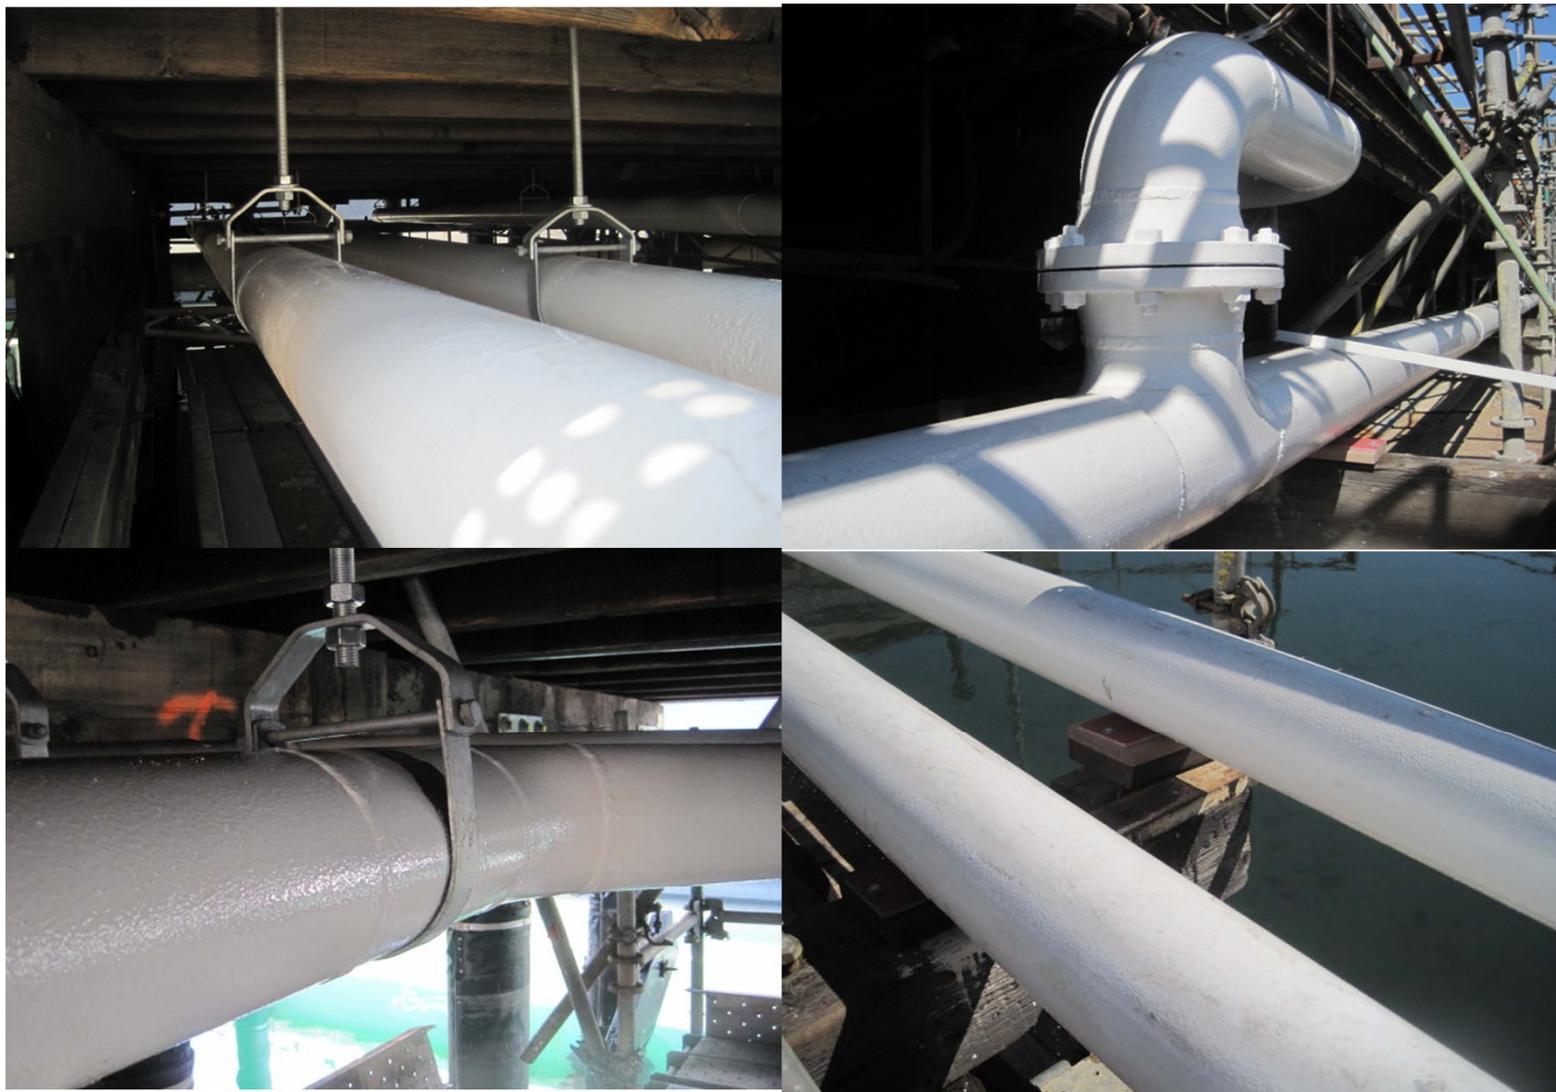
- API 570 inspection revealed areas of significant external corrosion on uncoated pipe with as little as .10” remaining thickness
- Based on established corrosion rates, some areas only required external coating to mitigate future corrosion
- Areas under pipe clamps were unknown and were not able to be inspected with UT
 - Pipe to clamp areas were known not to have a non-conductive material between pipe and steel support
 - Dissimilar metals creates a known corrosion cell in the marine environment where moisture is trapped
 - These areas were treated as unknowns and were to be inspected separately with the proper precautions

- ❑ Two Part Strategy to exposed pipe repair
 - Depending on site-specific corrosion, either prep and externally coat, or
 - In the areas of exposed piping (away from pipe supports), “Snap-Wrap” Clockspring© materials were chosen as final mitigations
- ❑ Majority of piping had majority of original thickness and could be coating as the full mitigation
- ❑ Isolated areas required clockspring repairs; generally as a result of improper support-to-pipe buffer material
 - Generally in areas of trapped water to pipe
 - Dissimilar metal to metal contact

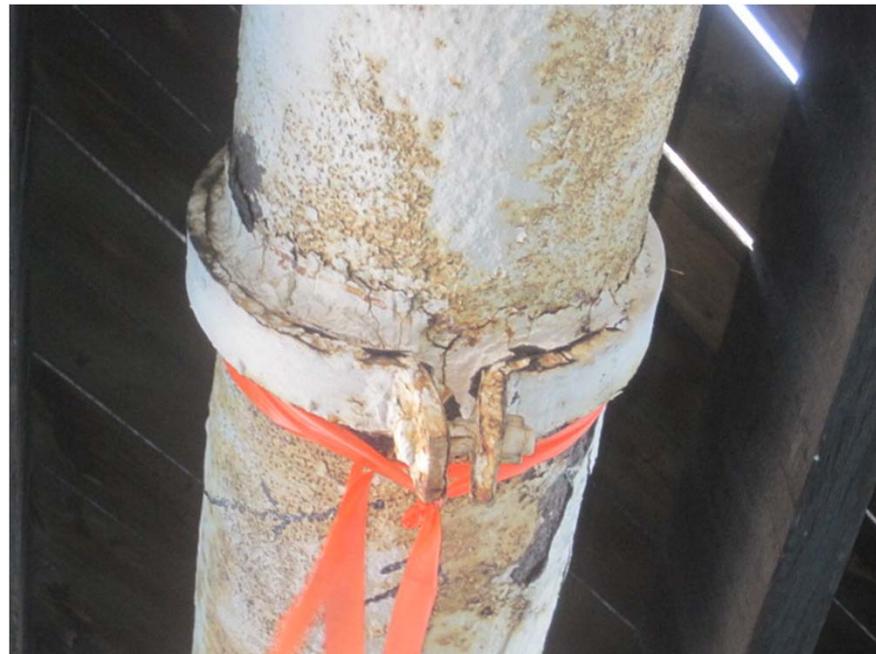
- Original plan was to support, remove clamps, UT, then repair similar to the exposed pipe depending on the RT under the pipe support
- No evidence or history of leak or weep on the pipe or support
- Alternative was to construct new transfer line and to demo existing.
