# SANTA BARBARA CHANNEL COASTAL HAZARD REMOVAL PROJECT

California State Lands Commission

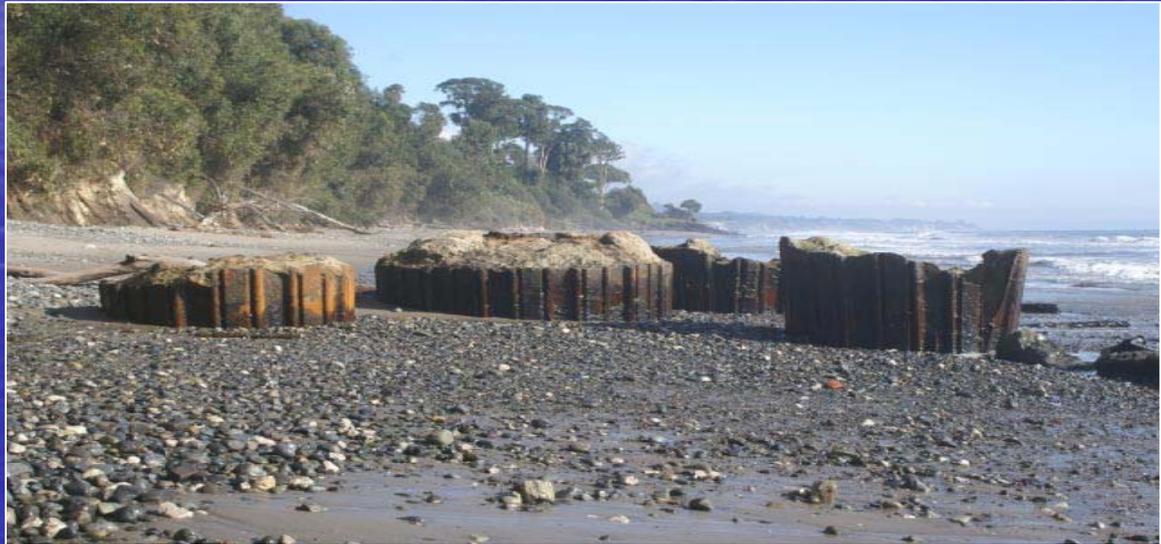
# ***Hazards Include***

- ***Sheet Pile, H-pile, Round pile***
- ***Concrete with exposed rebar***
- ***Wellheads with remaining well casings***
- ***Hazards are sometimes always exposed and others only exposed during low sand events***

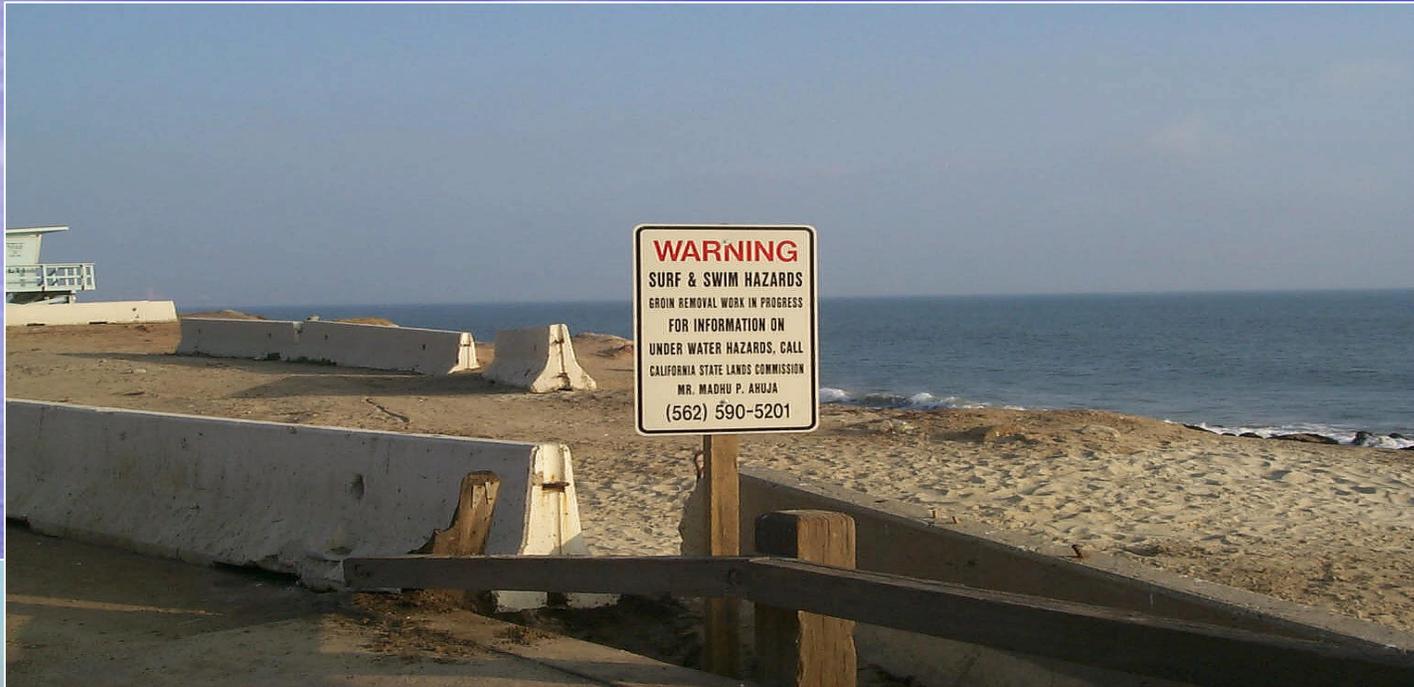
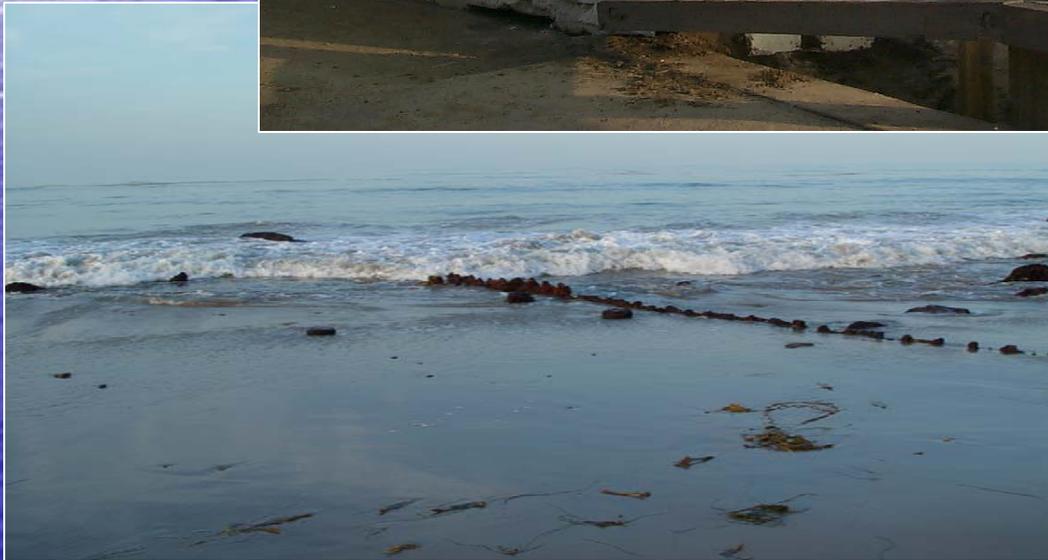
# Las Tunas Beach

- 5 derelict groins with exposed sheet piling constructed in 1934
- Sheet Pile, concrete cap & exposed rebar
- Exposed H-Pile
- 1 groin that required remediation work

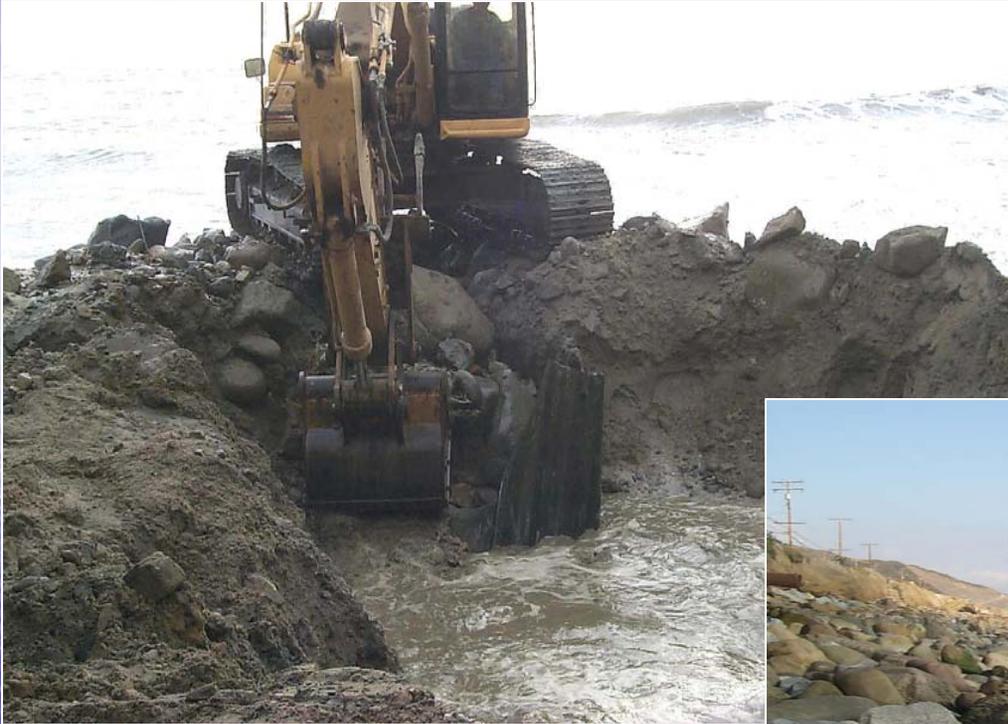
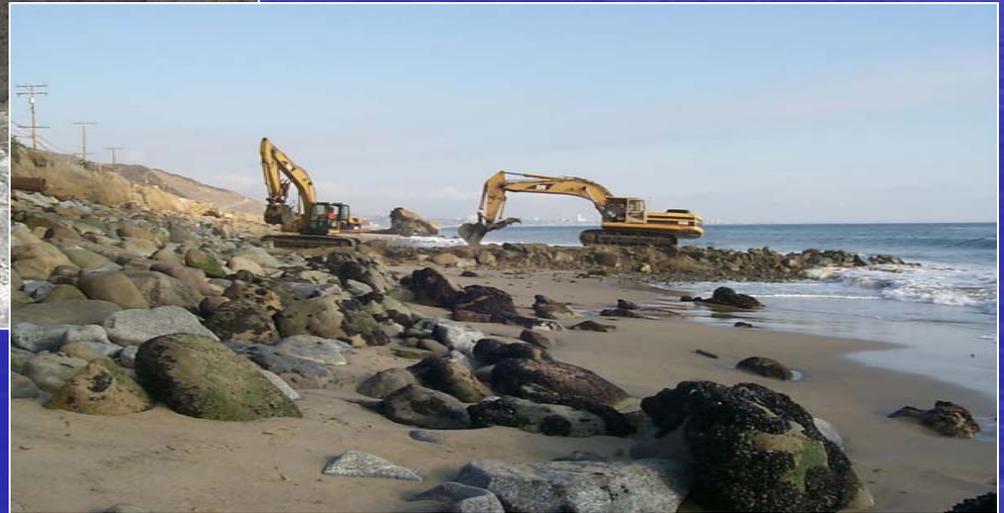
# *Las Tunas Beach – Removal Operations*

- Onshore & Offshore Spread
- Onshore Spread
  - CAT 330 Excavators
  - U/W & Topside Burning Equipment
- Offshore Spread
  - Divers working in surf line supported from beach
  - U/W Burning Equipment

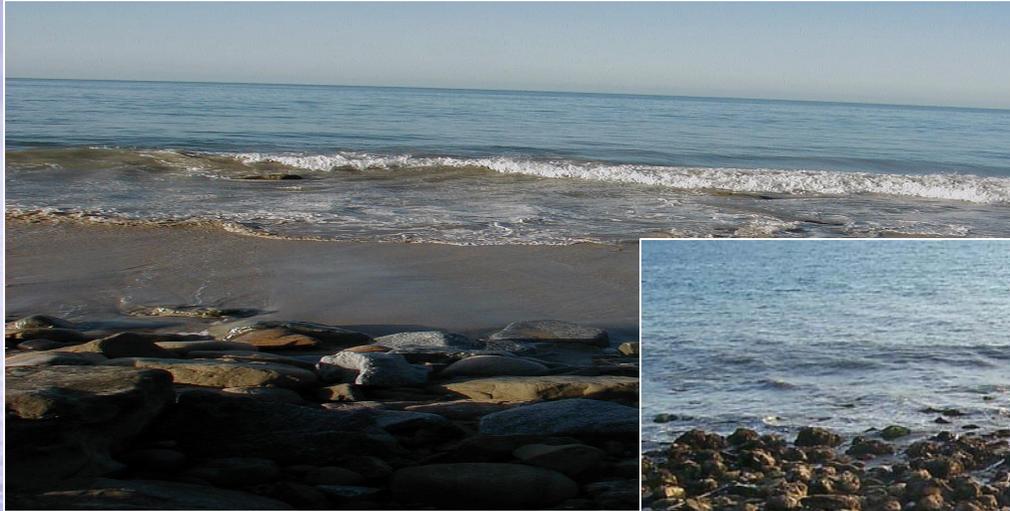
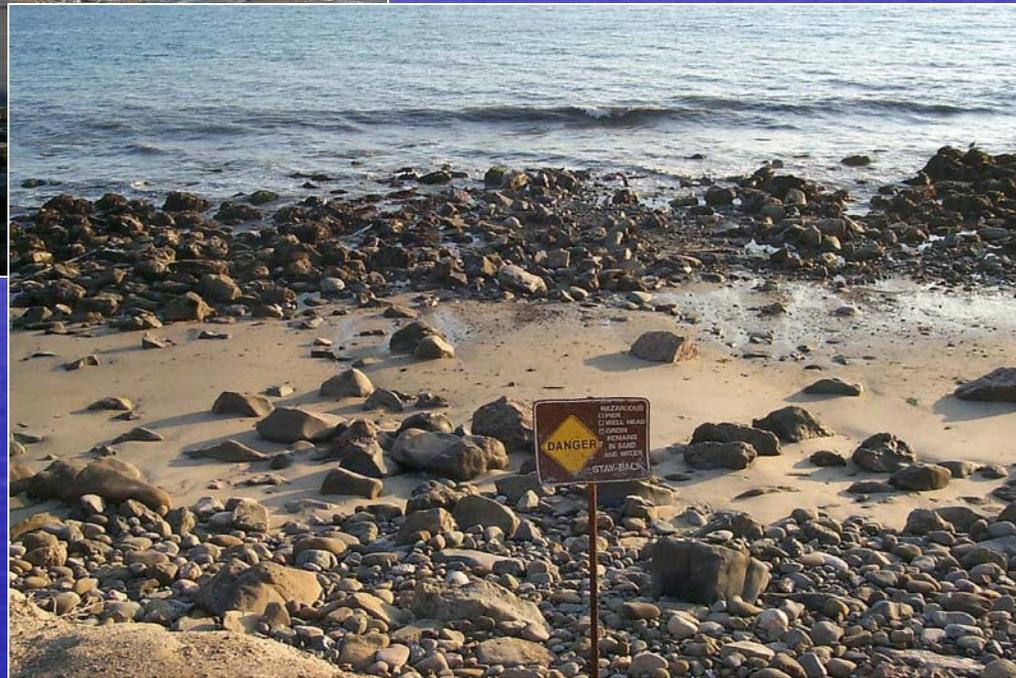
# *Las Tunas Beach – Post Project*

- Over 900 feet of groin removed
- Recovered sheet pile average height of 5 feet
- Divers removed approximately 265 feet of sheet pile from the surf area

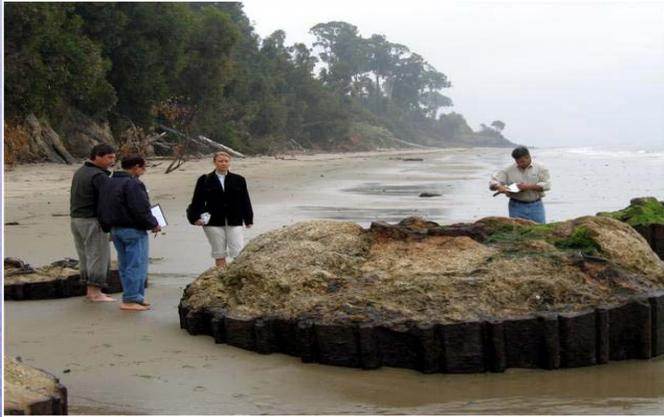
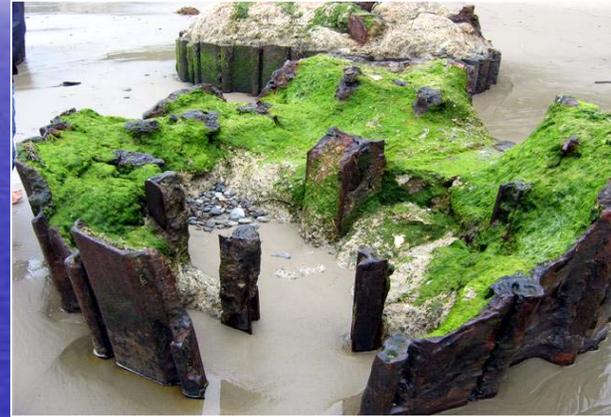
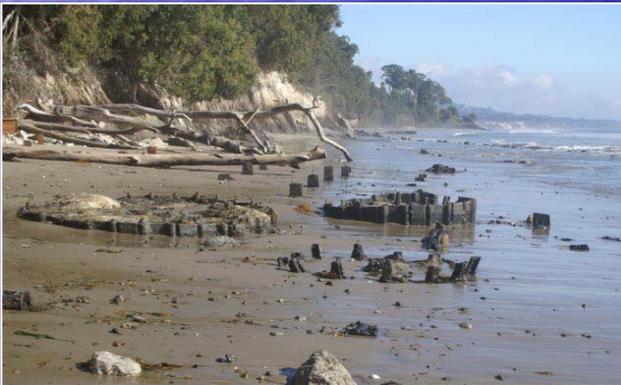
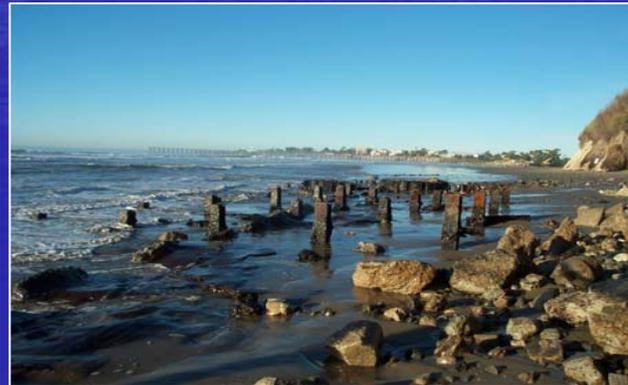
# Goleta Beach Hazard Removal

- This site is located on Goleta Beach, SB County; east of the Goleta Slough
- The site consists of 4 former drilling sites known as James-136, Sands-137, Crandall-138, and Parker-139
- Each site contained a center well caisson and four surrounding caissons
- Additional hazards included approximately 250 10 “ H-pile

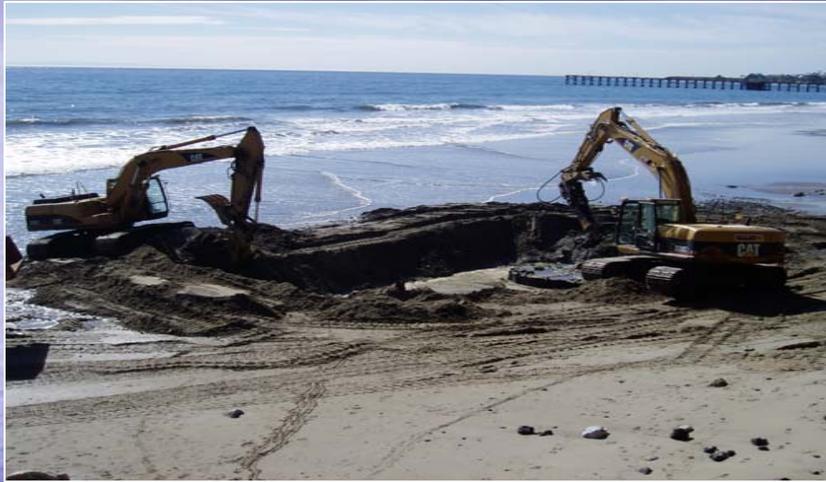
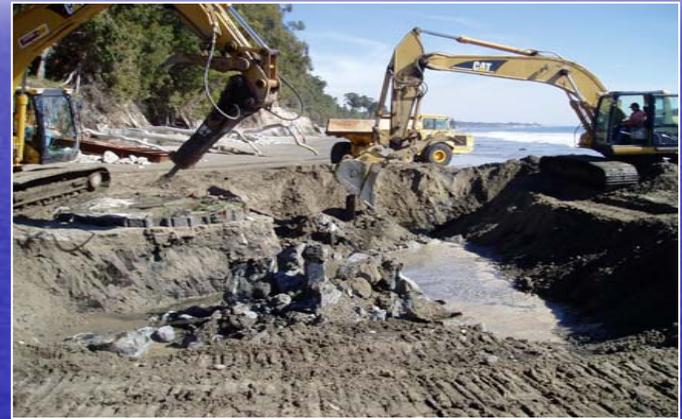
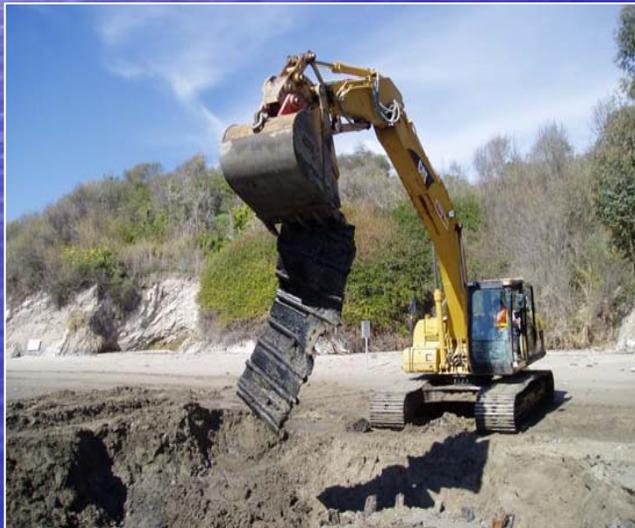
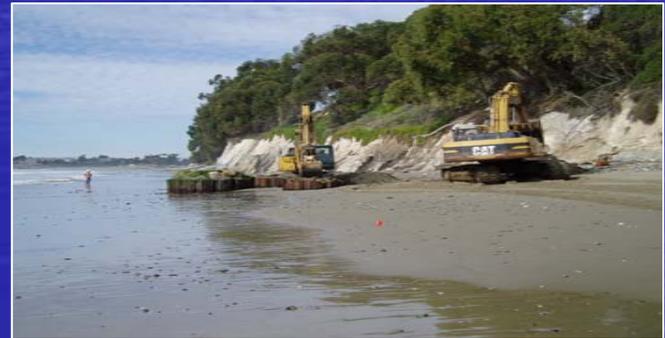
# Removal Methodology

- Onshore Spread
  - 2 each CAT 330 Excavators complete with hydraulic breaker & thumb attachment
  - 6 wheel drive end loader dump truck
  - 100-Ton Crane
  - U/W & Topside Burning Equipment
