Chile Earthquake and Tsunami of February 27th, 2010

ASCE/COPRI RECONNAISSANCE

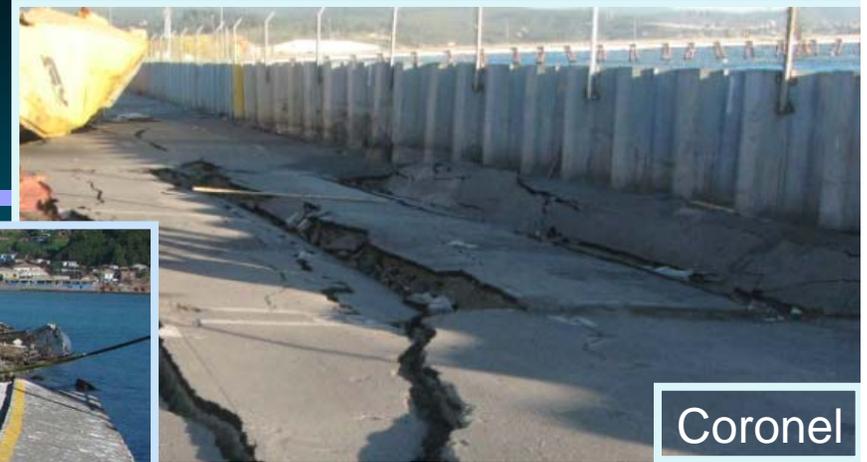
Observations: Loss of Dikes/ Sheetpiles/ Retaining Walls

- ◆ Loss of dike/sheetpile/retaining wall results in loss of backlands
- ◆ Tsunami removes evidence (if any) of liquefaction

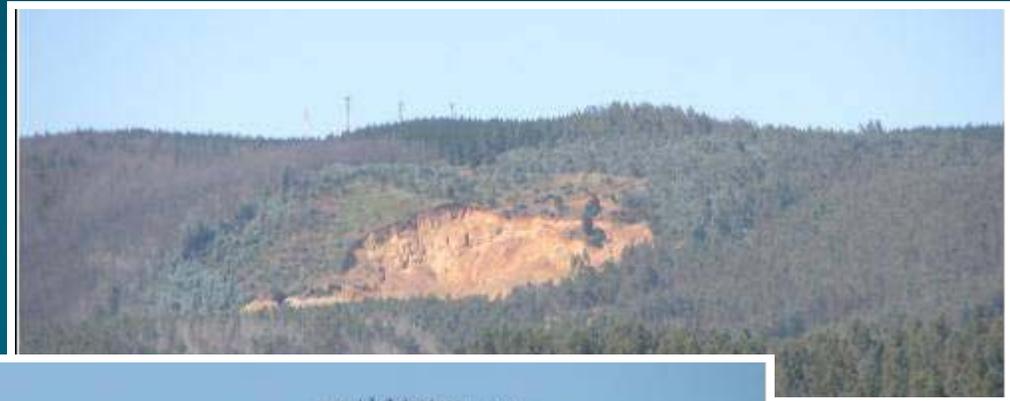
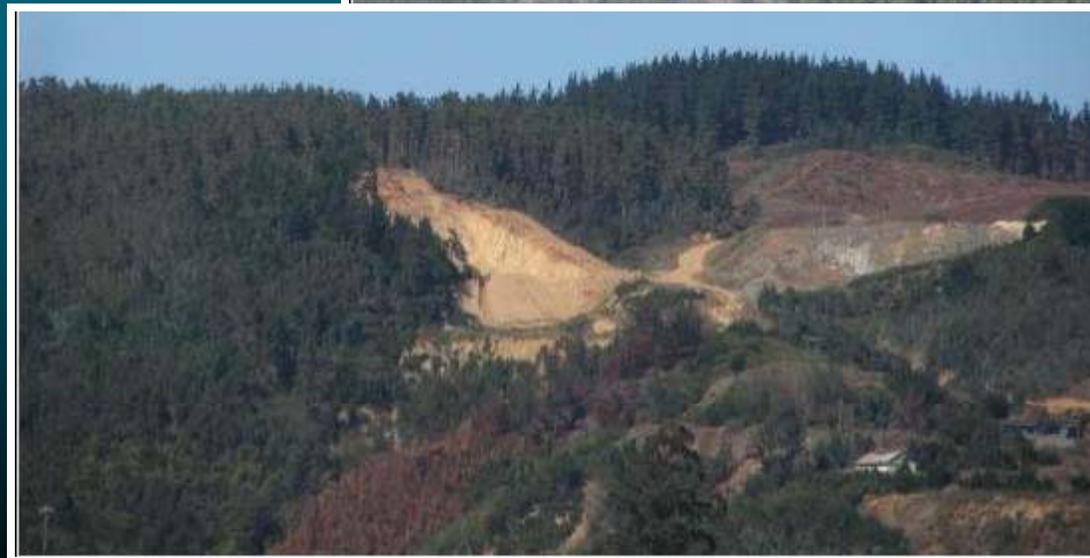
Observations Soil Slope Failures

- ◆ Dry Season – It could have been worse!

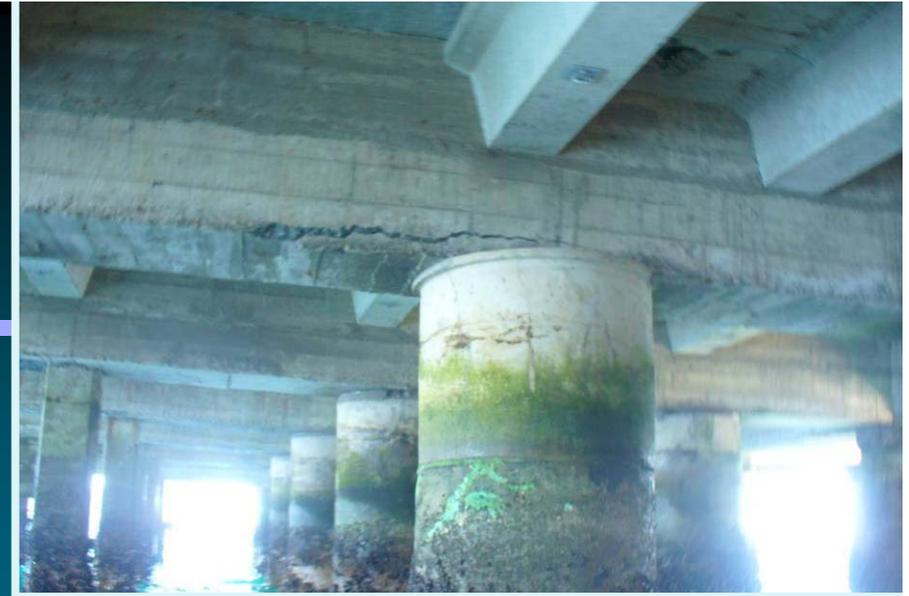
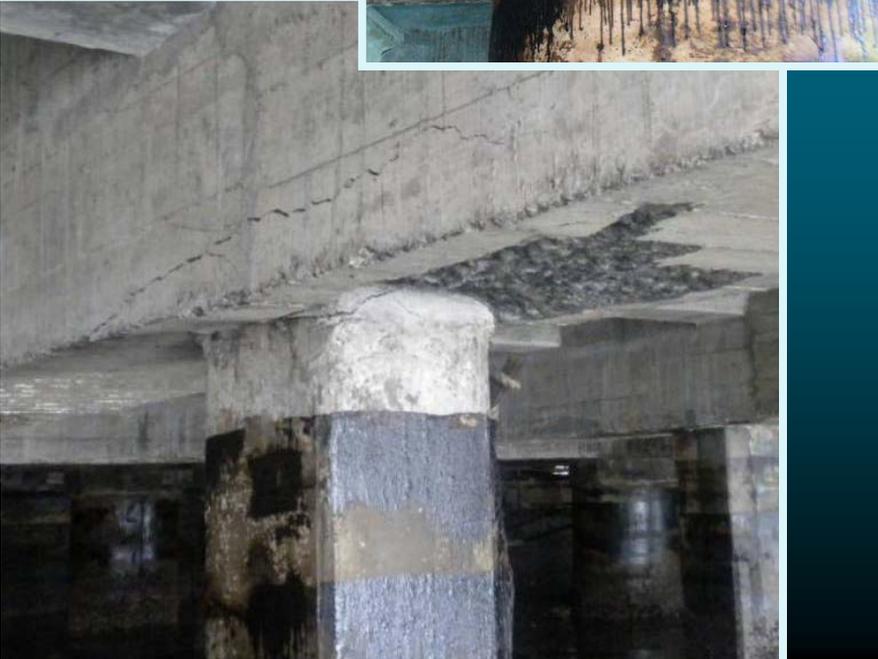
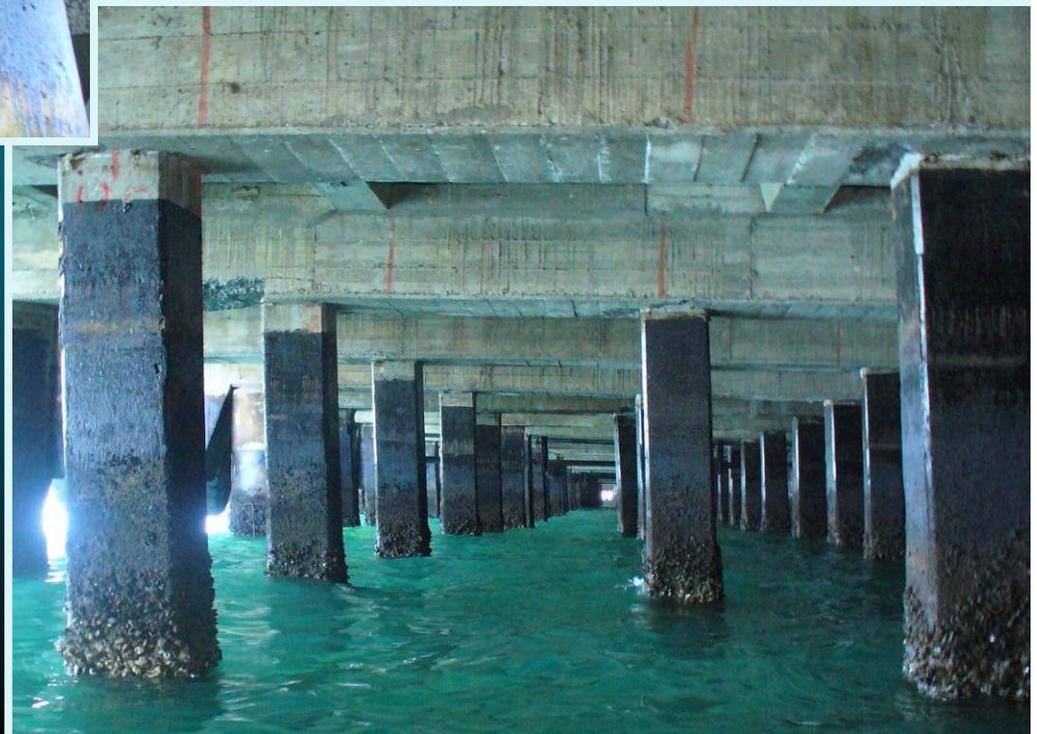
San Vicente Port

Observations Concrete Pier / Wharf

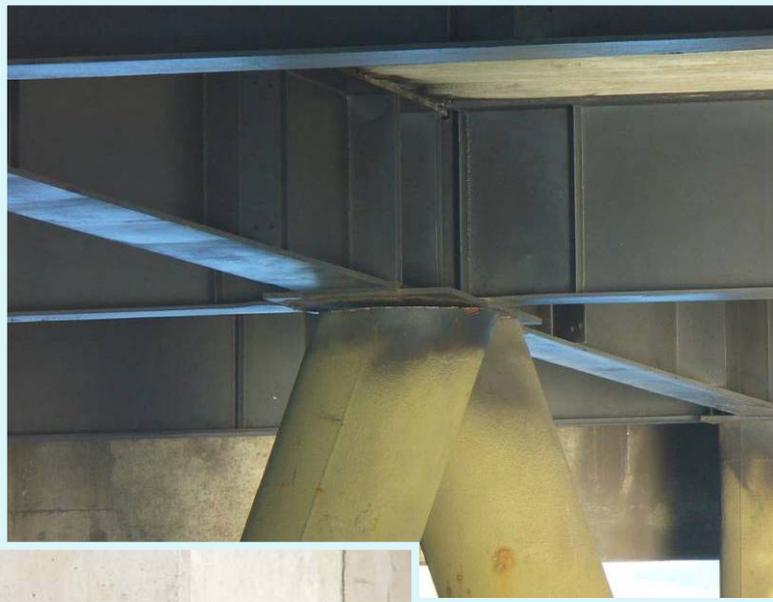
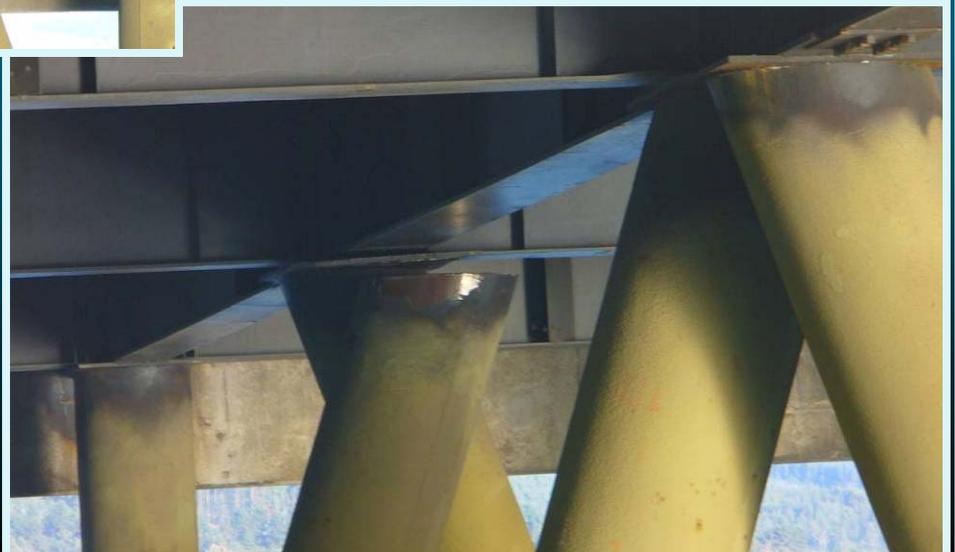
Port of Coronel

Observations Steel Pier / Wharf

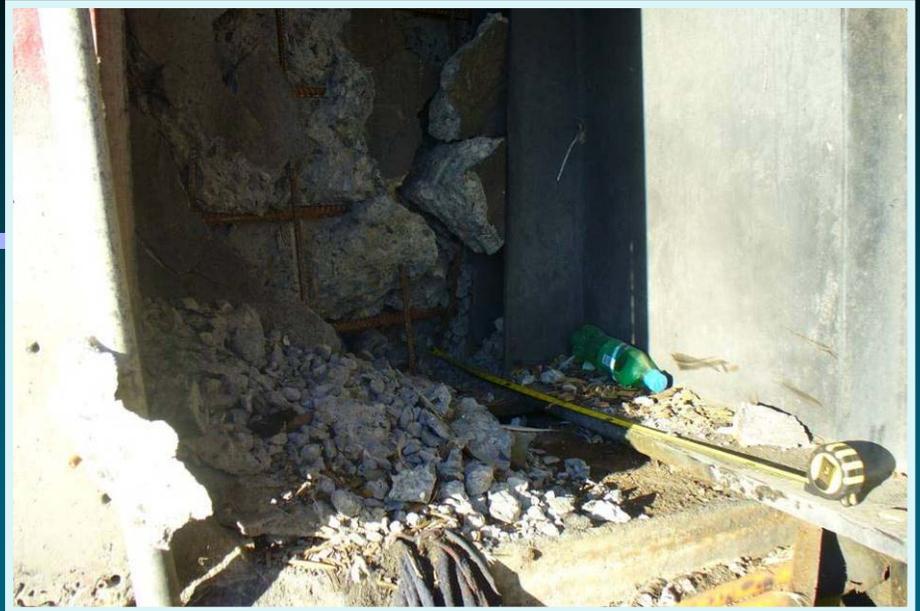
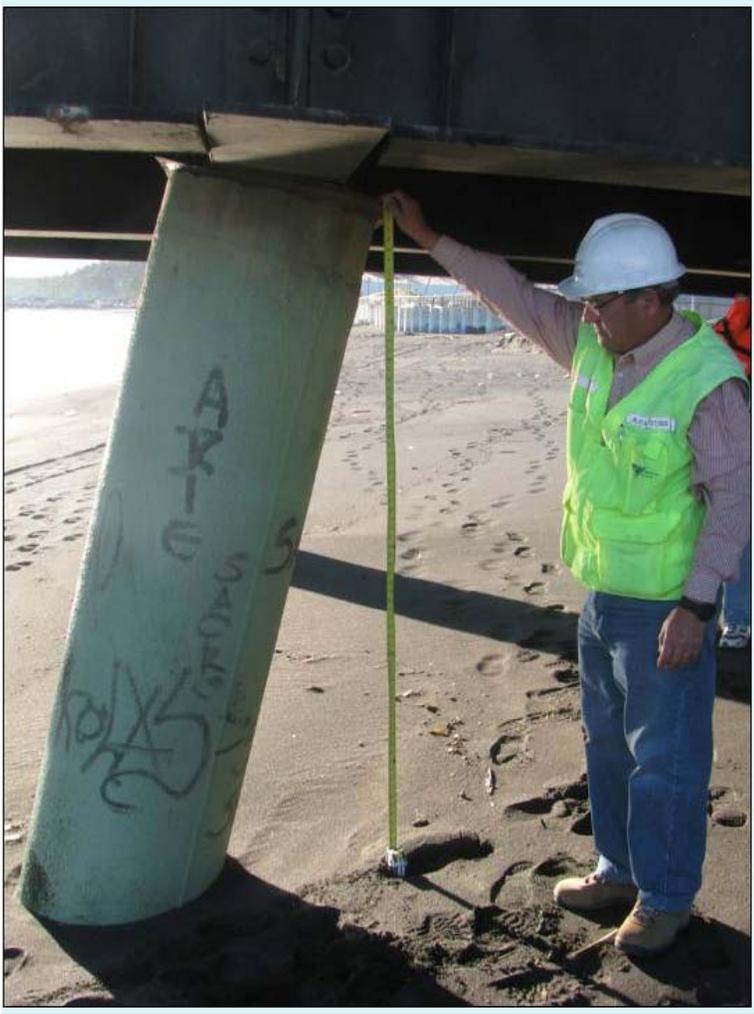
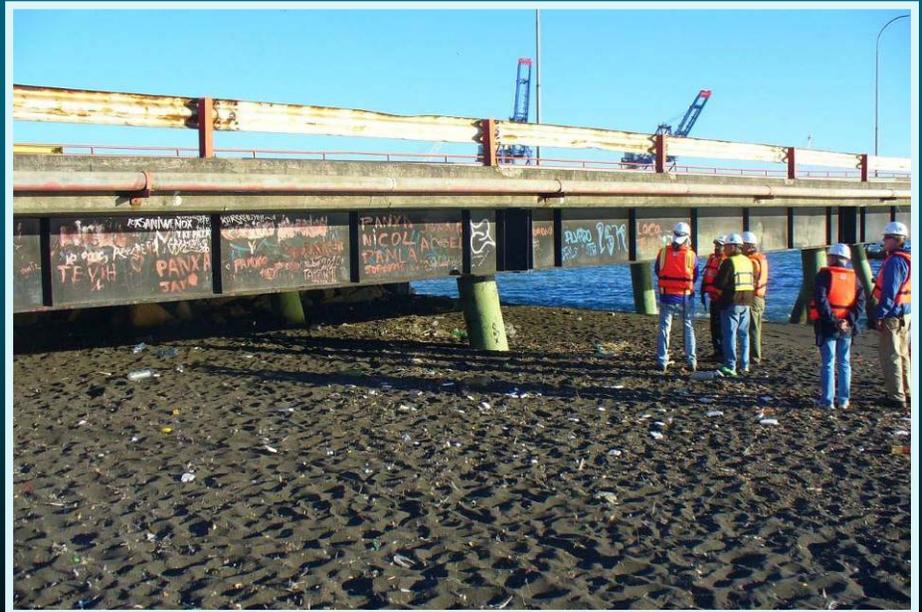
Port of Coronel

Observations Kinematic Loading

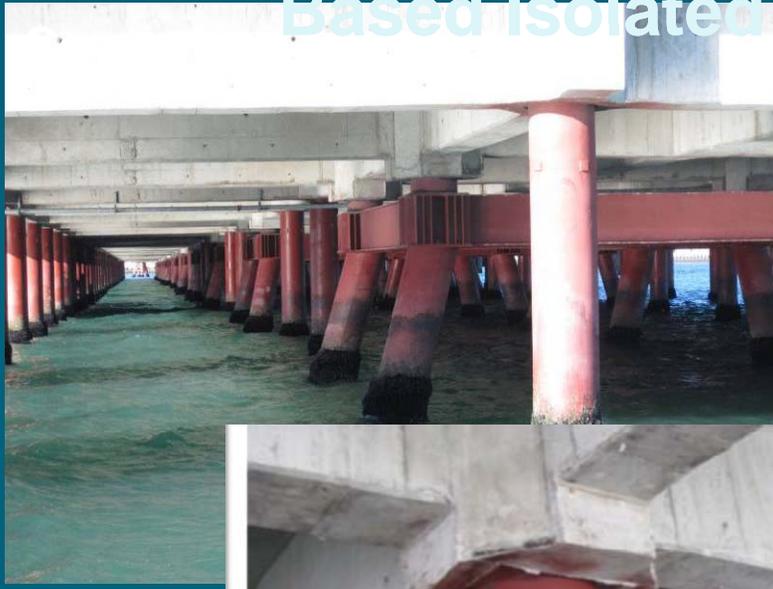
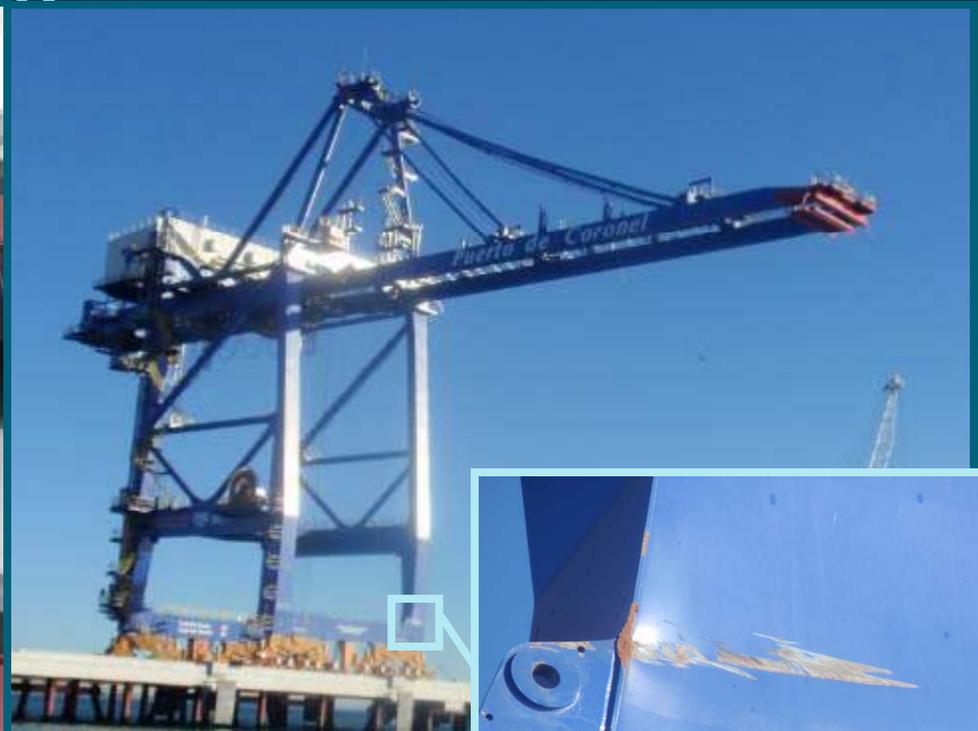
Based Isolated

Designed and constructed (including isolators) in Chile
No damage seen or measured (not instrumented)

Crane at base isolated structure hit by vessel

Possibly due to interaction during earthquake

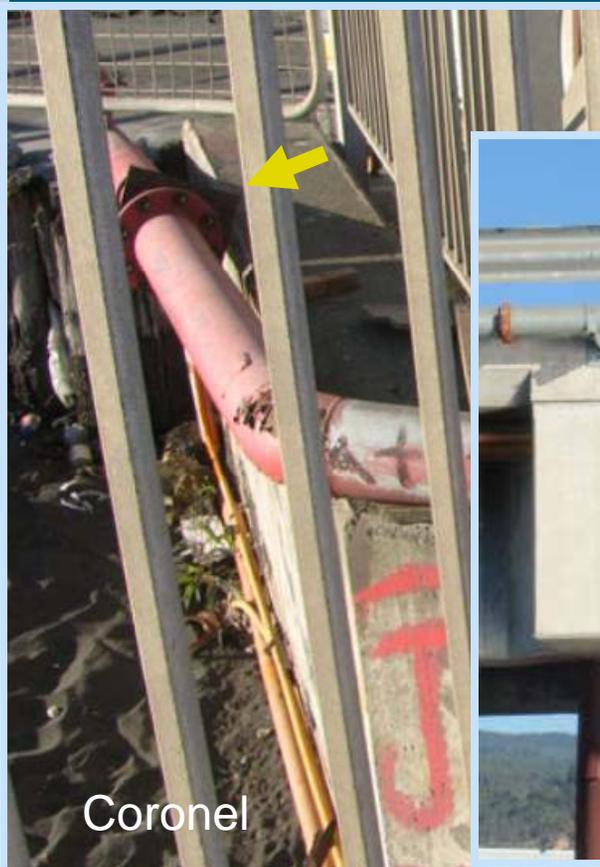
Coronel

Observations Piping

- ◆ Performed well, no ruptured piping found, even where pounding or anchorage loss

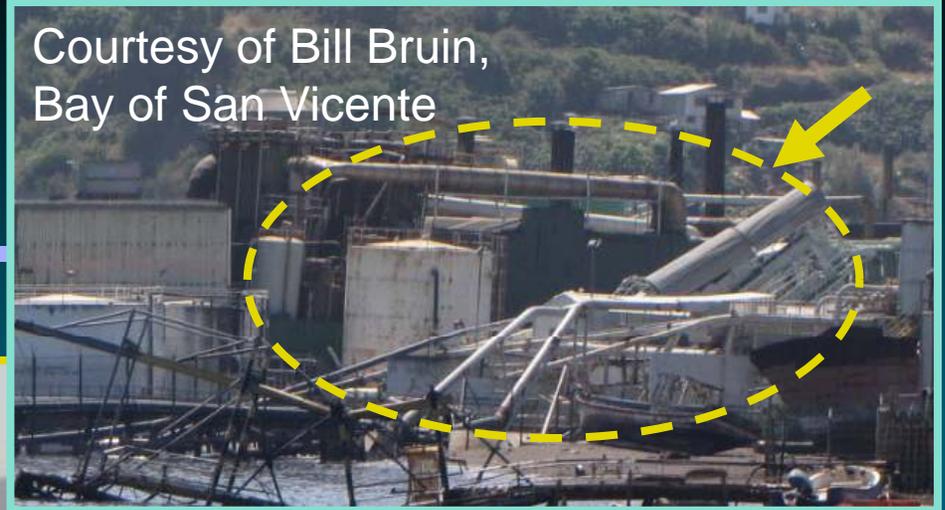
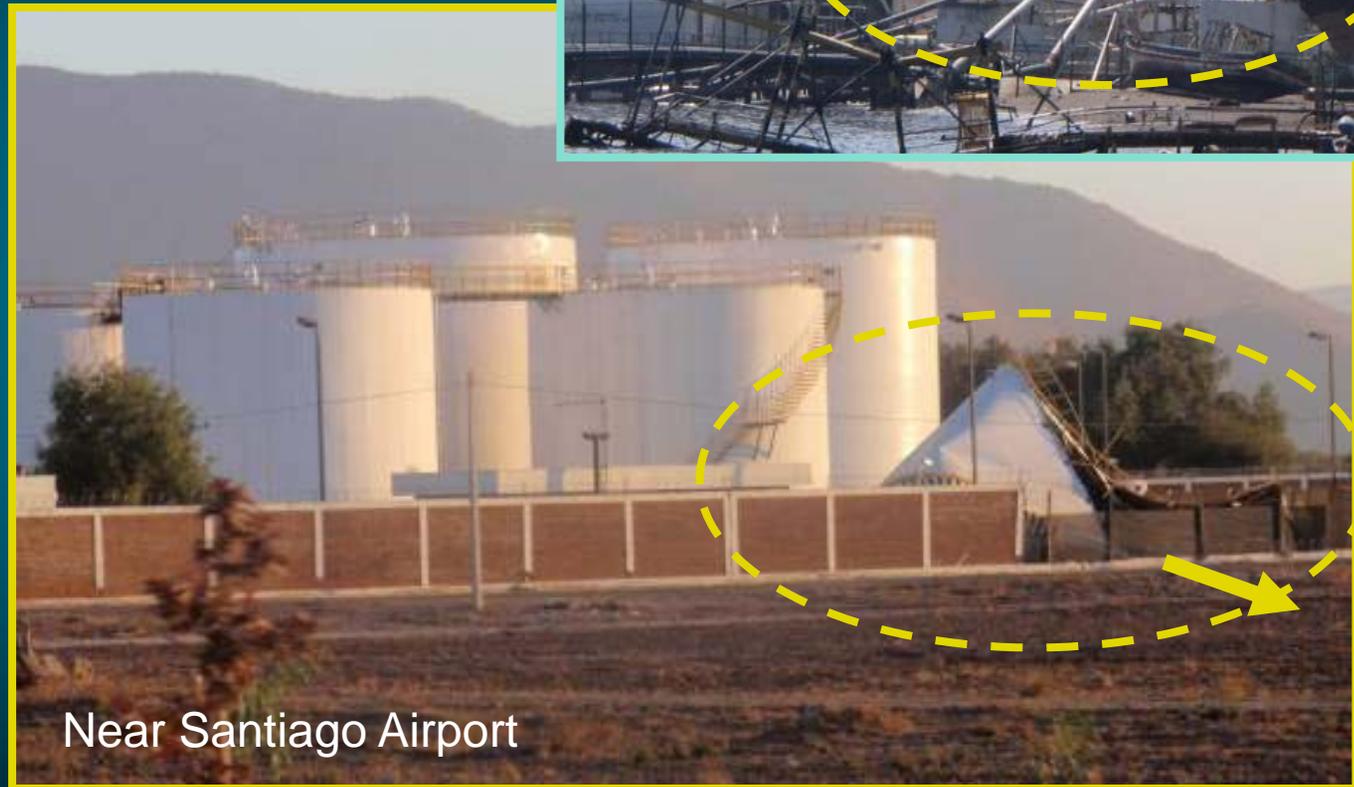
Observations Tanks

Courtesy of Bill Bruin,
Bay of San Vicente

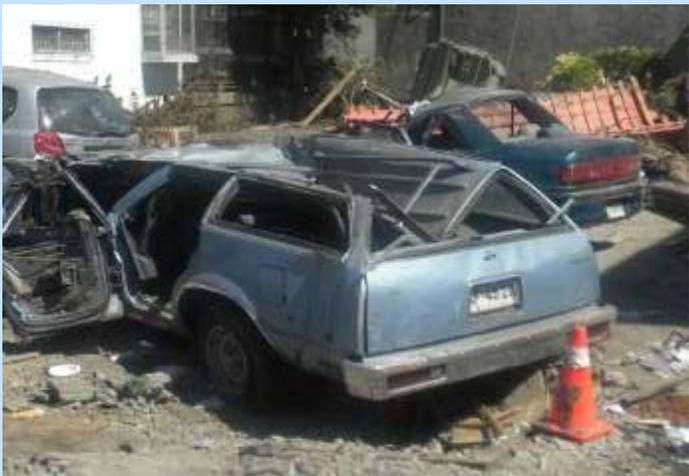
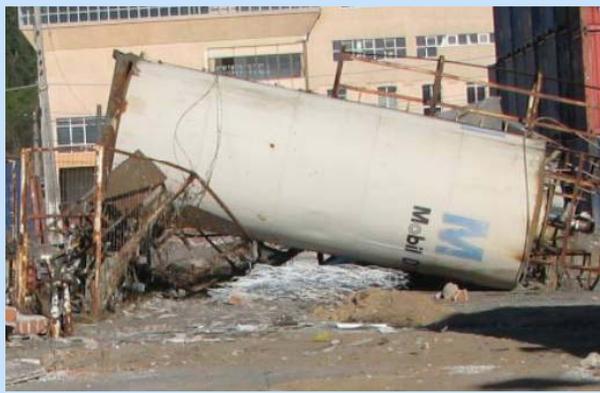
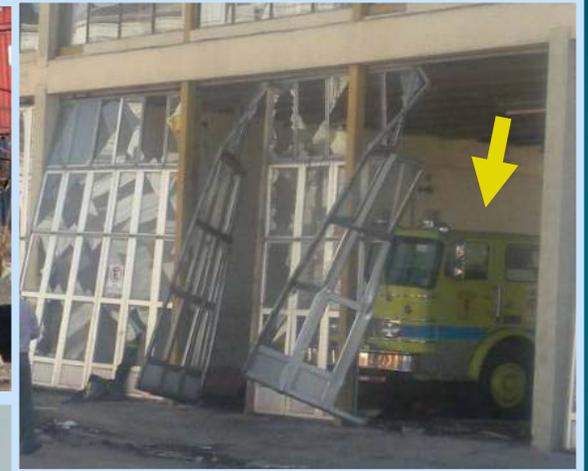
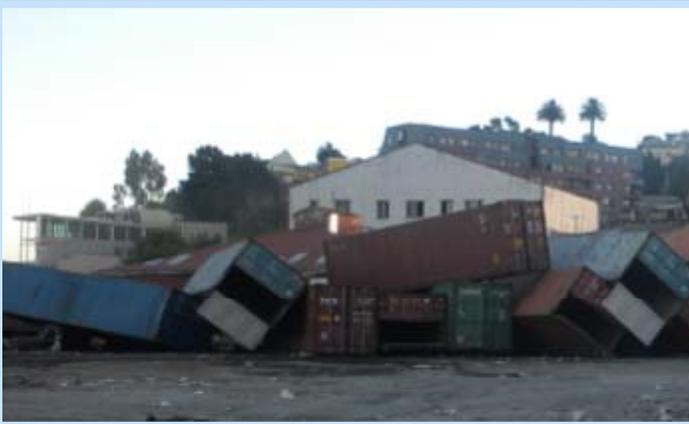
Observations Tsunami – Impact Damage

- ◆ Much of the damage is from debris impact

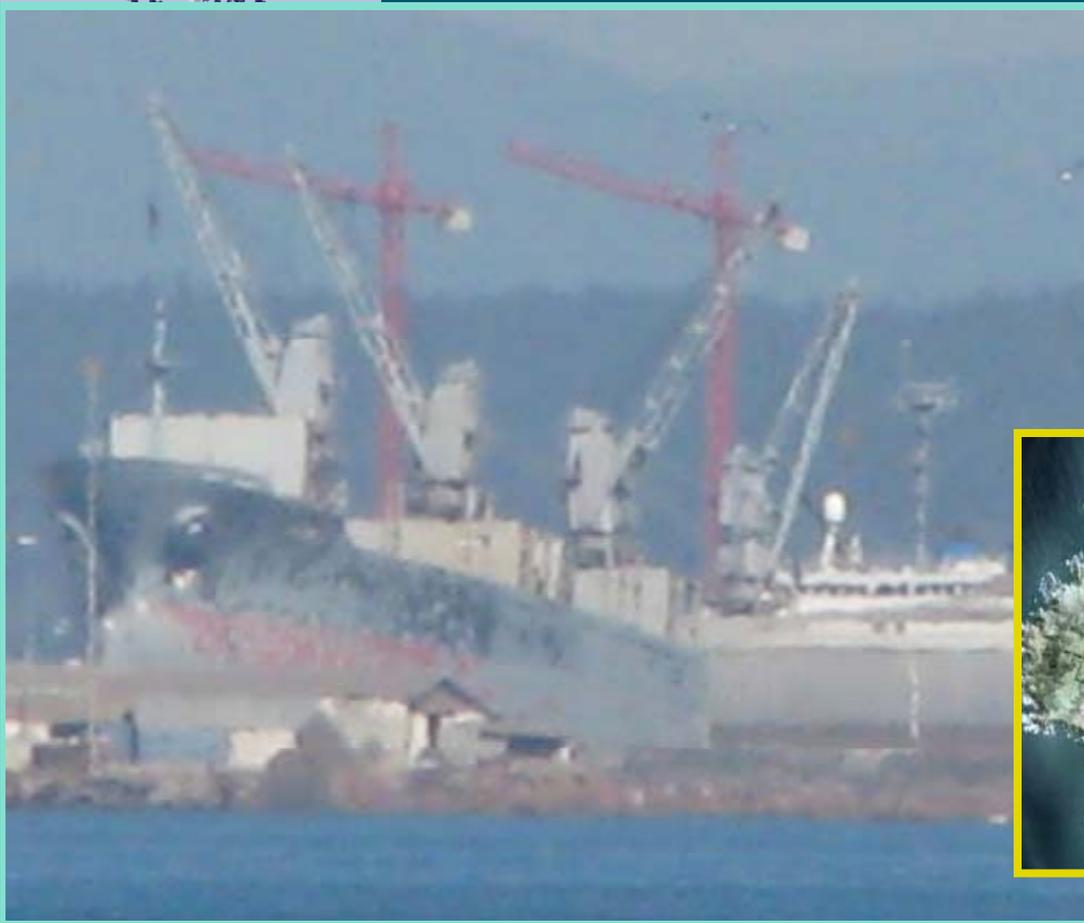
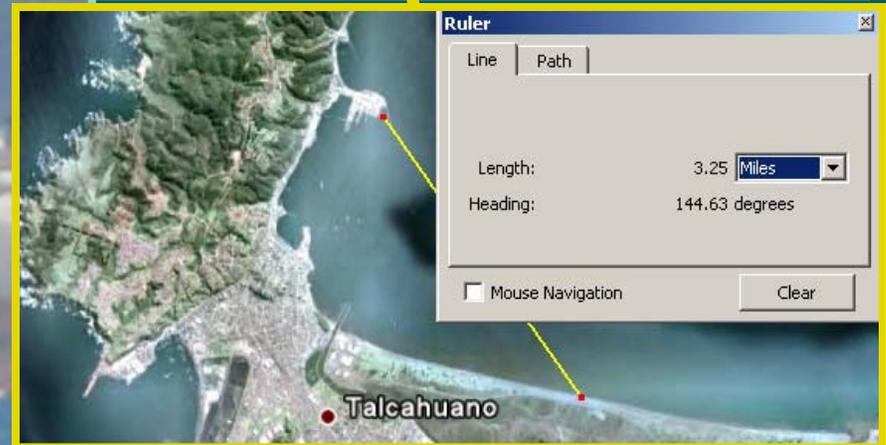
Observations Tsunami – Vessel Theft

- ◆ Breaks lines, carries away vessel

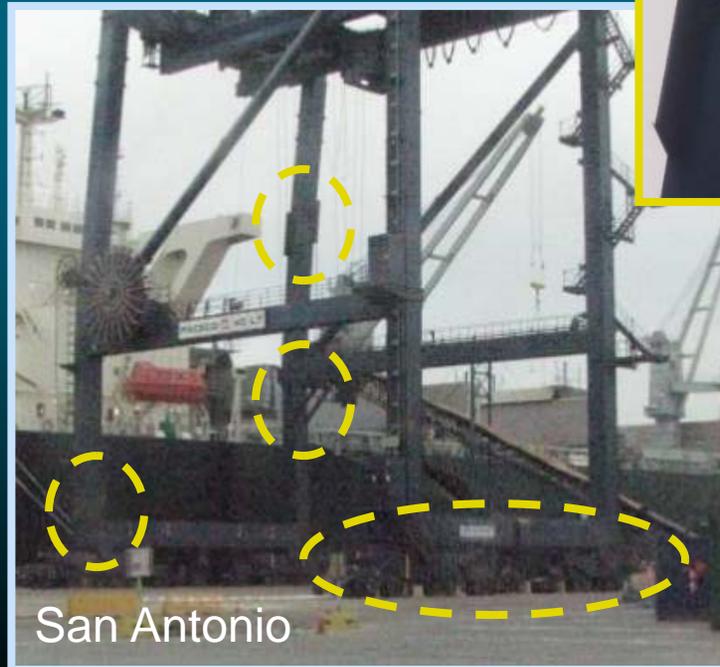
San Antonio

Cranes – Vessel Escape

- ◆ During earthquake power lost
- ◆ Cranes left inside vessels or w/ hanging containers
- ◆ Vessel escapes – catches container / crane and damages it

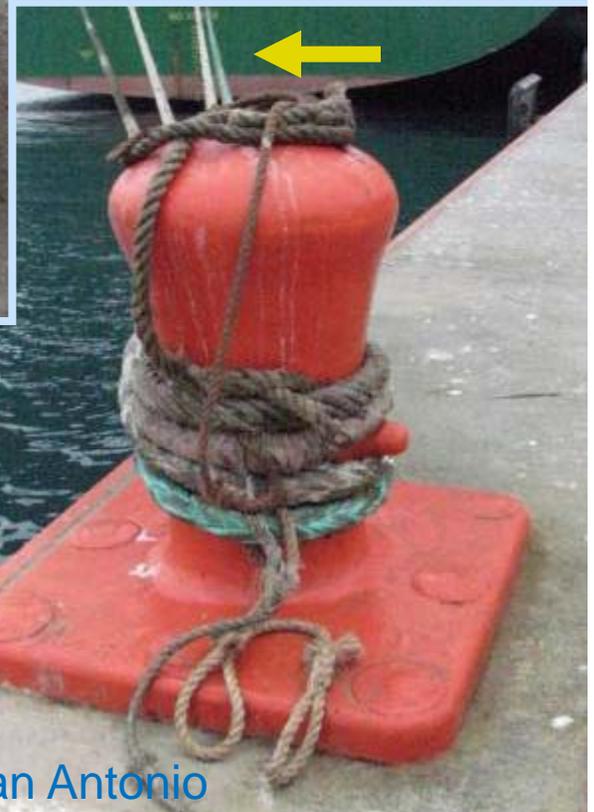
Bollards – Vessel Escape

- ◆ Do not use quick release hooks in Chile (costs)
- ◆ Most bollards performed well, but San Antonio lost 3
