*Underwater Oil Detection and
Recovery Operations*
Prevention First 2016

Michael Popa
T&T Marine Salvage

Overview

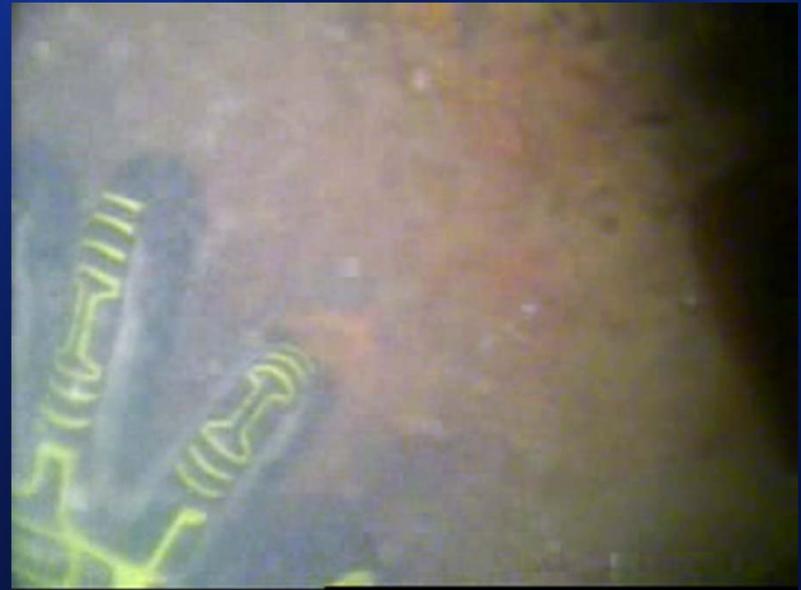
Diver places finger in top deck of rake

- Barge approximately 120-ft by 35-ft with 4 to 5-ft visible above the mudline.
- Barge covered in marine growth; 4 to 6-in in some locations.
- Discovered holes on bow rake and four open hatches forward; eight closed cargo hatches
- Due to low visibility and heavy marine growth, hand-over-hand assessment was required

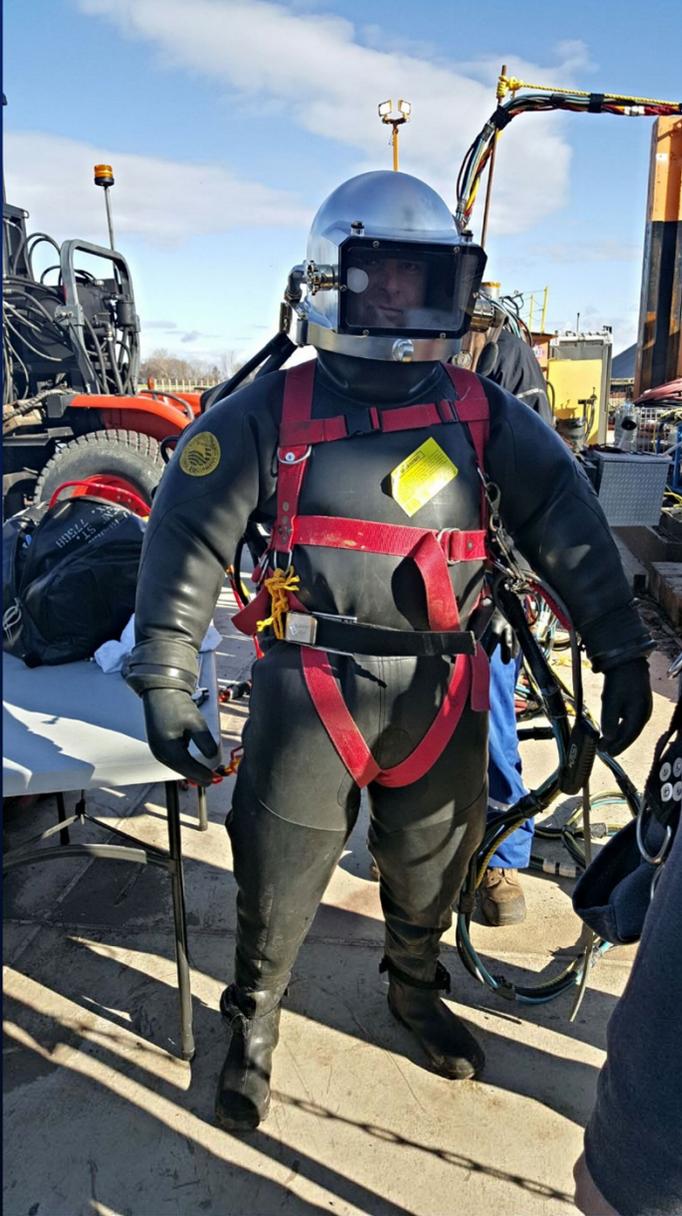
Positive Pressure DESCO Helmet and HAZMAT Viking Dry Suit

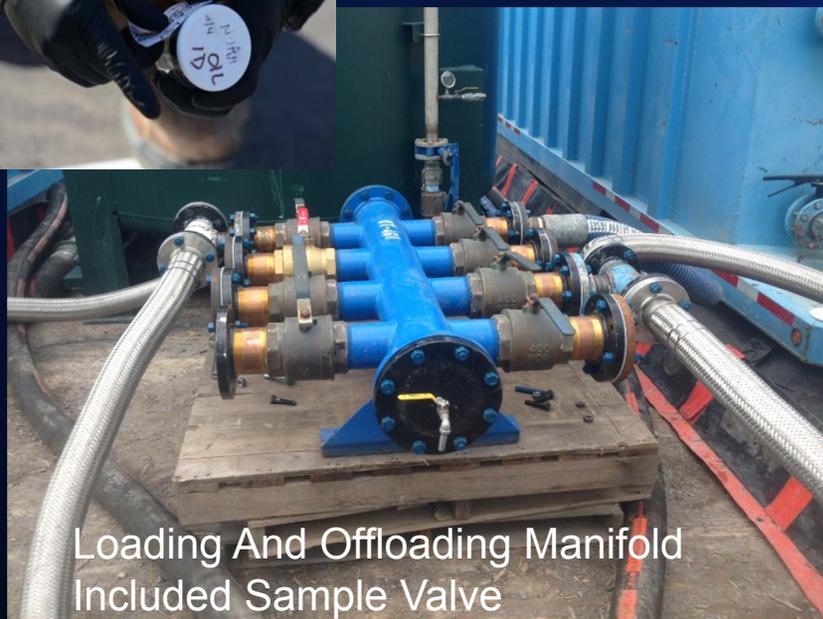
Loading And Offloading Manifold
Included Sample Valve

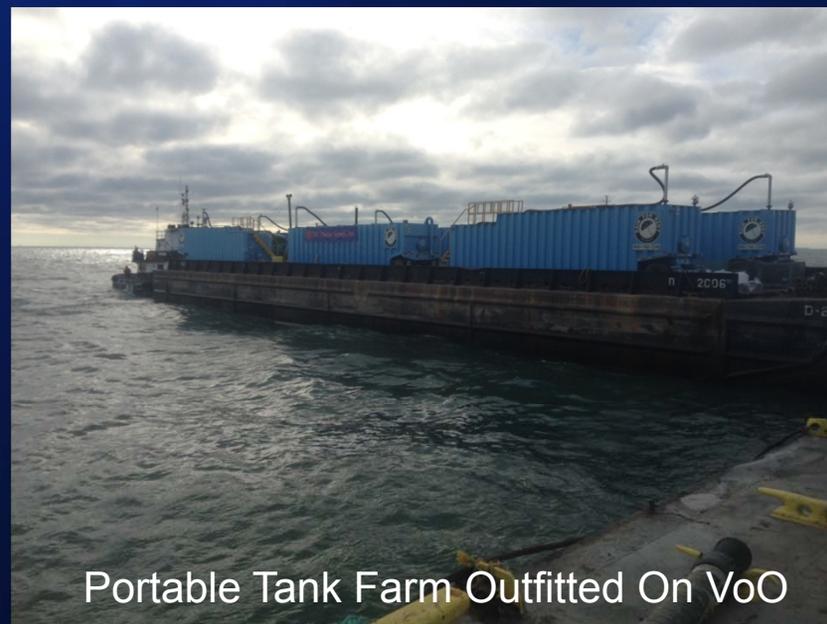
Portable Tank Farm Outfitted On VoO

Portable Tanks Utilized On Vessel Of Opportunity (VoO)

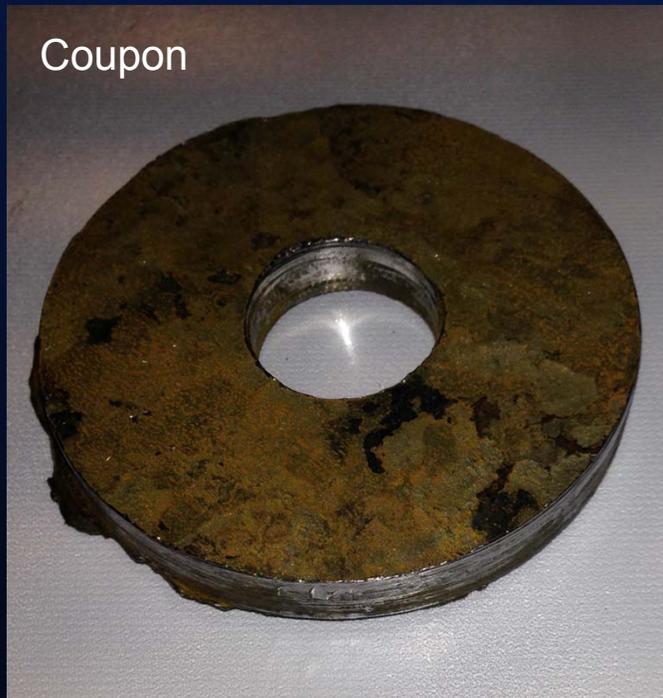
Coupon

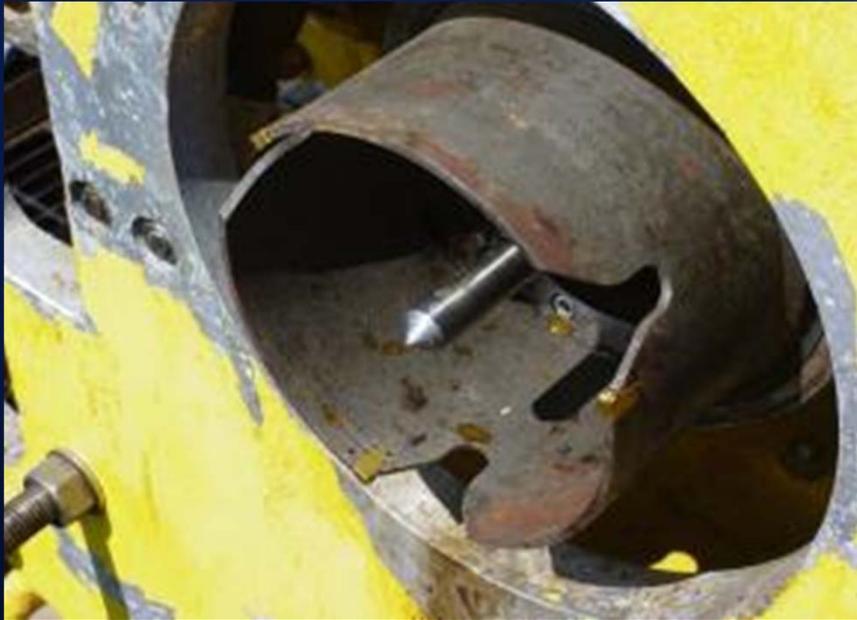
Milling Unit

ROV friendly plugs were on hand. These can be inserted by ROV into the holes milled into the fuel tanks

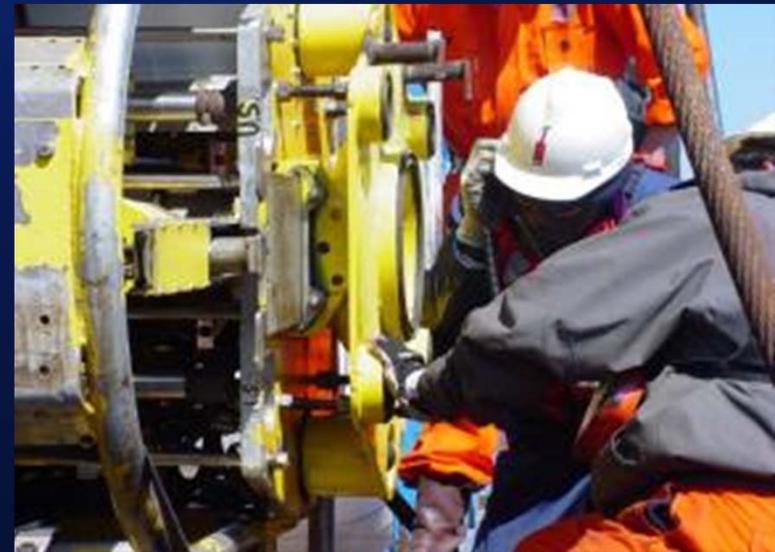
Base Plate Connection
