**SEAWALL MAINTENANCE PROJECT
110 GROVE LANE, CAPITOLA**

BIOTIC REPORT

November 13, 2015

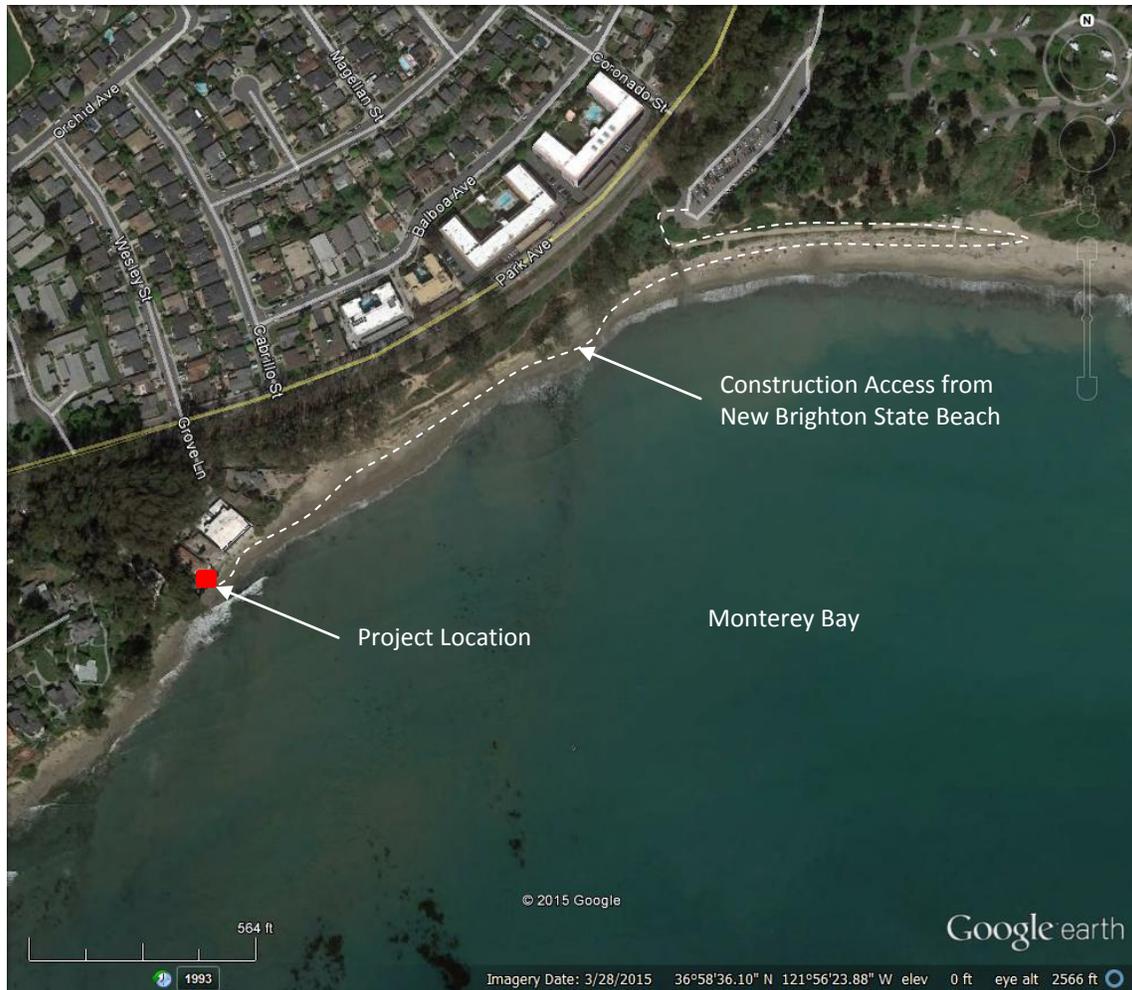
Figure 2. Project Location on Aerial (Google aerial dated 3/28/15)

The proposed project is the maintenance of the existing seawall, as depicted in plans prepared by R.I. Engineering, Inc. (plans dated August 2012). The work involves removing loose natural materials from damaged seawall areas and applying new shotcrete. The treated areas will include new rebar installed into the seawall/native bluff (secured with epoxy grout), placement of a rebar grid on the seawall surface and applying new shotcrete (minimum depth of 1.5 inches). The new shotcrete will be feathered into the existing wall. The plan depicts five repair areas on the sea wall. One work repair area will occur below the mean high tide line; all of the other repair areas are located above the mean high tide line. The project includes installation of a temporary fiber roll at the base of the seawall work area each working day. All concrete washout and equipment staging will occur at the top of the cliff; however, construction access to the seawall will be along the toe of the sea cliff from nearby New Brighton State Beach. Figure 2 shows the location of the project and the construction access on an aerial image.

This plant community occurs on the upper edge of the sea cliff. The vegetation is dominated by non-native ice plant (*Carpobrotus edulis*). Other plants growing amid the dense ice plant are other non-native species, such as pampas grass (*Cortaderia jubata*). Native species are limited to clumps of seaside daisy (*Erigeron glaucus*). Figure 2 depicts this vegetation type at the top of the sea cliff.

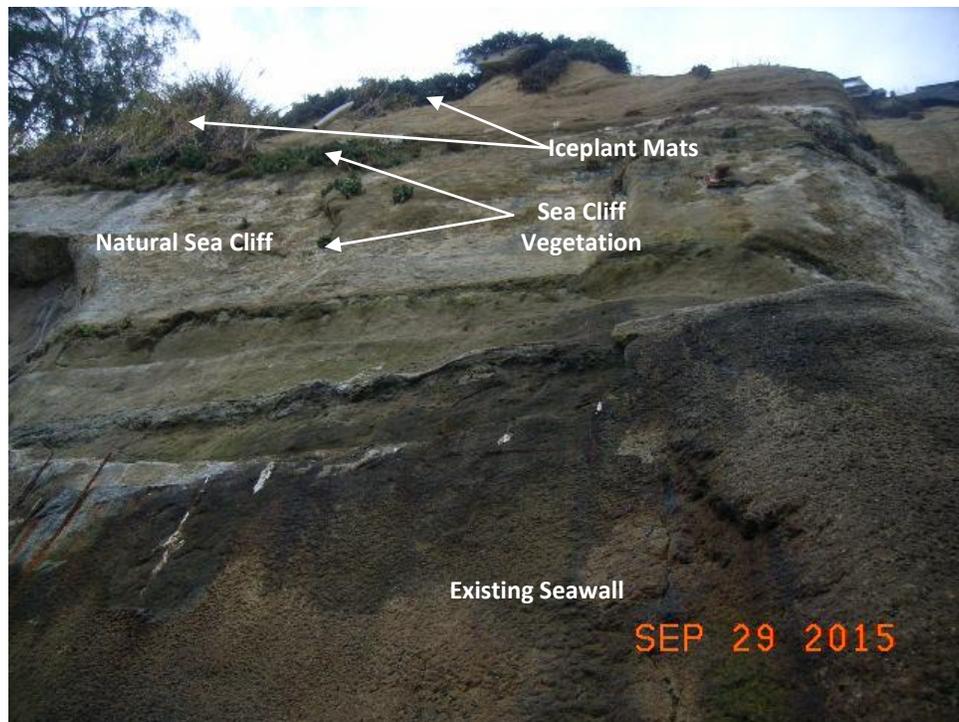
Figure 3. Distribution of Vegetation and Habitat Types in Work Area, September 2015

Each terrestrial vegetation type, its California vegetation code, and state ranking (rarity) are listed in Table 1. The distribution of these communities is depicted on Figure 3.

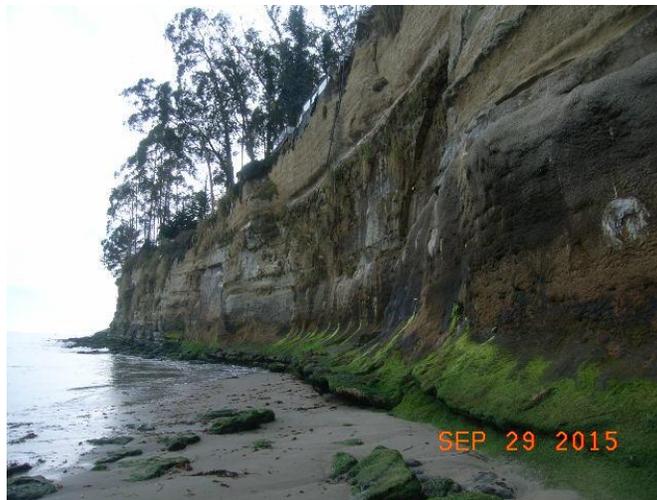
Figure 4. View of seawall and sea cliff, looking southerly from shoreline, showing algal zone (sea lettuce), patches of sea cliff vegetation, bare areas in the surf/wave zone, and beach, September 2015

Portions of the sea cliff support small patches of vegetation. Crevices and crack in the sea cliff support sea rocket (*Cakile maritima*), seaside daisy, cut-leaved plantain (*Plantago coronopus*), and sedge (*Carex sp.*). The majority of the sea cliff is devoid of vegetation. Vegetation within the tidal zone is limited to patches of sea lettuce (*Ulva sp.*). The character of the sea cliff vegetation is depicted in Figure 4. The land between the sea cliff and the ocean is active beach/rocky shore. This area is devoid of vegetation as it is the area between mean tide and the furthest inland reach of storm waves. Figure 5 depicts the character of the construction access route from New Brighton State Beach to the seawall work area.

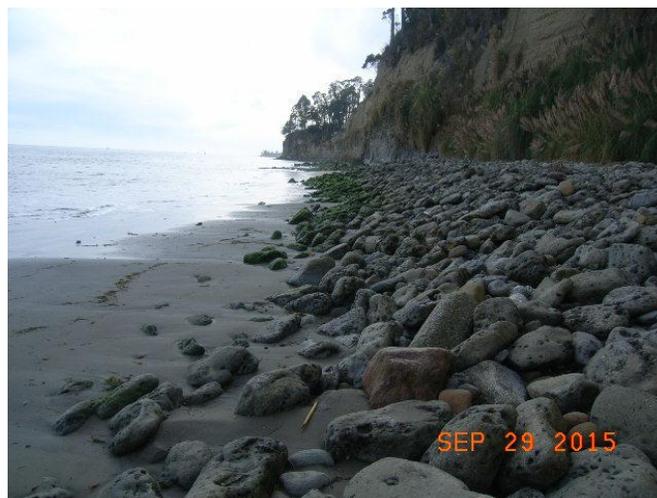
Figure 5. View of construction access route, looking southerly from New Brighton State Beach to the work area, September 2015

As depicted on the project plans, the seawall maintenance will require access on open, sandy beach areas and along the rocky shore. Approximately 1,800 linear feet of beach/shoreline will be traversed to access the work area. An access permit from California Department of Parks and Recreation (State Parks) will be required. According to the project engineer, approximately 10 working days will be needed for the seawall work, with access limited to minus tides. Although the beach is an environmentally sensitive habitat; due to the lack of vegetation and the temporary nature of the construction, the impact to biological resources on the sandy beach is less than significant.
