L1. Historic and/or Common Name: Hungry Hollow Canal

*Resource Name or #: Y-20

*Resource Name or #: John Ritchie House

*Resource Name or #: Herman Richter House

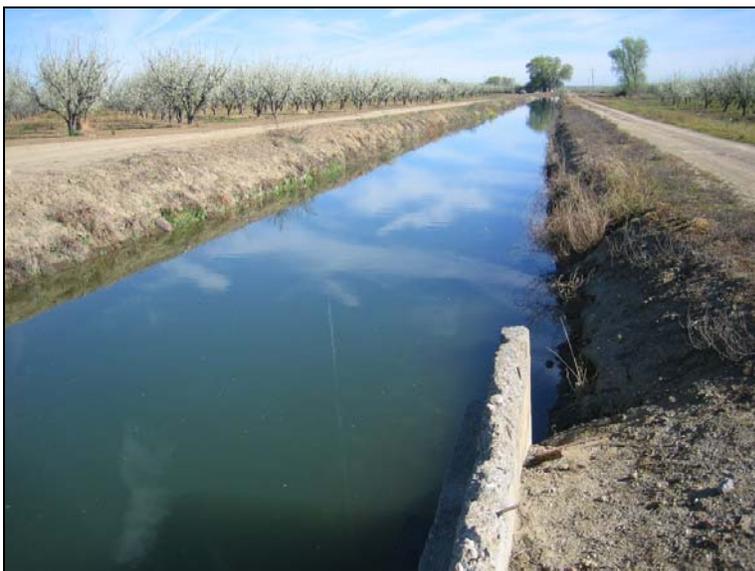
The Hungry Hollow Canal was only recorded for 1300 feet. It is a long earthen-walled canal presently in use that measures approximately 25 feet wide and 9 feet deep. The irrigation water in this canal originates from Cache Creek and passes through the Capay Dam and the West Adams Canal before spurring to the Hungry Hollow Canal.

L7. Integrity Considerations: The canal is in good condition, in use, and actively maintained.

Northeastern overview of Hungry Hollow Canal; 03/19/2007; IMG_1365

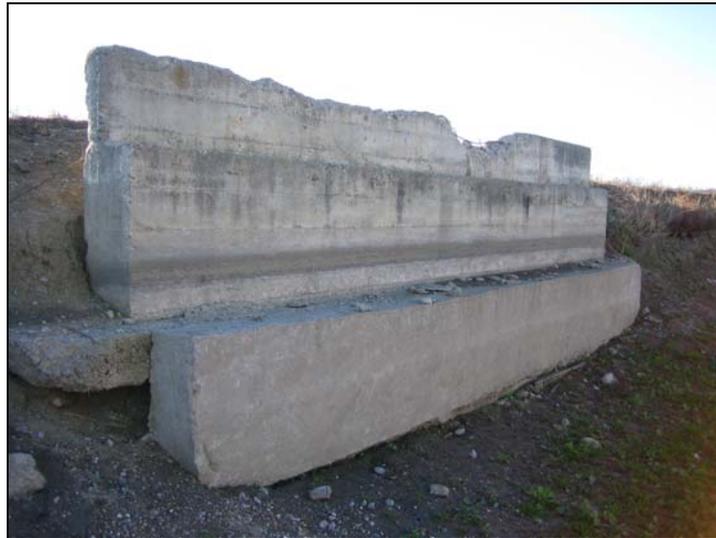
Feature Y-9a: This feature consists of the remnants of a bridge that once crossed the Hungry Hollow Canal. Its concrete foundations are situated on either side of the earthen canal. Only the stepped (likely for the beams of the bridge) foundations of the bridge are in existence. The date of manufacture for this bridge is unknown, but it is likely from the historic era. The bridge once connected to dirt access roads on either side of the canal. The bridge would have spanned approx. 25 feet. The height of the foundations or abutments from the canal ground level is approx. 5 feet 10 inches. The eastern bridge abutment measures approx. 20.5 feet long, 34 inches thick at the present water level, and 14 inches thick above the water level. The ledge for the beams is approx. 18 inches wide. The bridge is in poor condition; rusted metal rebar is exposed in broken portions of the foundations.

Southeastern overview of the eastern bridge abutment of Feature Y-9a; 02/23/2007; IMG_003

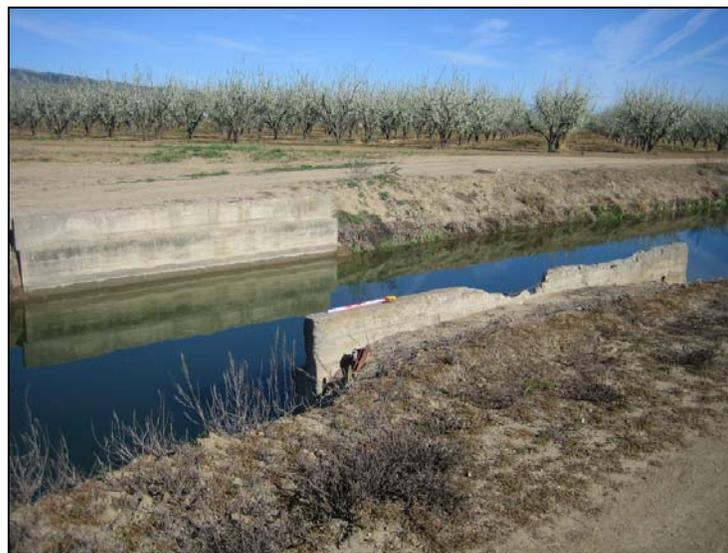
Northwestern overview of Feature Y-9a; 03/19/2007; IMG_1363.

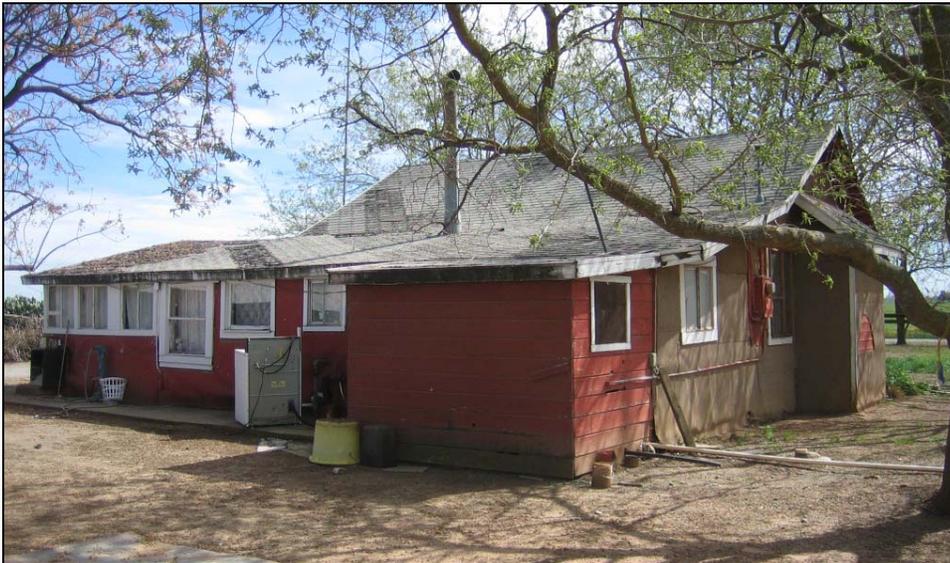
Overview of the north and west elevations of Building No.1; 03/19/2007; IMG_1381

Building No. 1 is approximately 84 feet from the north edge of CR 17, and measures approximately 39 feet long x 36.5 feet wide. The main block of the building is one-and-one-half stories high and has a pier-and-post foundation. The roof is sheathed with composition roofing and the exterior walls are clad with horizontal clapboard siding, wrapped in several places with tar paper. A tall metal stovepipe extends from the slope of the roof of the one-story addition at the north side of the main block. The current entrance is at the east end of the addition. It features a six-paneled door flanked by a pair of 9-paned windows on the south side and two wood-framed single paned fixed windows on the north side. The east facing, gable end of the main block depicts an aluminum slider at each end. (See continuation sheet for more description of this building)

The north elevation of Building No. 1 features a ribbon of three aluminum sliders at the east end, a larger wood-framed double-hung window in the center, and three additional odd sized windows at the west end. A small shed-roofed addition extends north from the west end of the length-wide addition; it features a door at the east end and a single screened window at the center of the west elevation. A small shed-roofed addition, about the size of a closet, is centered under the gable of the west elevation. Two aluminum sliders are on each side of the small addition and a third, smaller aluminum slider is on the one-story addition at the north end. It appears that the original façade is on the south side, although the wooden six-panel door does not appear to be used for entry. Two aluminum slider windows, similar in size to those on the east elevation are at each side of the door; a large air conditioning unit is seated on a wood-frame and attached to the window at the east end. The main block of the building has the appearance of a mail order house of balloon-frame construction popular in the late nineteenth to early twentieth century. However, the building has been modified through a rambling progression of later additions and shed attachments. (See continuation sheet for barn description)

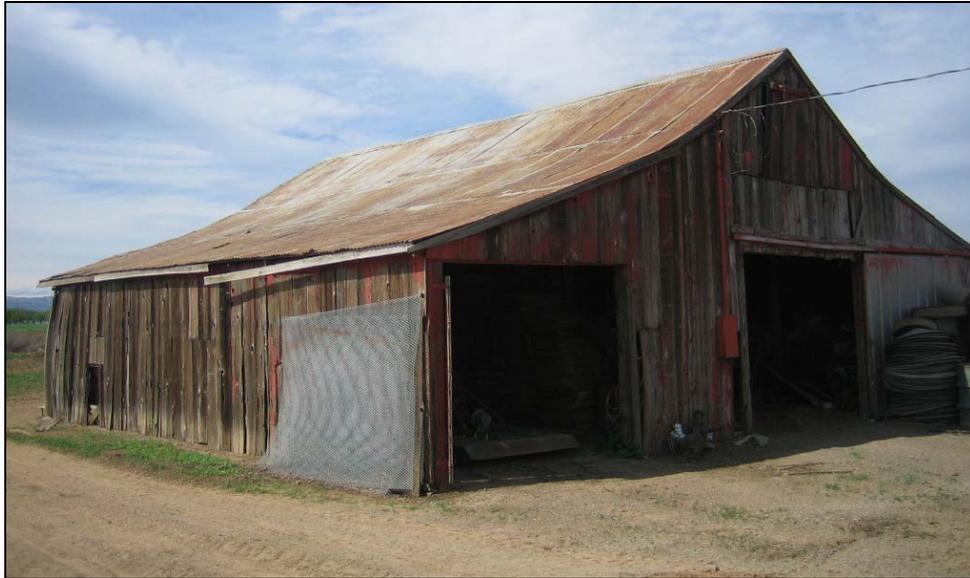
Northwest of the farm residence is a large historic barn (Building No. 2) measuring 72 feet long x 38.5 feet wide. Numerous bunk houses and storage buildings are nearby the barn. It is front-gabled and the roof is sheathed with corrugated iron panels; it exhibits flared ends. The barn lacks a foundation and there is evidence of termite damage. The walls are clad with vertical wood planks, generally about 9 inches wide. The age of the historic building has not been determined, but during the inventory, it was noted that only round-headed nails were used during construction of this building.

The east façade features a large sliding door, with an overhead track and pulleys, centered under the gable. There is some evidence that the door opening was once much taller, but it was later reduced in size. Another large doorway is at the south end of the façade and there are no windows on this side of the building.

The only fenestration on the south elevation is a rectangular cut-out on the lower portion of the wall which appears at the west end. The fascia is loose along the east end of the roofline and the west end of the elevation is unstable. It appears to be buckling from items piled against the wall inside the building.

Building No.2: Northwestern overview of east façade and south elevation of the barn at Y-20; 03/19/2007; IMG_1384.

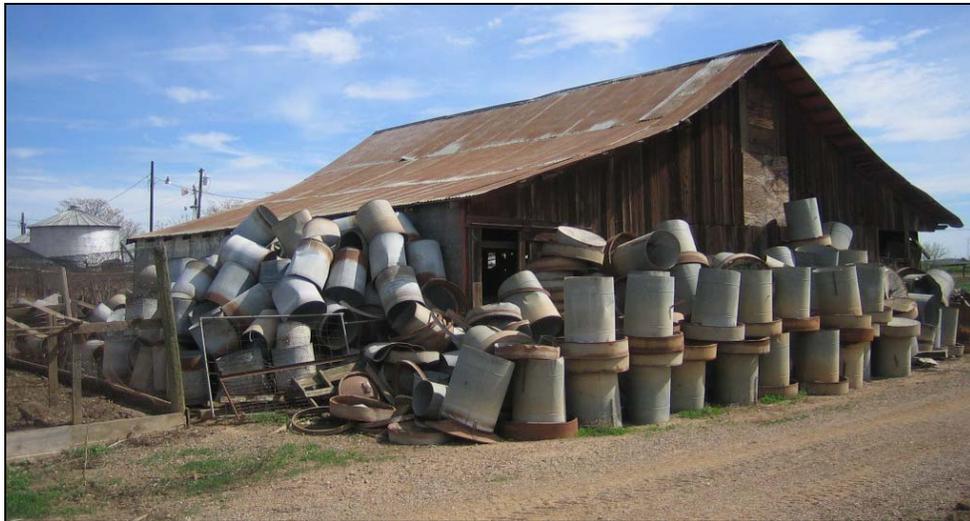
The barn is presently being used for storing hay and agricultural equipment; however, it abuts a large pheasant cage. As a result, there are poultry feeders are piled high and strewn about next to the building's north and west elevations. The south end of the west elevation features two doorways at the south end that are now unstable. Two more adjacent doorways are present on the north end. Centered under the gable is a large linear piece of sheet metal used to repair the wall. Throughout the building additional maintenance repairs have been made with metal sheets and plywood. It is in fair to poor condition.

Building No.2: Southeastern overview of the north and west elevations of the barn at Y-20; 03/19/2007; IMG_1388.

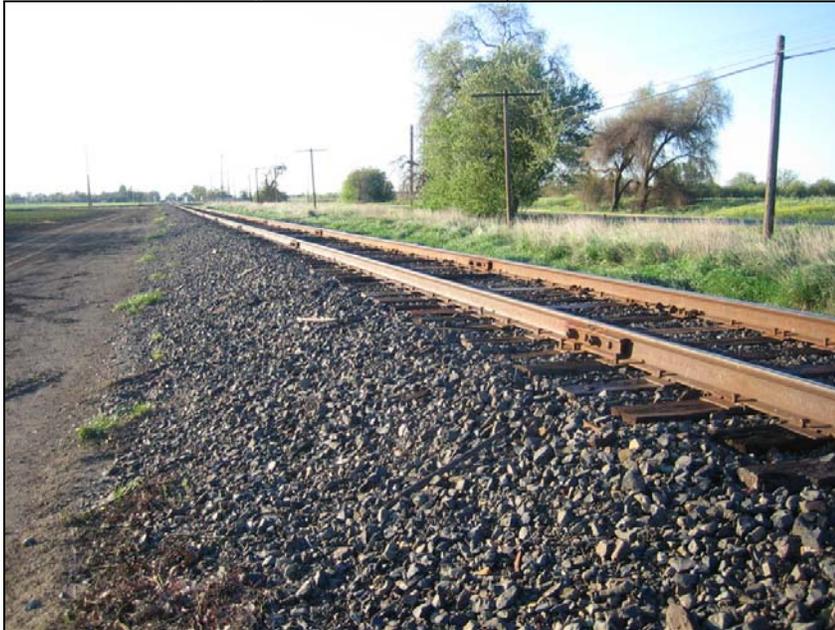
This resource consists of the historic alignment of the Northern Railway Company. The recorded segment is now the Southern Pacific Railroad and actively in use. This segment parallels Interstate 5, and is oriented in a northwest-southeast direction. The tracks sit on a raised bed of ballast made of sub-angular basalt rocks, approximately 2.5 feet high. The raised bed extends 9 feet on either side of the tracks. The railway tracks are separated by 62 inches. According to Larkey and Walters (1987:47), the railroad construction was started in 1875. It was completed sometime before 1879, as depicted in the Yolo County Atlas (Yolo County 1879).

Overview of the Southern Pacific Railroad tracks, facing southwest; 03/21/2007; Camera Pictures 001.

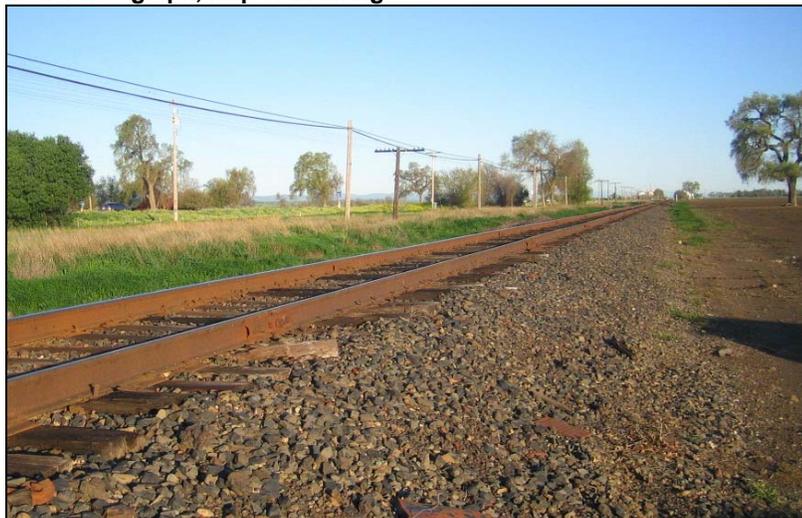
The recorded segment is actively in use. This segment parallels Interstate 5, and is oriented in a northwest-southeast direction. The tracks sit on a raised bed of ballast made of sub-angular basalt rocks, approximately 2.5 feet high. The raised bed extends 9 feet on either side of the tracks. The railway tracks are separated by 62 inches. The rail ties are made of wood.

L7. Integrity Considerations: The original Northern Railway Company railroad grade has been replaced on the same alignment by modern tracks. The railroad is presently used by Southern Pacific and actively maintained.

(View, scale, etc.)
Overview of the Southern Pacific Railroad tracks, facing northwest; 03/21/2007; Camera Pictures 002.

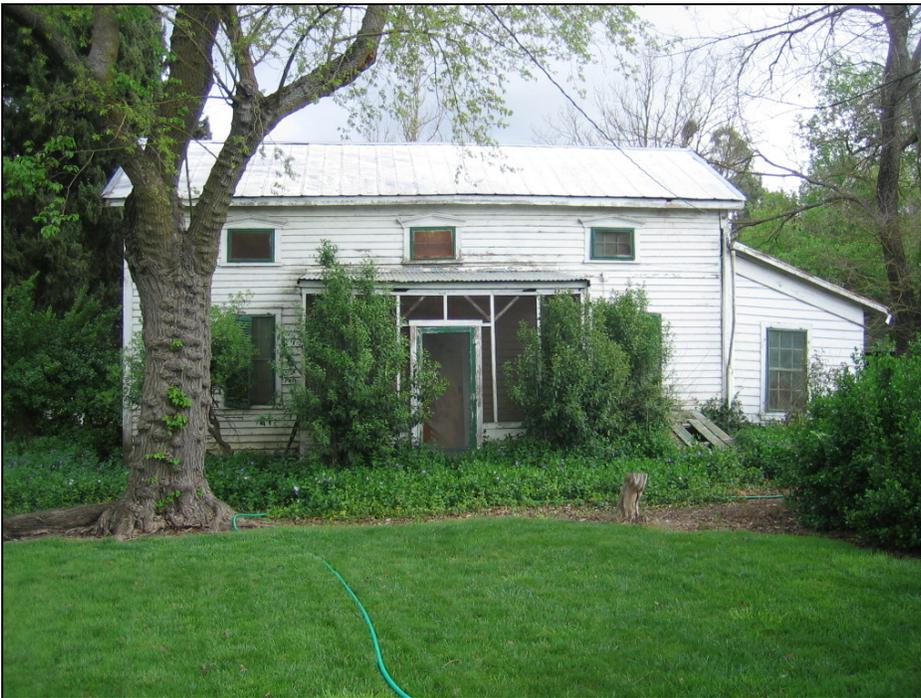
Building No.1: This building consists of the main residence. It is unoccupied and in fair condition. The house is white with green trimming around the door and windows; it has a tin roof. The covered porch area has a corrugated iron roof. It has an estimated construction date of 1860.

Front western façade of Building No.1; 03/20/2007; IMG_1411.

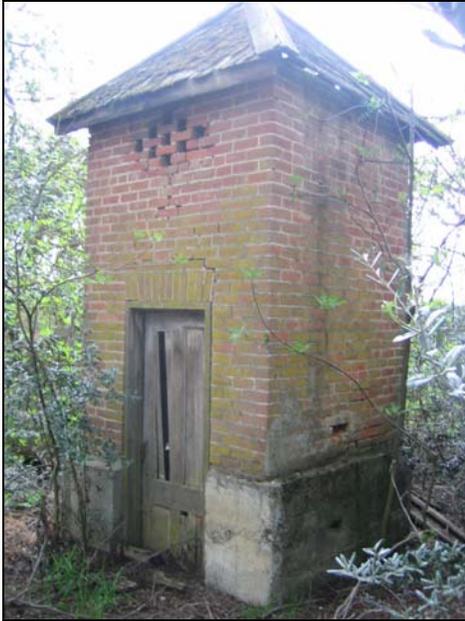
Building No. 2: This building consists of a brick smokehouse. It is in fair condition and has a roof made of wood shingles. Concrete was poured over the bricks at the base of the building for reinforcement.

Northern façade and eastern elevation of Building No.2, the brick smoke house; 03/20/2007; IMG_1422

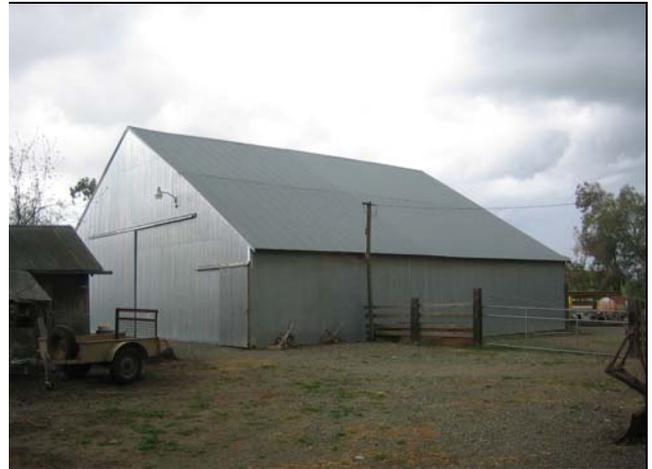
Building No. 3: This building consists of a large historic barn. According to Bruce Rodergerdts, this large barn was recently renovated with metal siding, but still has its original wood frame with square nails and wooden pegs.

Southwestern overview of the northern and western elevations of the barn (Building No.3); 03/20/2007; IMG_1424

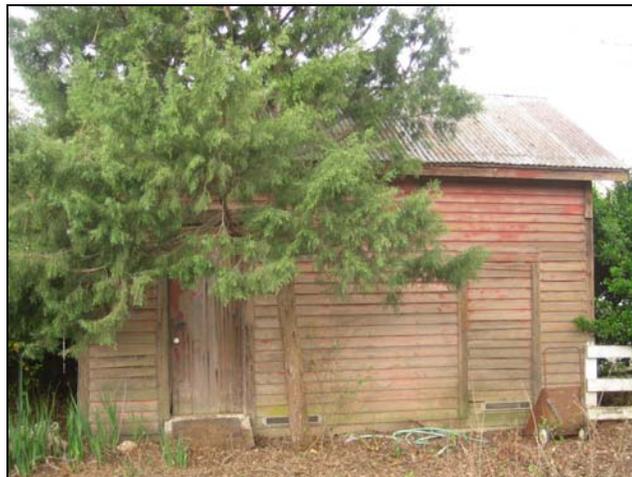
Buildings No. 4 and 5: These buildings consist of two historic bunkhouses. They are similar in construction and have red plank siding, a corrugated metal roof, and evidence of square nails.

Eastern façade of Building No.4, one of the two bunk houses that has square nails; 03/20/2007; IMG_1426

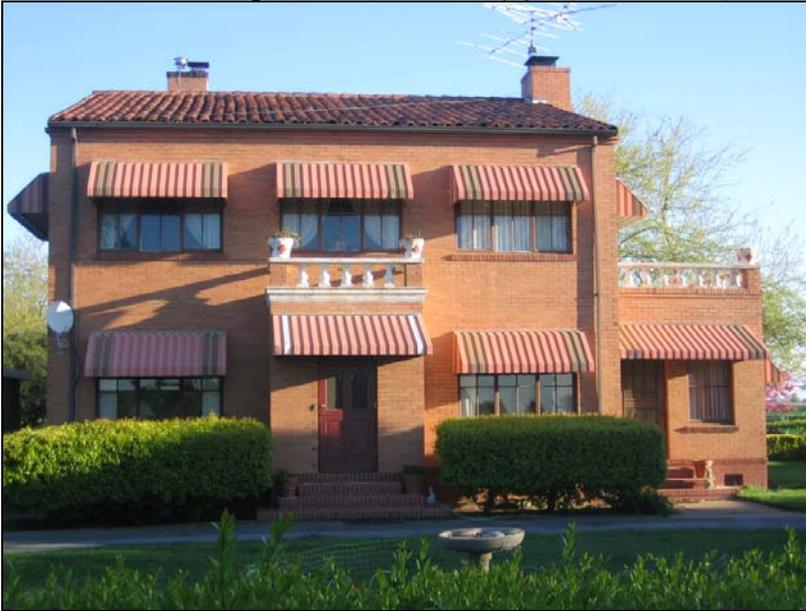
Building No. 1: Built in 1927, this residence is constructed of brick, and measures approximately 43 feet by 42 feet. The Mediterranean Revival-style house appears to have two floors and a basement. It has a ceramic tile roof and a brick foundation. The house also has two chimneys. The garden is well groomed and consists of a lawn with a bird bath, trimmed hedges and a grape vine fence, fruit trees, and a cork oak tree (*see Continuation Sheet, page 2*).

Northern overview of the southern façade of residence (Building No.1); 03/21/2007; CP003.

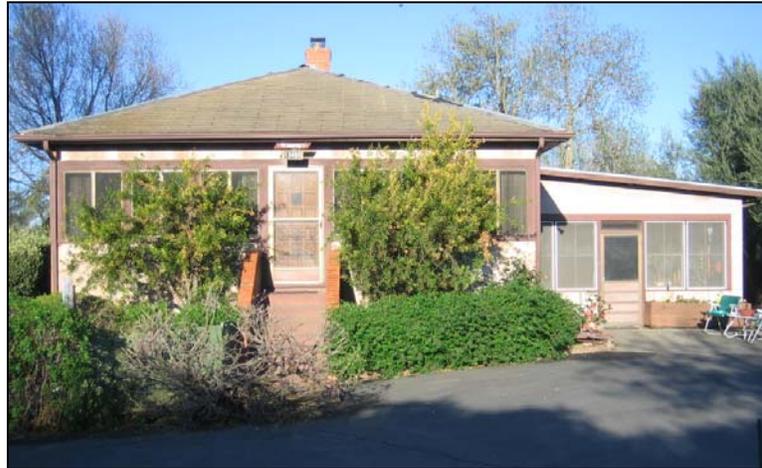
Building No. 2: This other older single-storied residence was, according to the owner, built between 1865 and 1875. The house still has its original foundations. The home was remodeled in 1949 and was originally two stories; it measures approximately 50 feet by 28 feet. The house has asbestos siding, one chimney, and a modern tar shingle roof. The house is surrounded by trees with a garden constructed of brick that has star-, clover-, circle- and square-shaped designs made of upside down beige stoneware bottles (circa. 1870).

Eastern façade of Building No.2, the older residence at HRI-4/114; 03/21/2007; CP018.

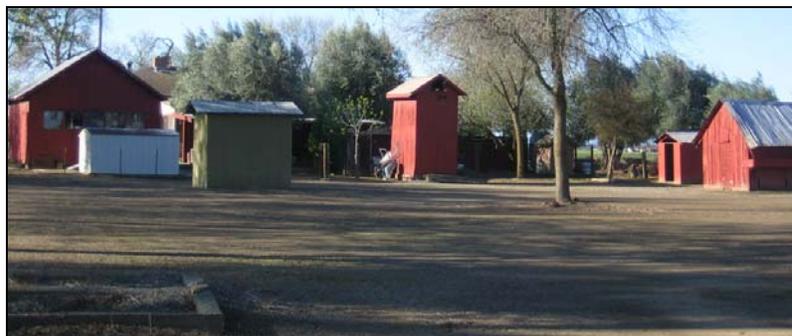
Building No. 3: This resource is a garage built in the early 1900s. It has red painted wood siding, a sheet metal roof, track doors, and a cement foundation. The garage measures approximately 32 feet by 18.5 feet.

Building No. 5: This resource is a bird house with a red painted wood siding and a corrugated iron roof. It has no visible foundation, but does have square nails; it measures approximately 15 feet by 10 feet 8 inches.

Southerly overview, from east to west, of three red historic buildings: the garage, the smoke house, and the bird house of HRI-4/114; 03/21/2007; CP032.

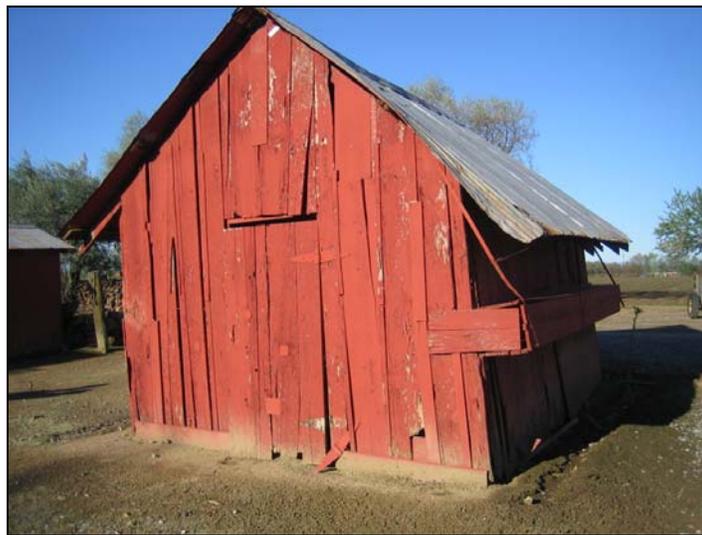
Southwesterly overview of the eastern façade and northern elevation of the bird house (Building No. 4) at HRI-4/114; 03/21/2007; CP026.

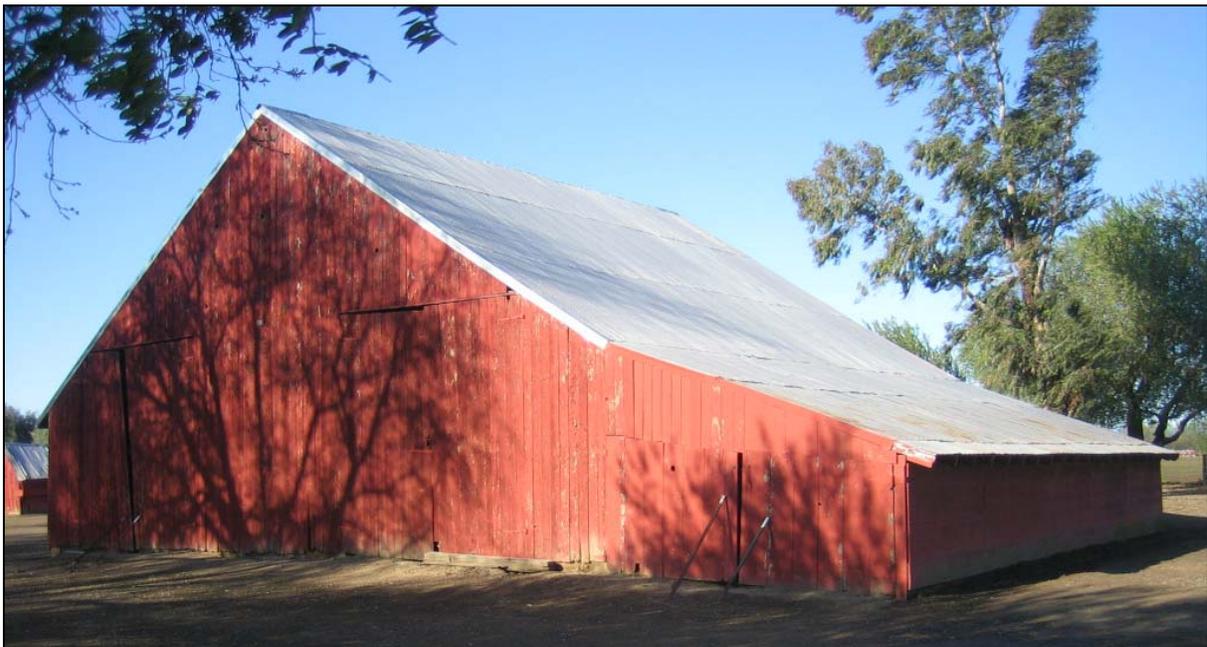
Building No. 7: This resource is a large wooden granary. It is sided with red painted wooden planking and appears to be approximately 25 feet high, and measures approximately 59 feet by 41 feet. The roof is relatively new and consists of unpainted corrugated metal. The foundation is made of brick and is four bricks high. The wooden siding of the granary has evidence of square and modern nails. This building also has four large doors.

Southwesterly overview of eastern façade and northern elevation of the granary (Building No. 7) at HRI-4/114; 03/21/2007; CP030.
