HIGH RESOLUTION GEOPHYSICAL SURVEY OFFSHORE OF OCEANSIDE, CALIFORNIA

Field Operation Report

ECO-M Reference No. 15-01
12 June 2015

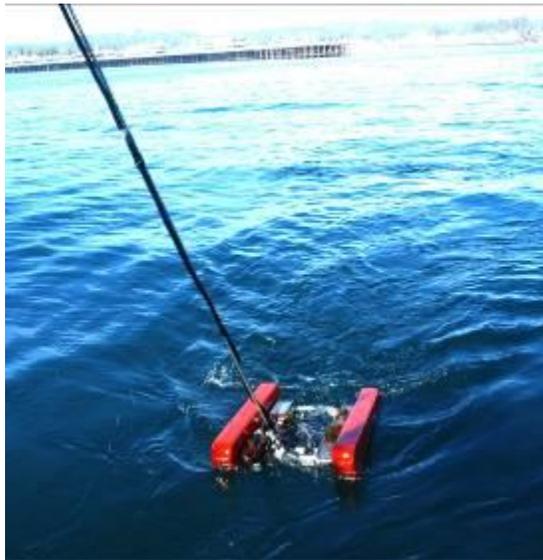
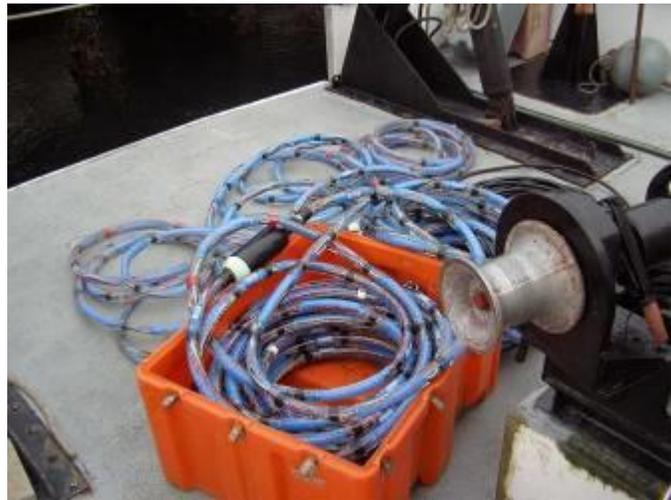
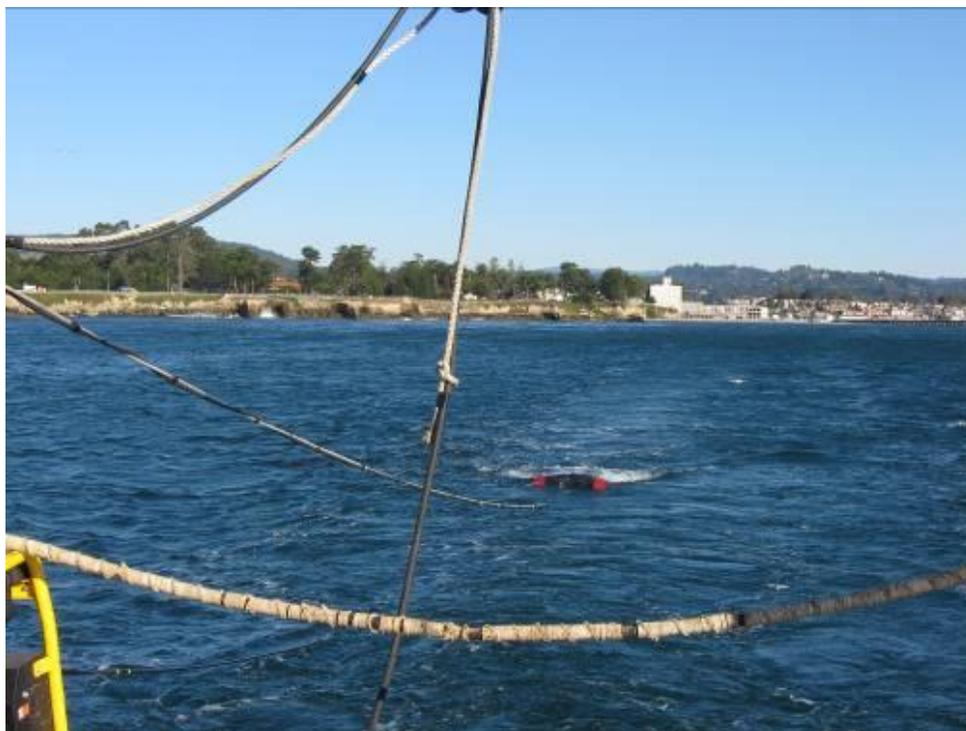
Figure 2-1. High-resolution multichannel seismic equipment: Above left is the 300-Joule Boomer in Tow; Above Right is the 16-channel GeoEel digital mini-streamer (24-channel version proposed effort). Below is a view of the equipment deployed for a survey offshore Santa Cruz, California. The boomer sled is in the mid-foreground and the streamer tail buoy is the white object in the right center.

The profiling system consisted of a 300-joule boomer acoustic source and a 24-channel GeoEel hydrophone streamer with group interval of 1.56-m (5-ft). The multichannel system is shown in Figure 2-1. The boomer source is capable of producing acoustic energy pulses with frequency bandwidth up to about 1,000-Hz, but considering spatial aliasing due to back-scattered acoustic energy in the water column, it normally provides useful bandwidth to about 500-Hz with a short streamer group interval. The final processed seismic profiles were filtered to a bandwidth of 72-640 Hz. At a typical compressional wave velocity in water-saturated sediments of about 1,520 m/s (5,000 ft/s), the sub-bottom resolution achieved is about 1.5-m (5-ft) for half wavelength events or about 0.6-m (2-ft) considering “tuning” effects.
