Chevron Eureka MOT Seismic Upgrade – Assessment to Retrofit Design, Permitting and Construction

Zach Pecor, Chevron

Rod Iwashita, Moffatt & Nichol

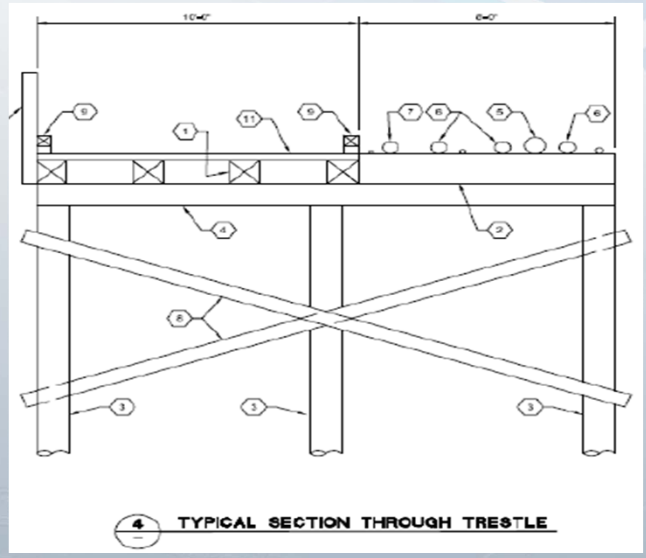
- **Light timber construction**
- **Simple pin or through bolt connections**
- **Piping seated on pile caps or wharf deck**
- **Plumb pile dominated response**
- **Batter piles w/ weak connections**
- **MOTEMS Seismic "Low" Risk**
  - Level 1: 36 year return period
  - Level 2: 224 year return period
  - Large acceleration due to nearby subduction zone

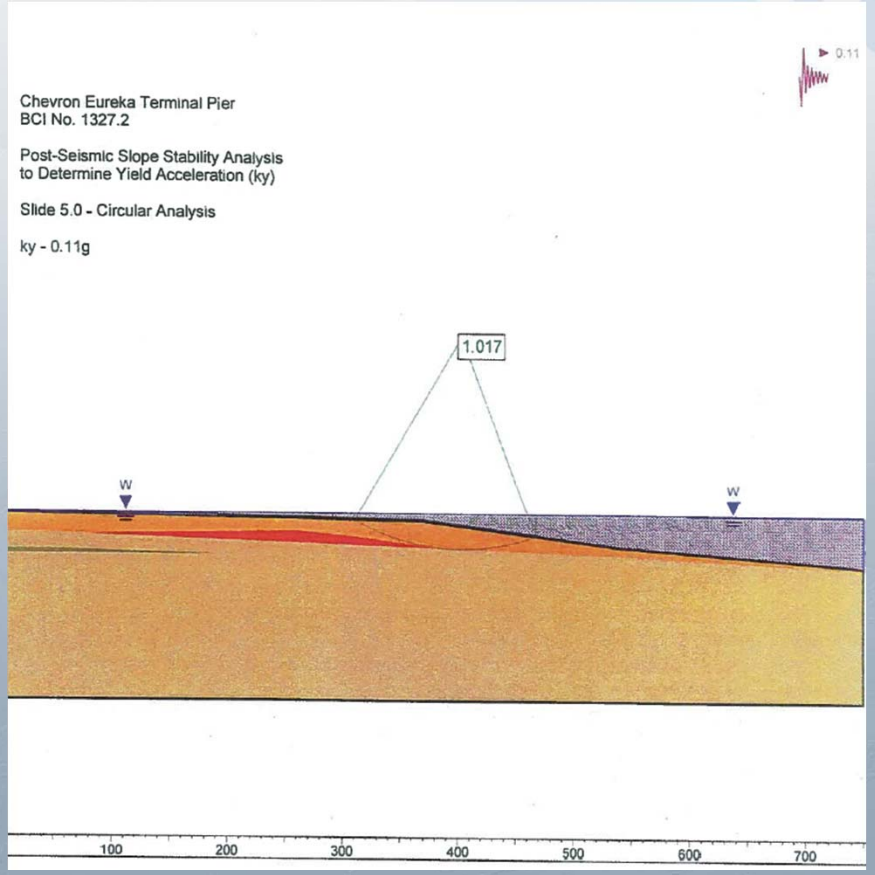
- **Initial Audit performed by others**
  - Concluded structurally deficient and required upgrade
  - Used conservative approach for soil spreading (up to 7 ft soil movement)

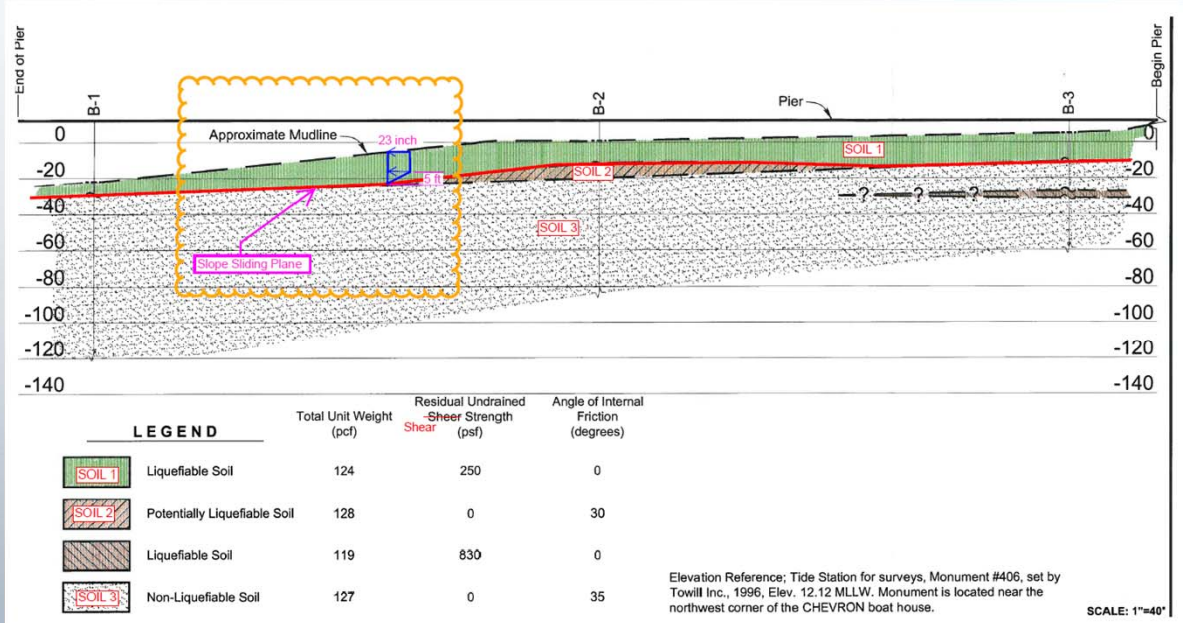
Figure 7: Soil Lateral Spread [EMI, 2014]

- **M&N performed refined seismic analysis, including refined kinematic load determination (by EMI)**
  - Reduced initial 24-84” movement to 23”
  - Now manageable
- **Used more refined analysis methods, material testing**

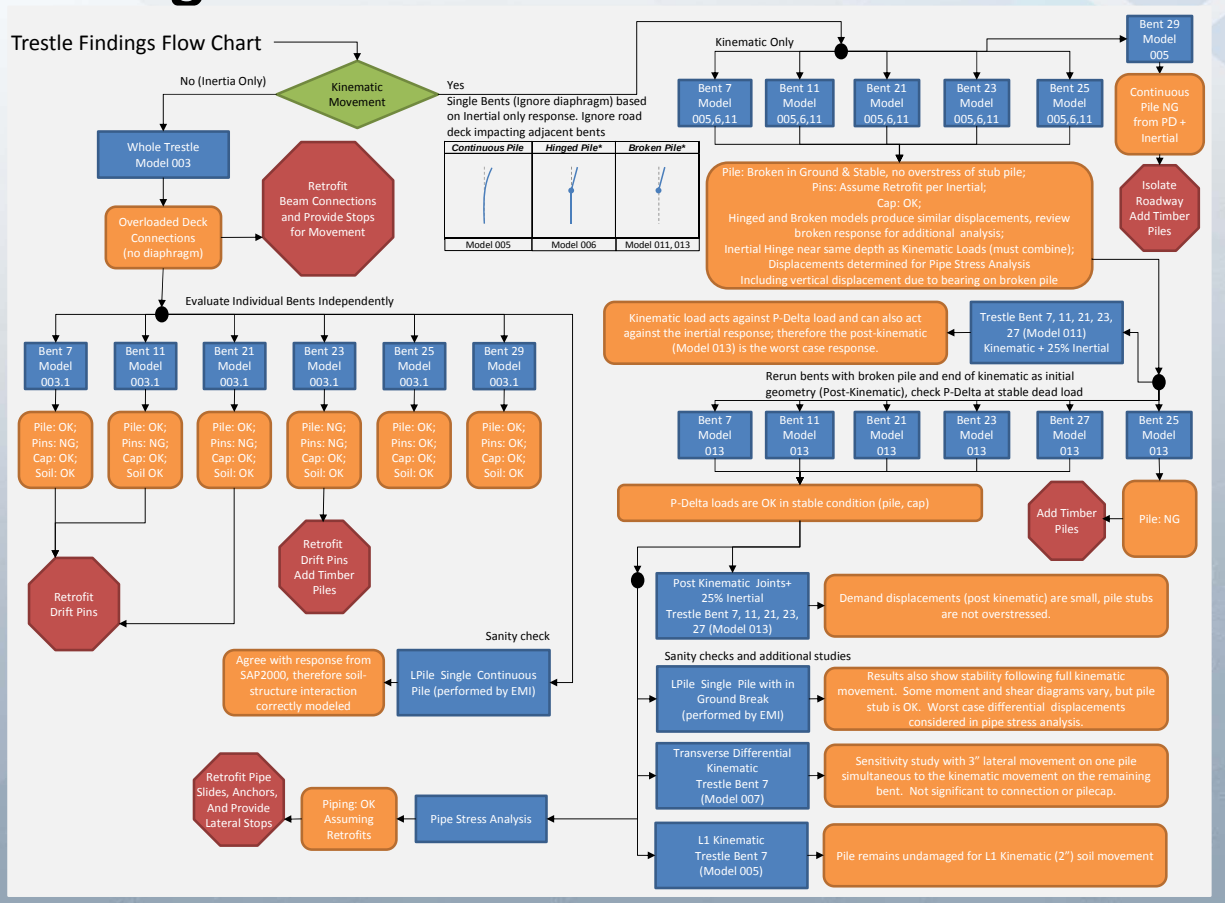
- **Many cases based on soil conditions and pile type**
  - Vertical stability maintained
  - No loss of containment
- **Seismic retrofit**
  - Critical elements protected

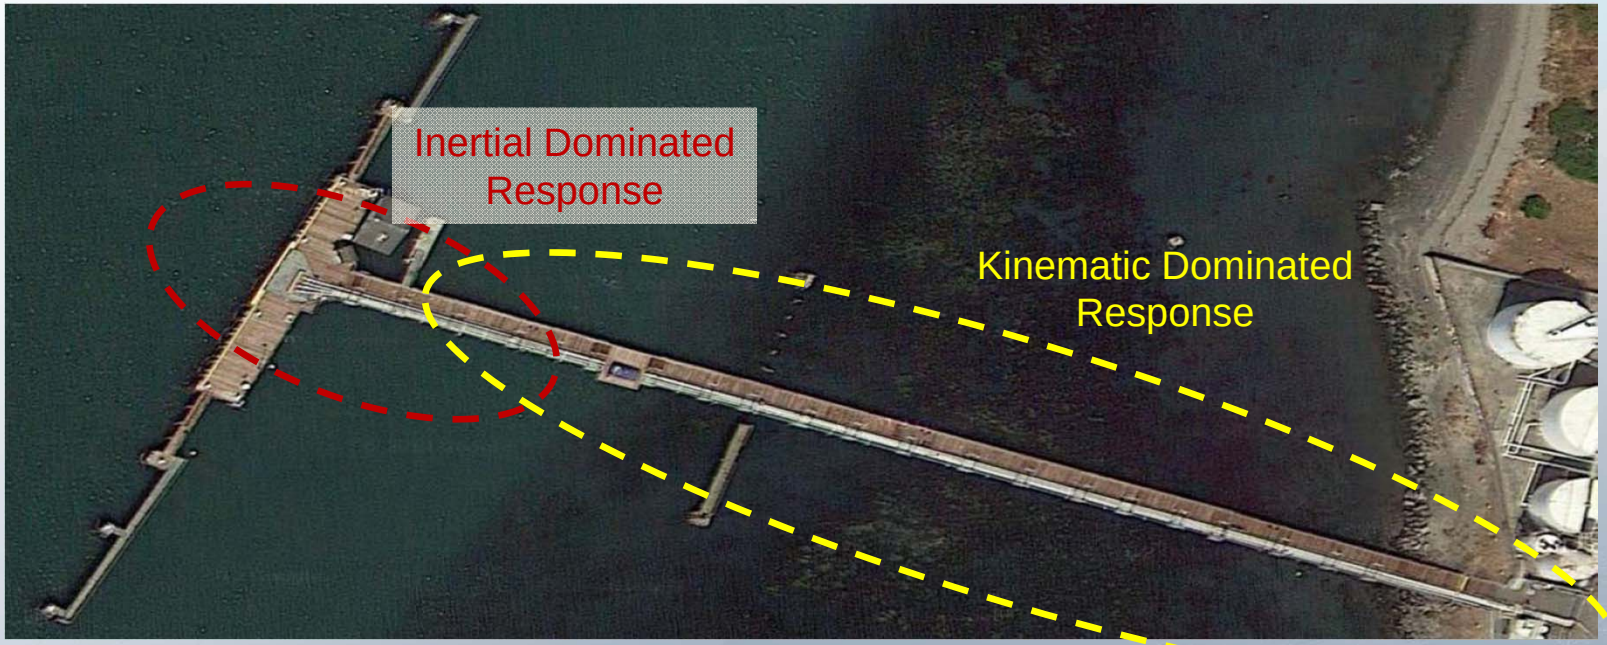
M&N Refined Seismic Analysis
Summary of Findings

- System response controlled by inertial and kinematic loading in different areas for different failure modes
- Retrofit required to satisfy MOTEMS requirements
