Use of Guided Long Wave
Ultrasonic Inspection for Anomaly
Locating and Use of Composite
Repair Materials

12" x 10" M-2 Oil Pipeline

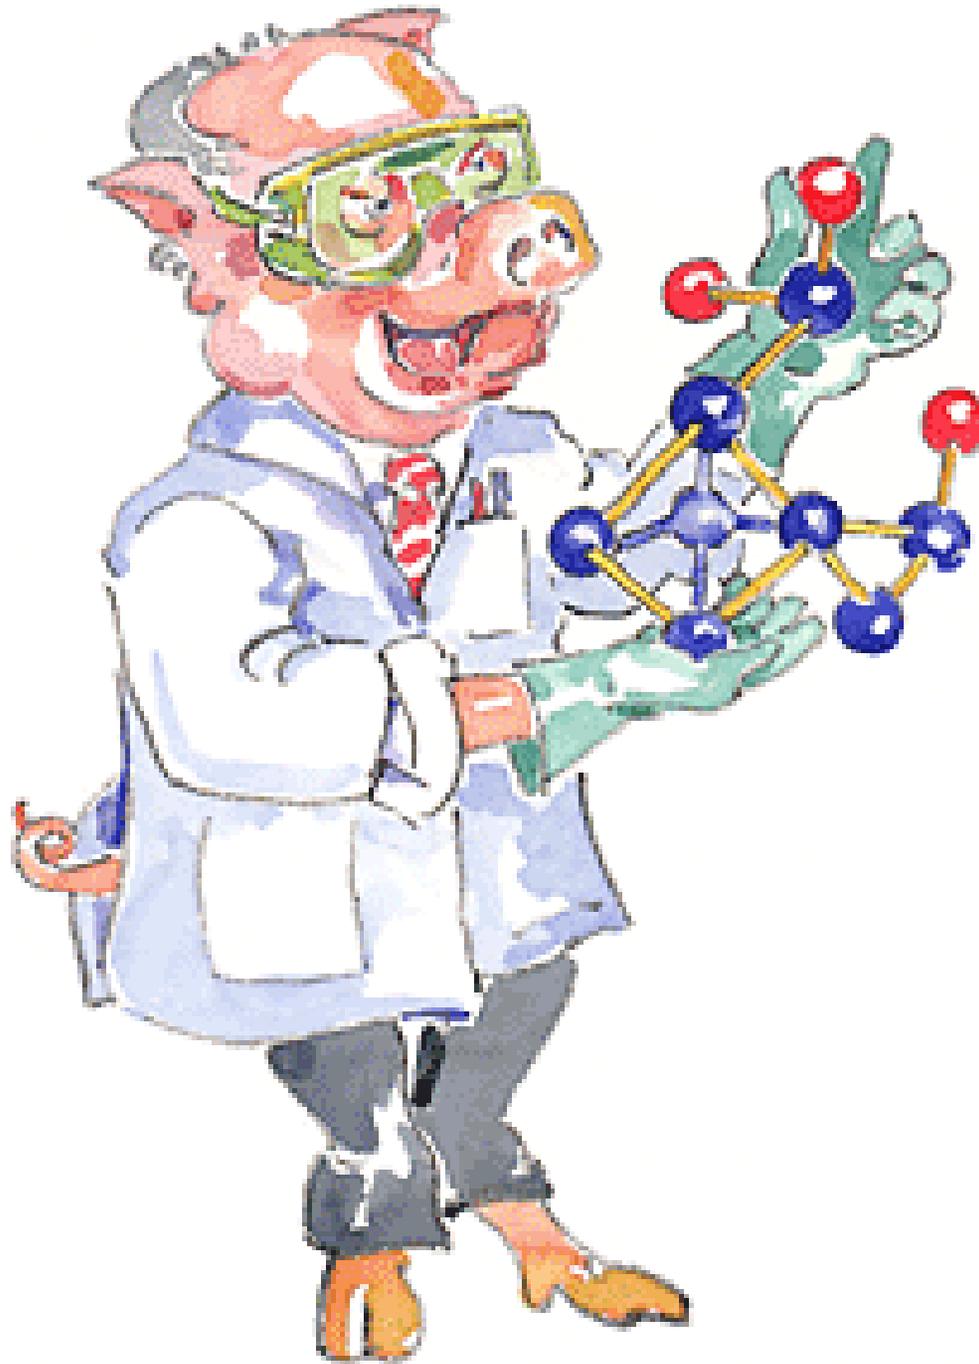
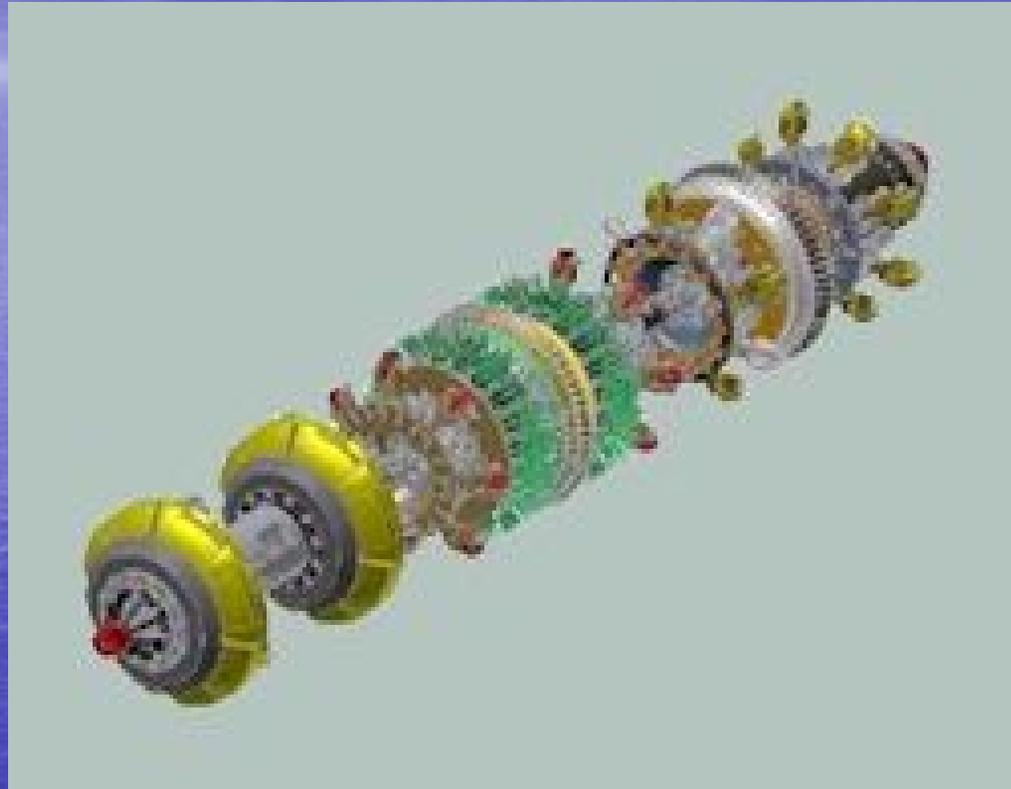
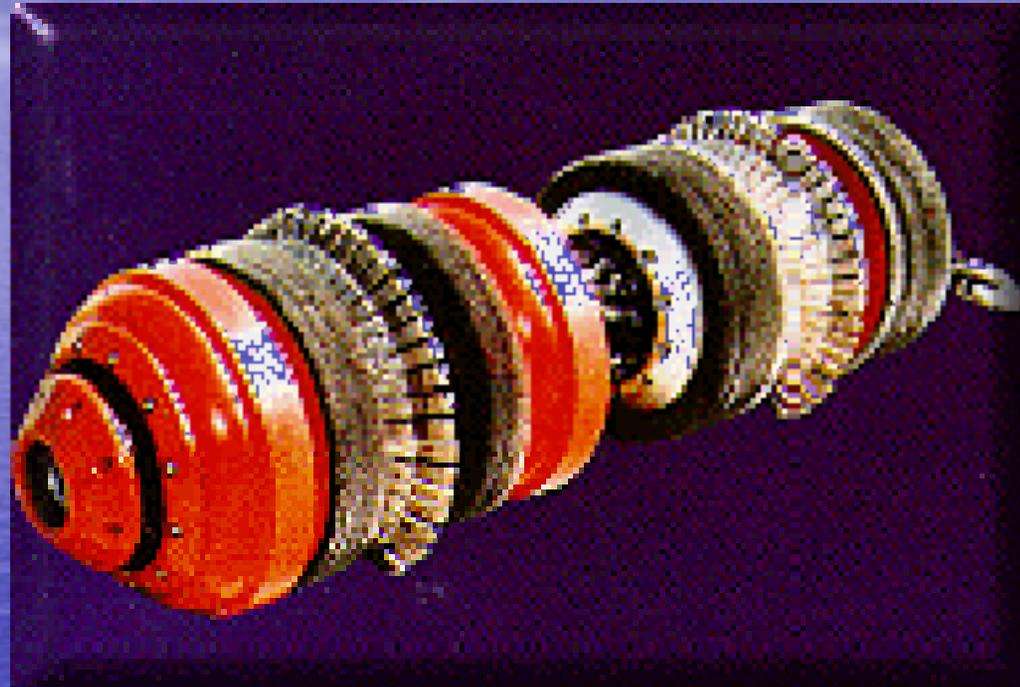
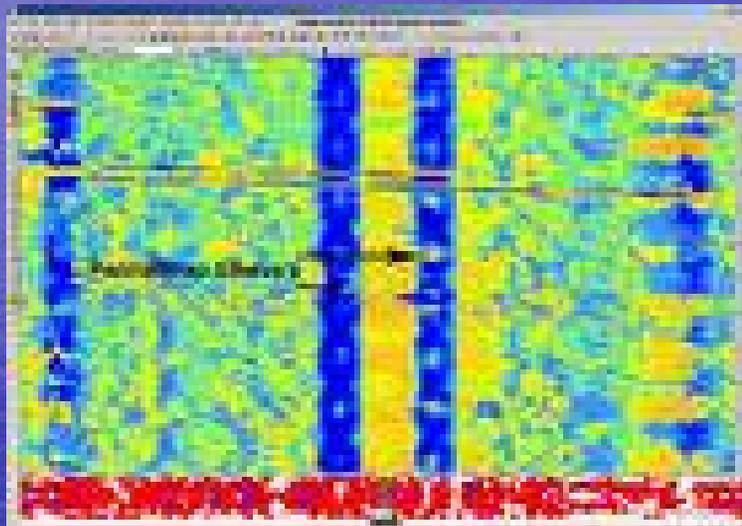
Internal "Smart Pig" Findings

- Line routinely inspected on a bi-annual basis
- January 2004 results indicated potential anomalies
 - Up to 53% wall loss
 - Over 134.5" in length
- Findings plotted on maps

- ANSI B31.G calculations resulted in de-rate of line to 613 psi
- Uncertainty over actual wall loss
- Uncertainty over location
 - Wheel Slippage
 - Lack of benchmarks offshore
 - Pipe buried under several feet of sand in fall and summer

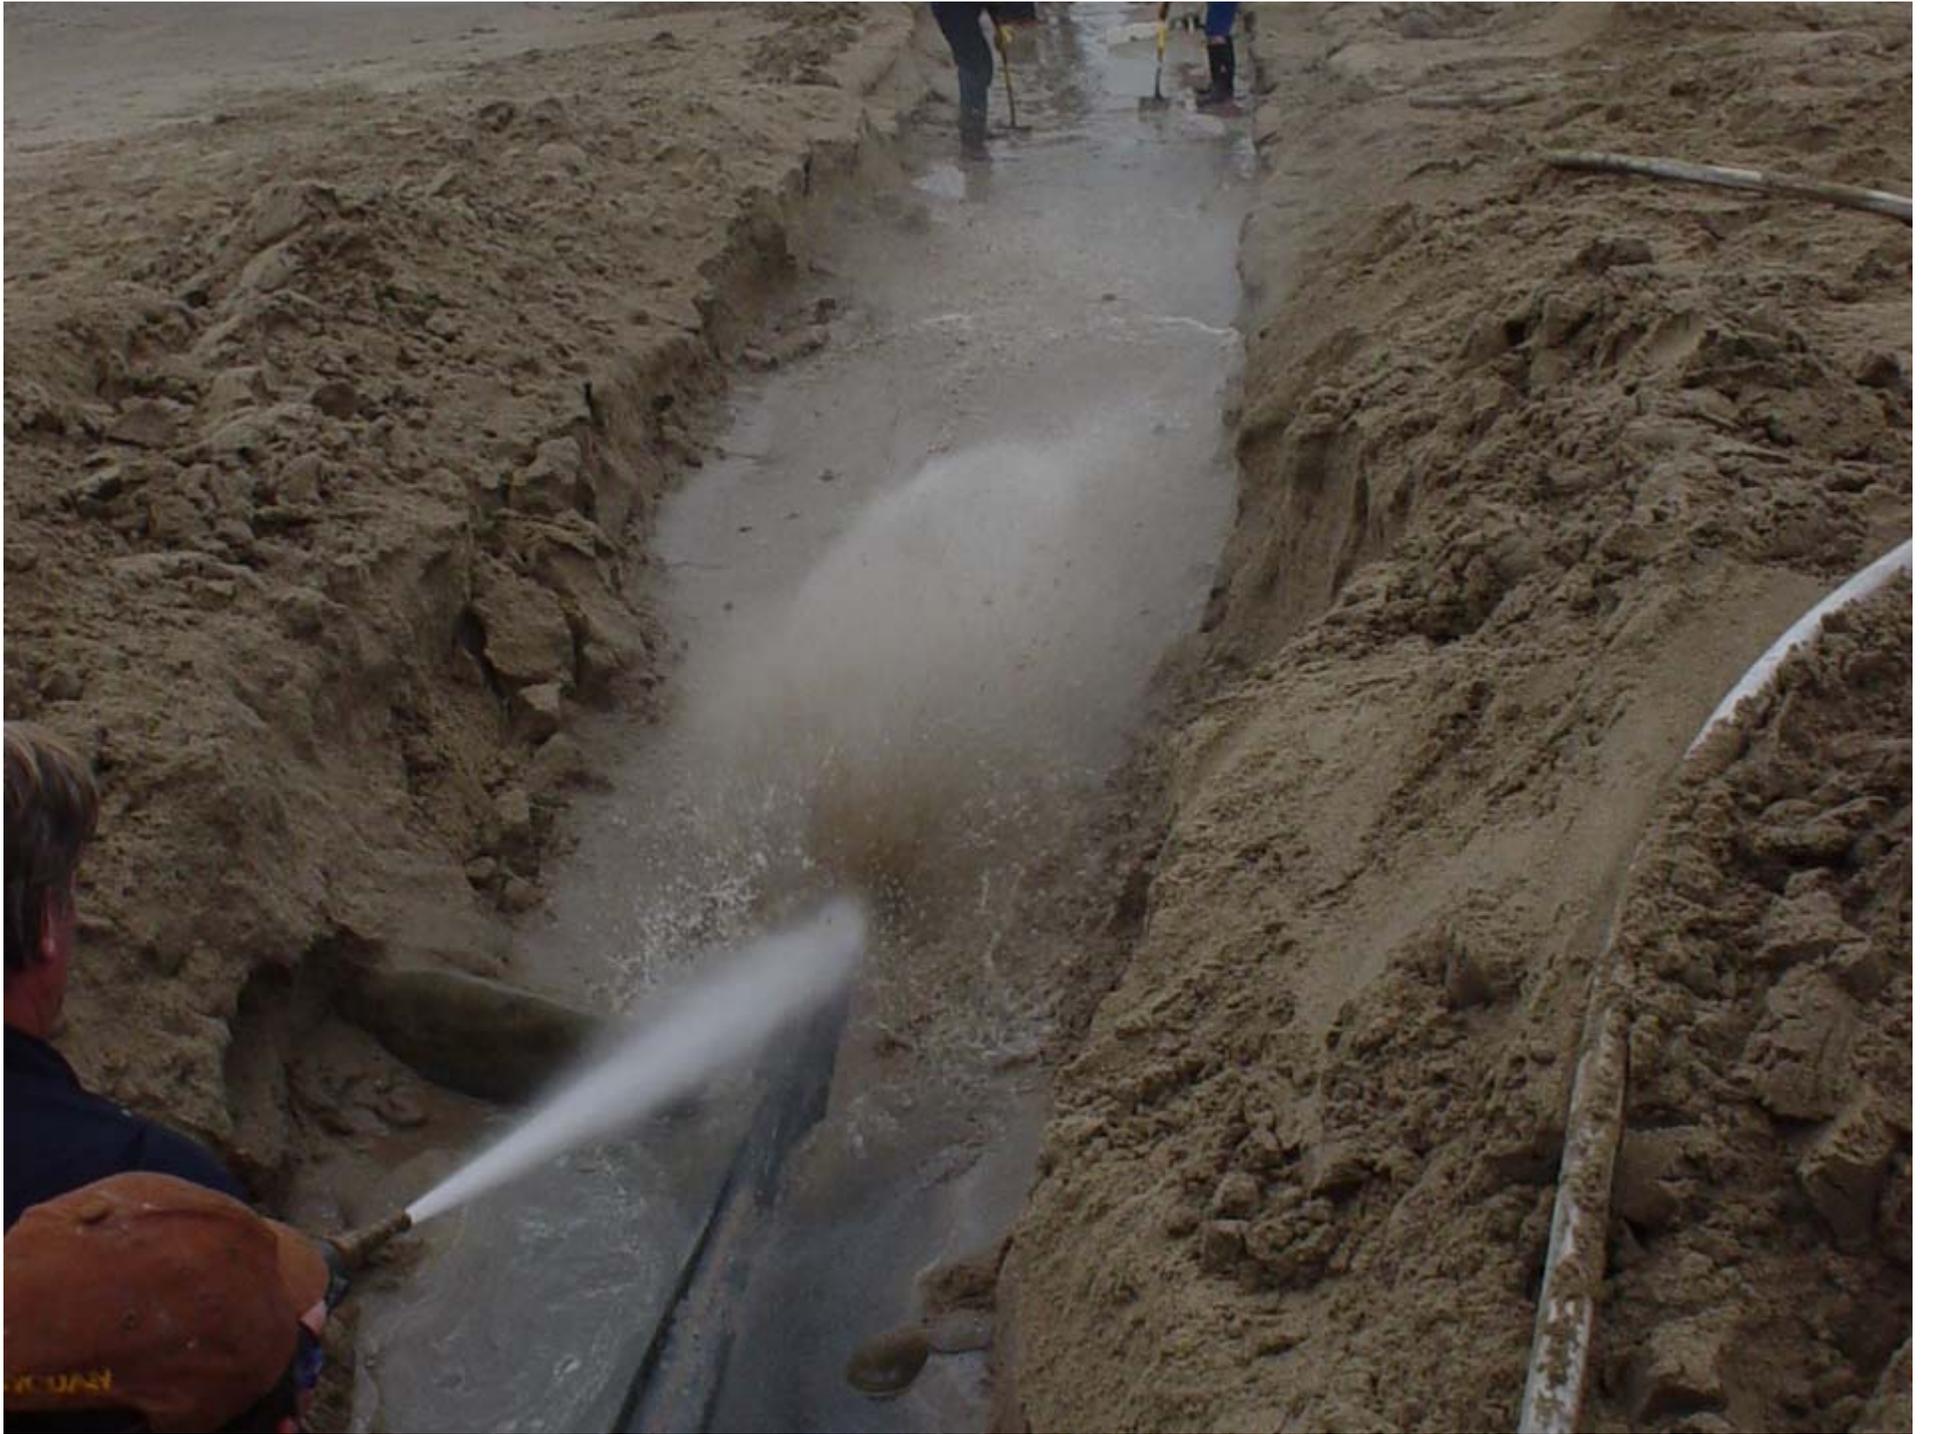
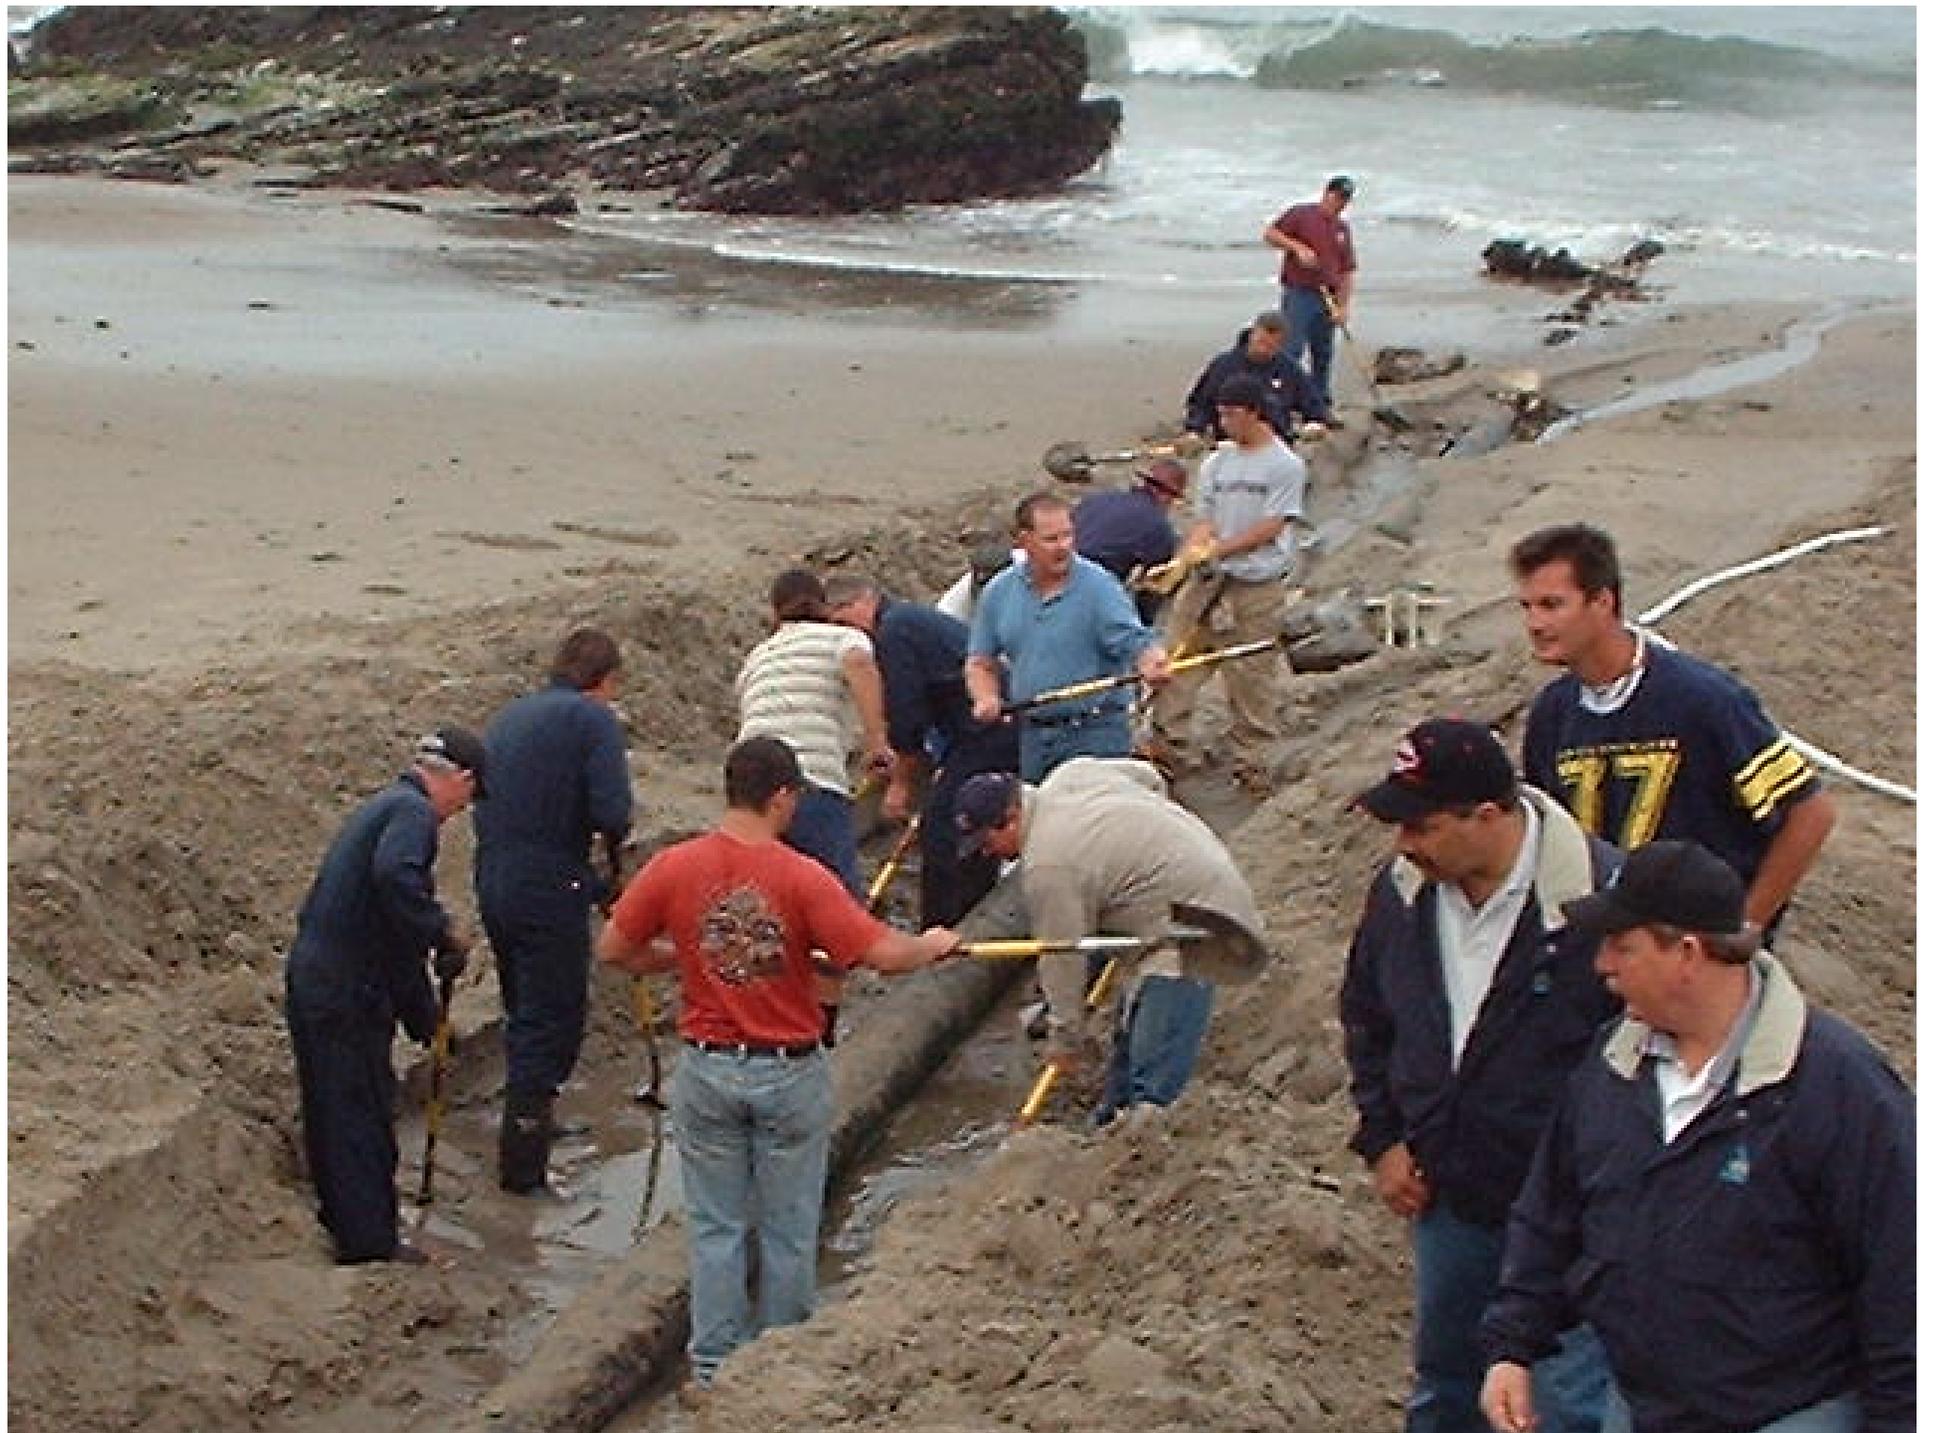
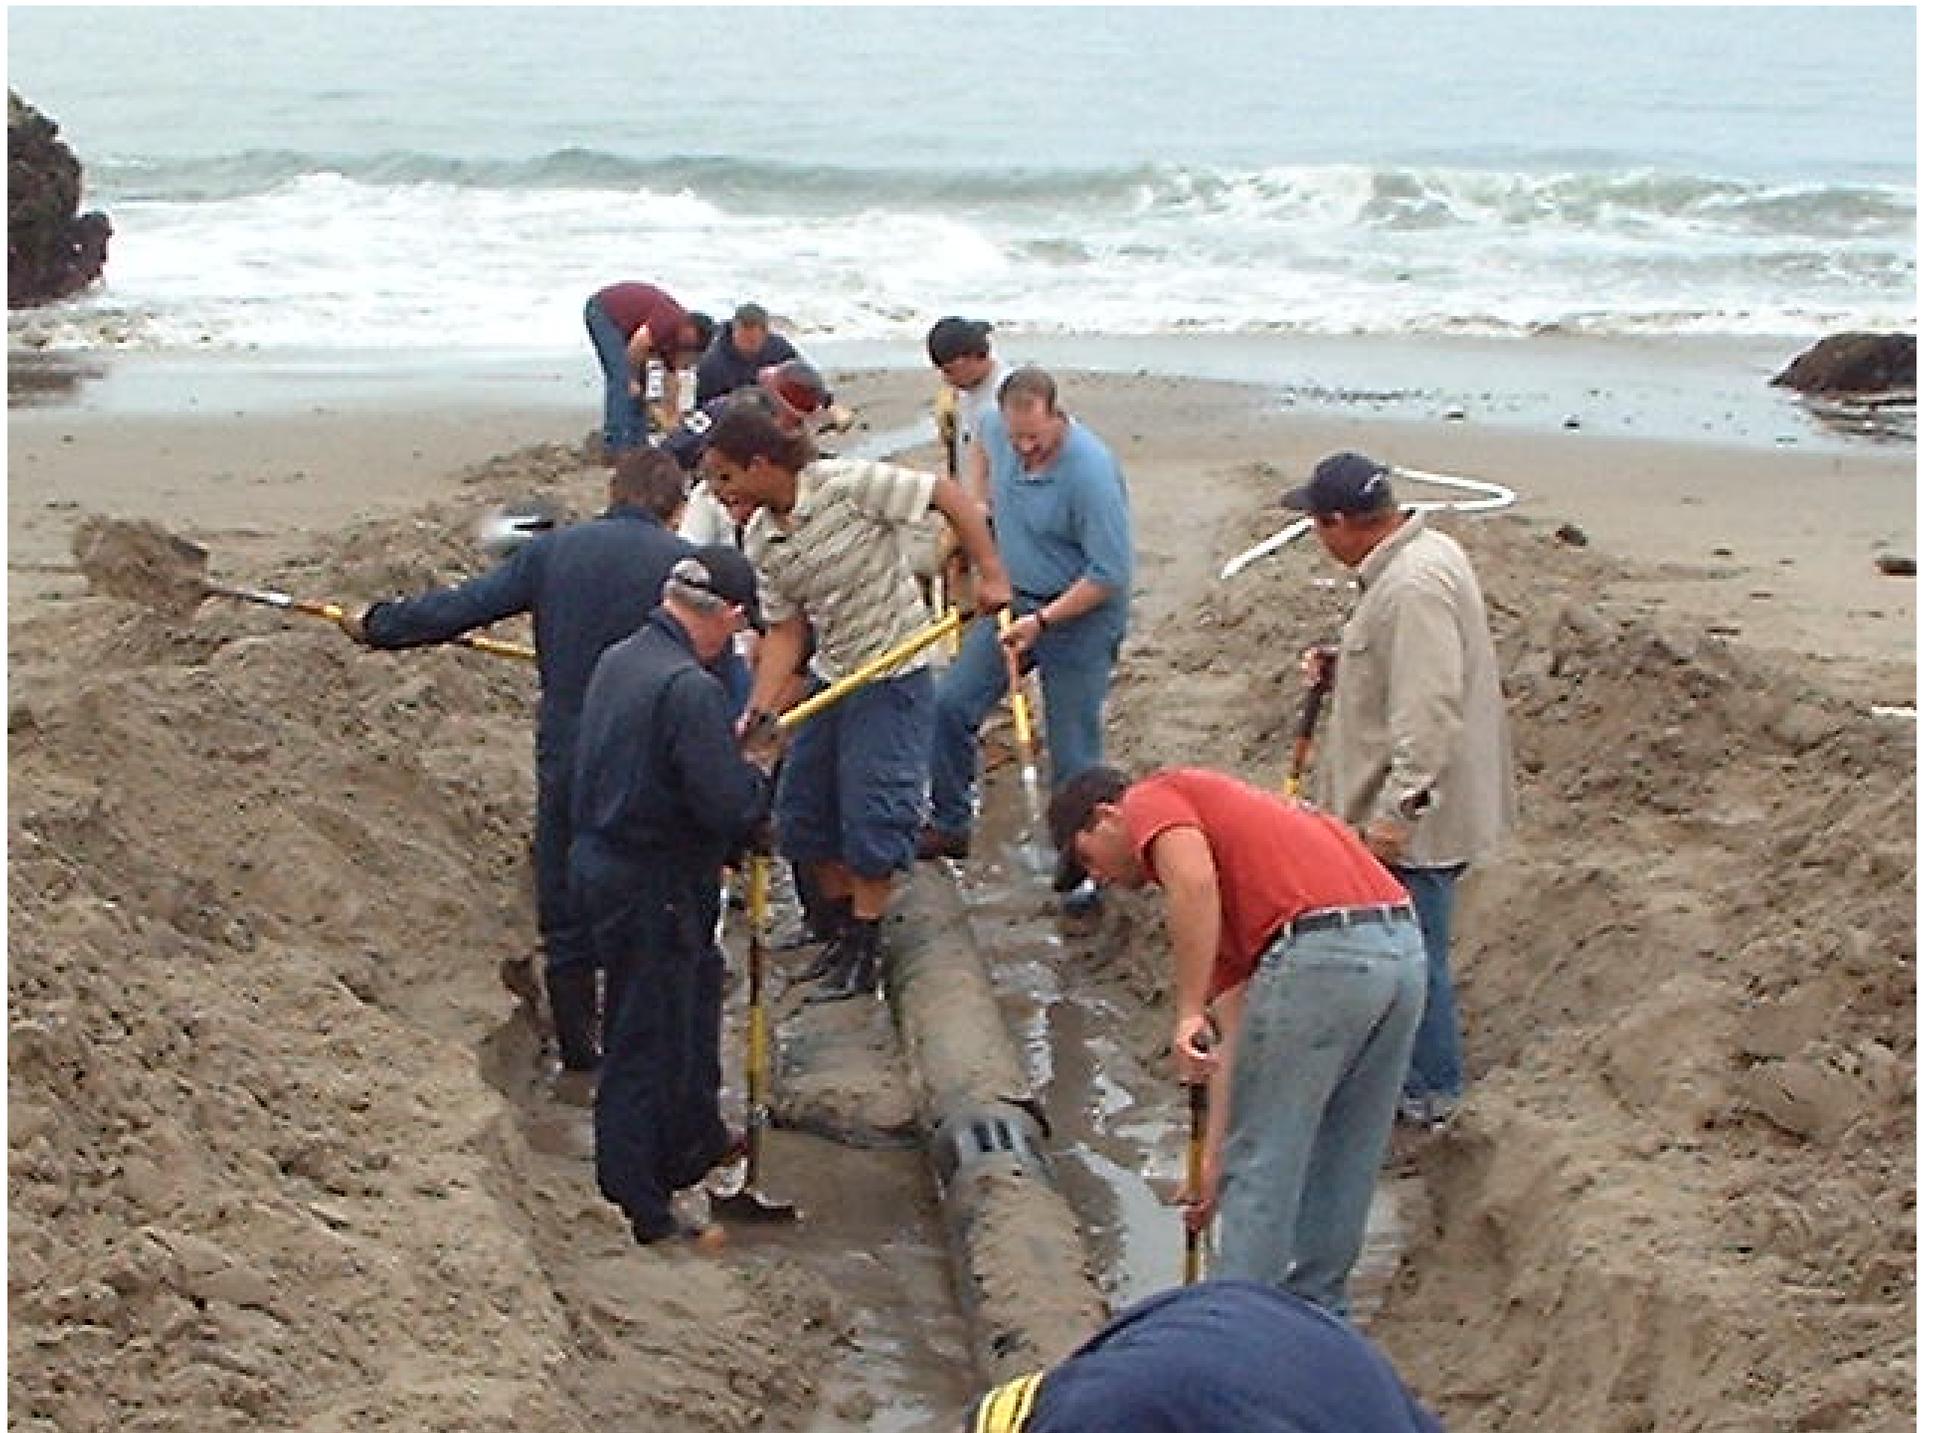
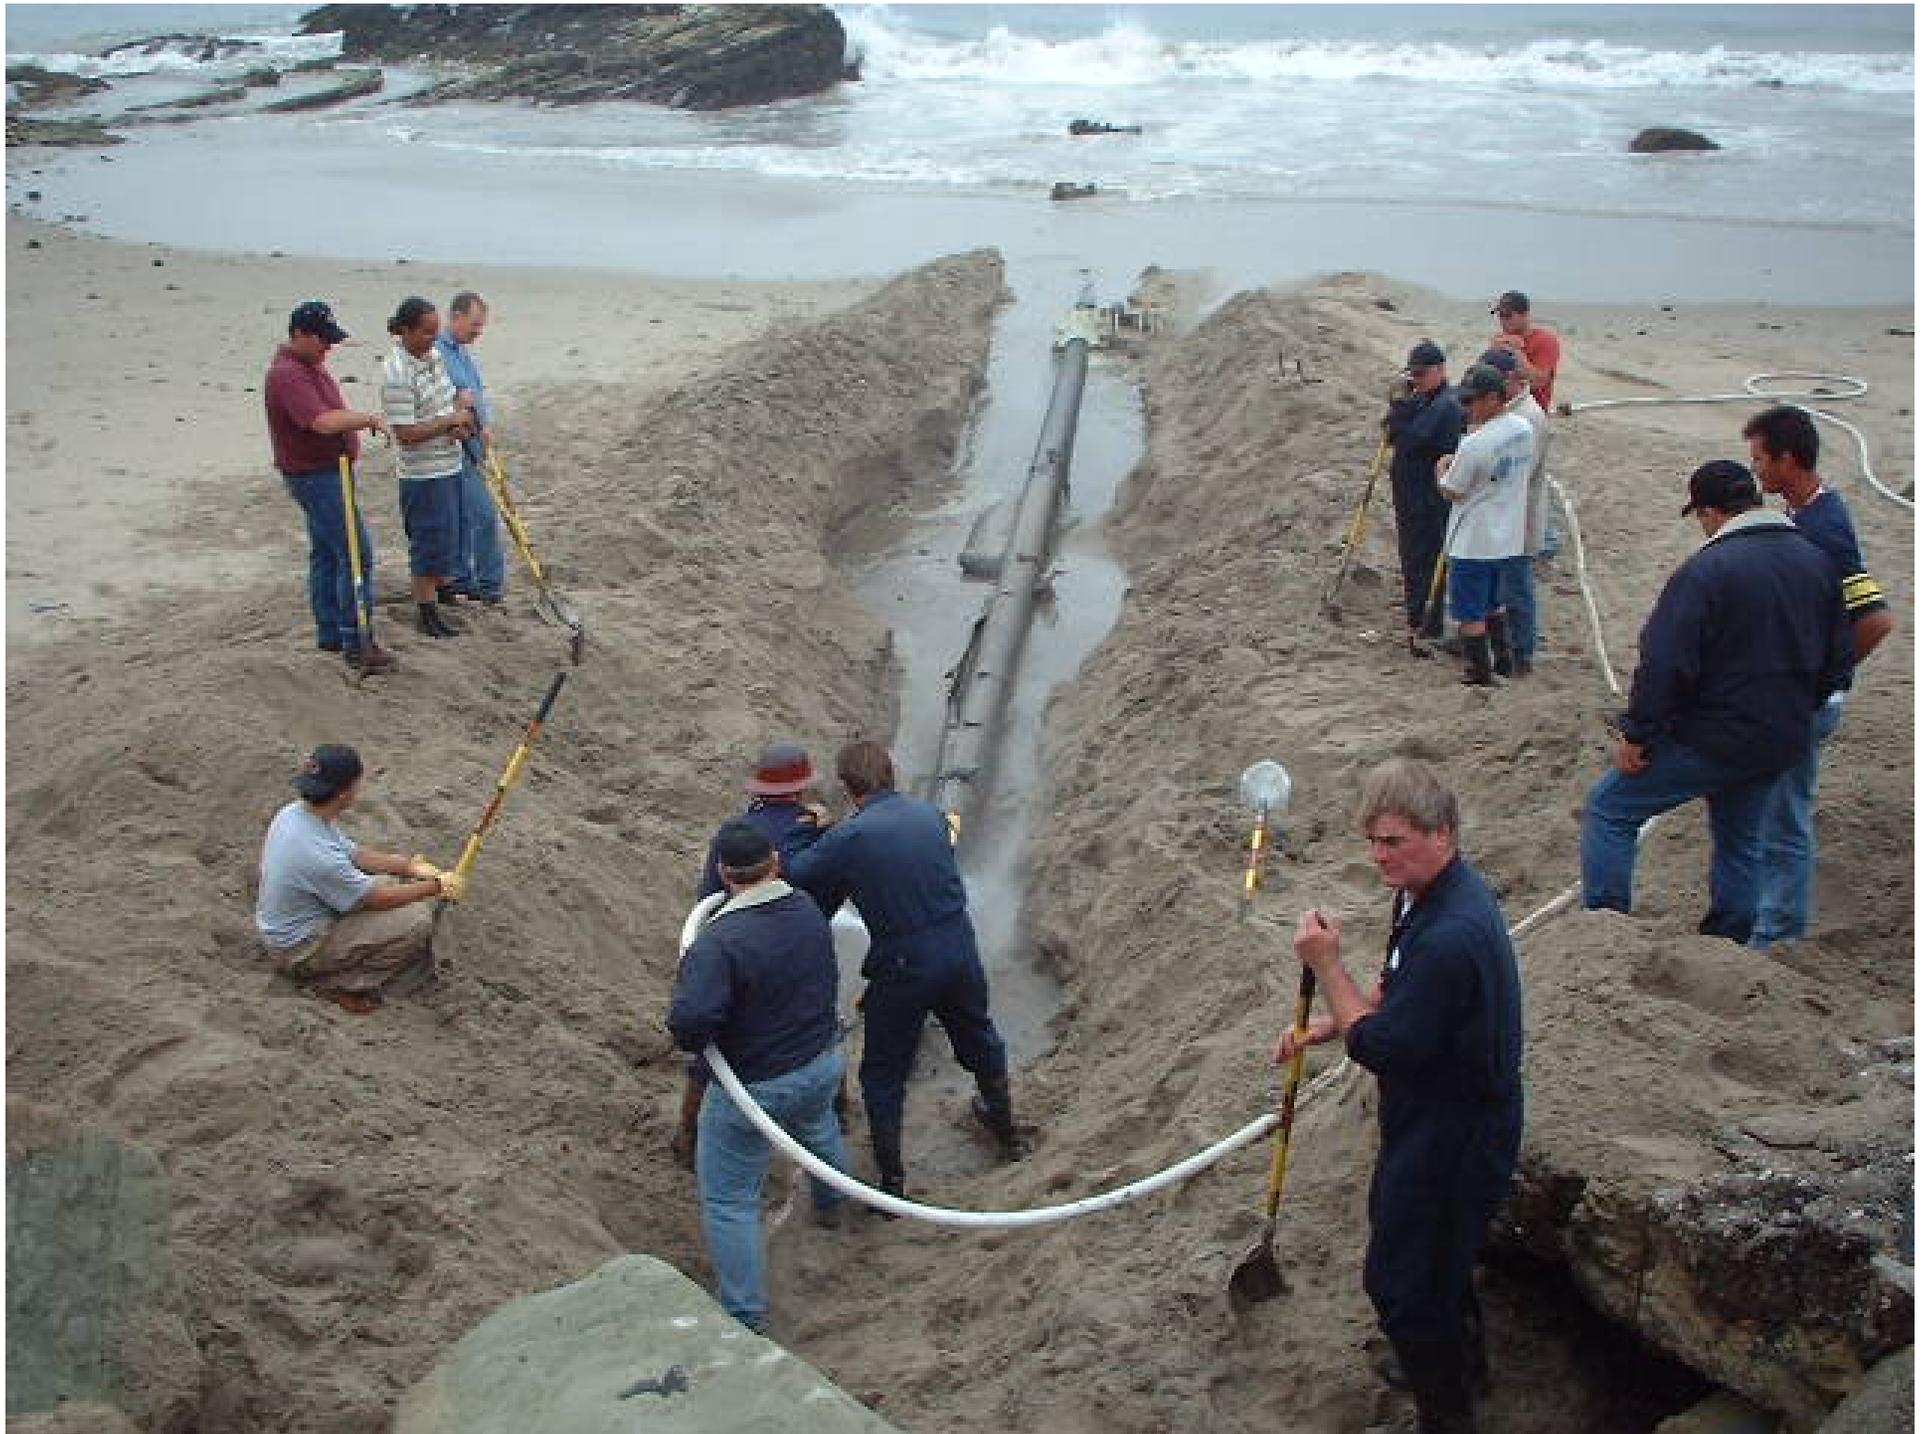
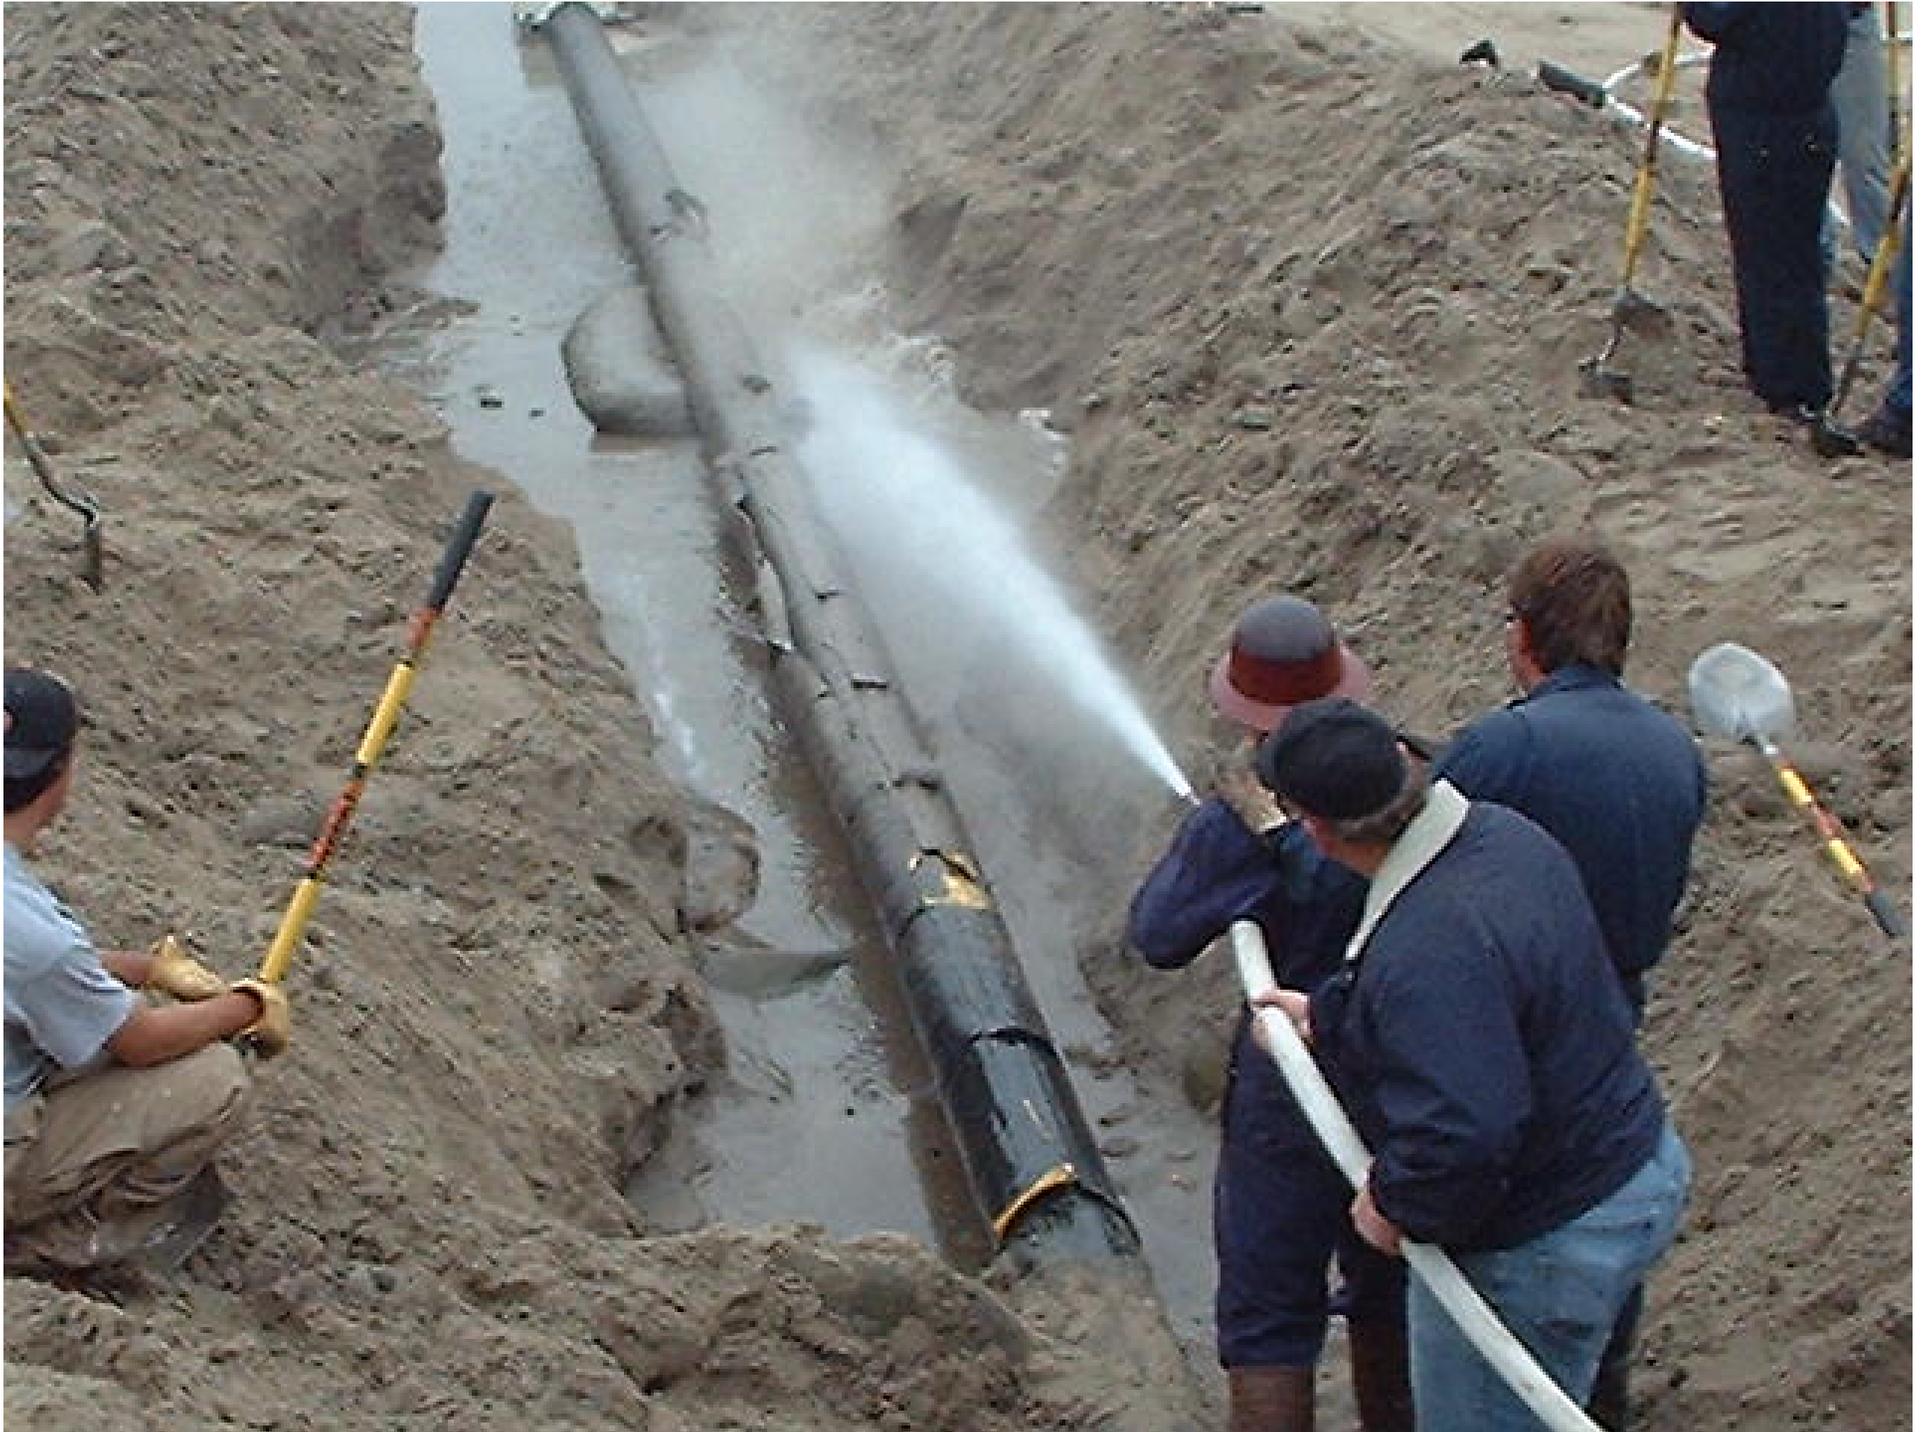
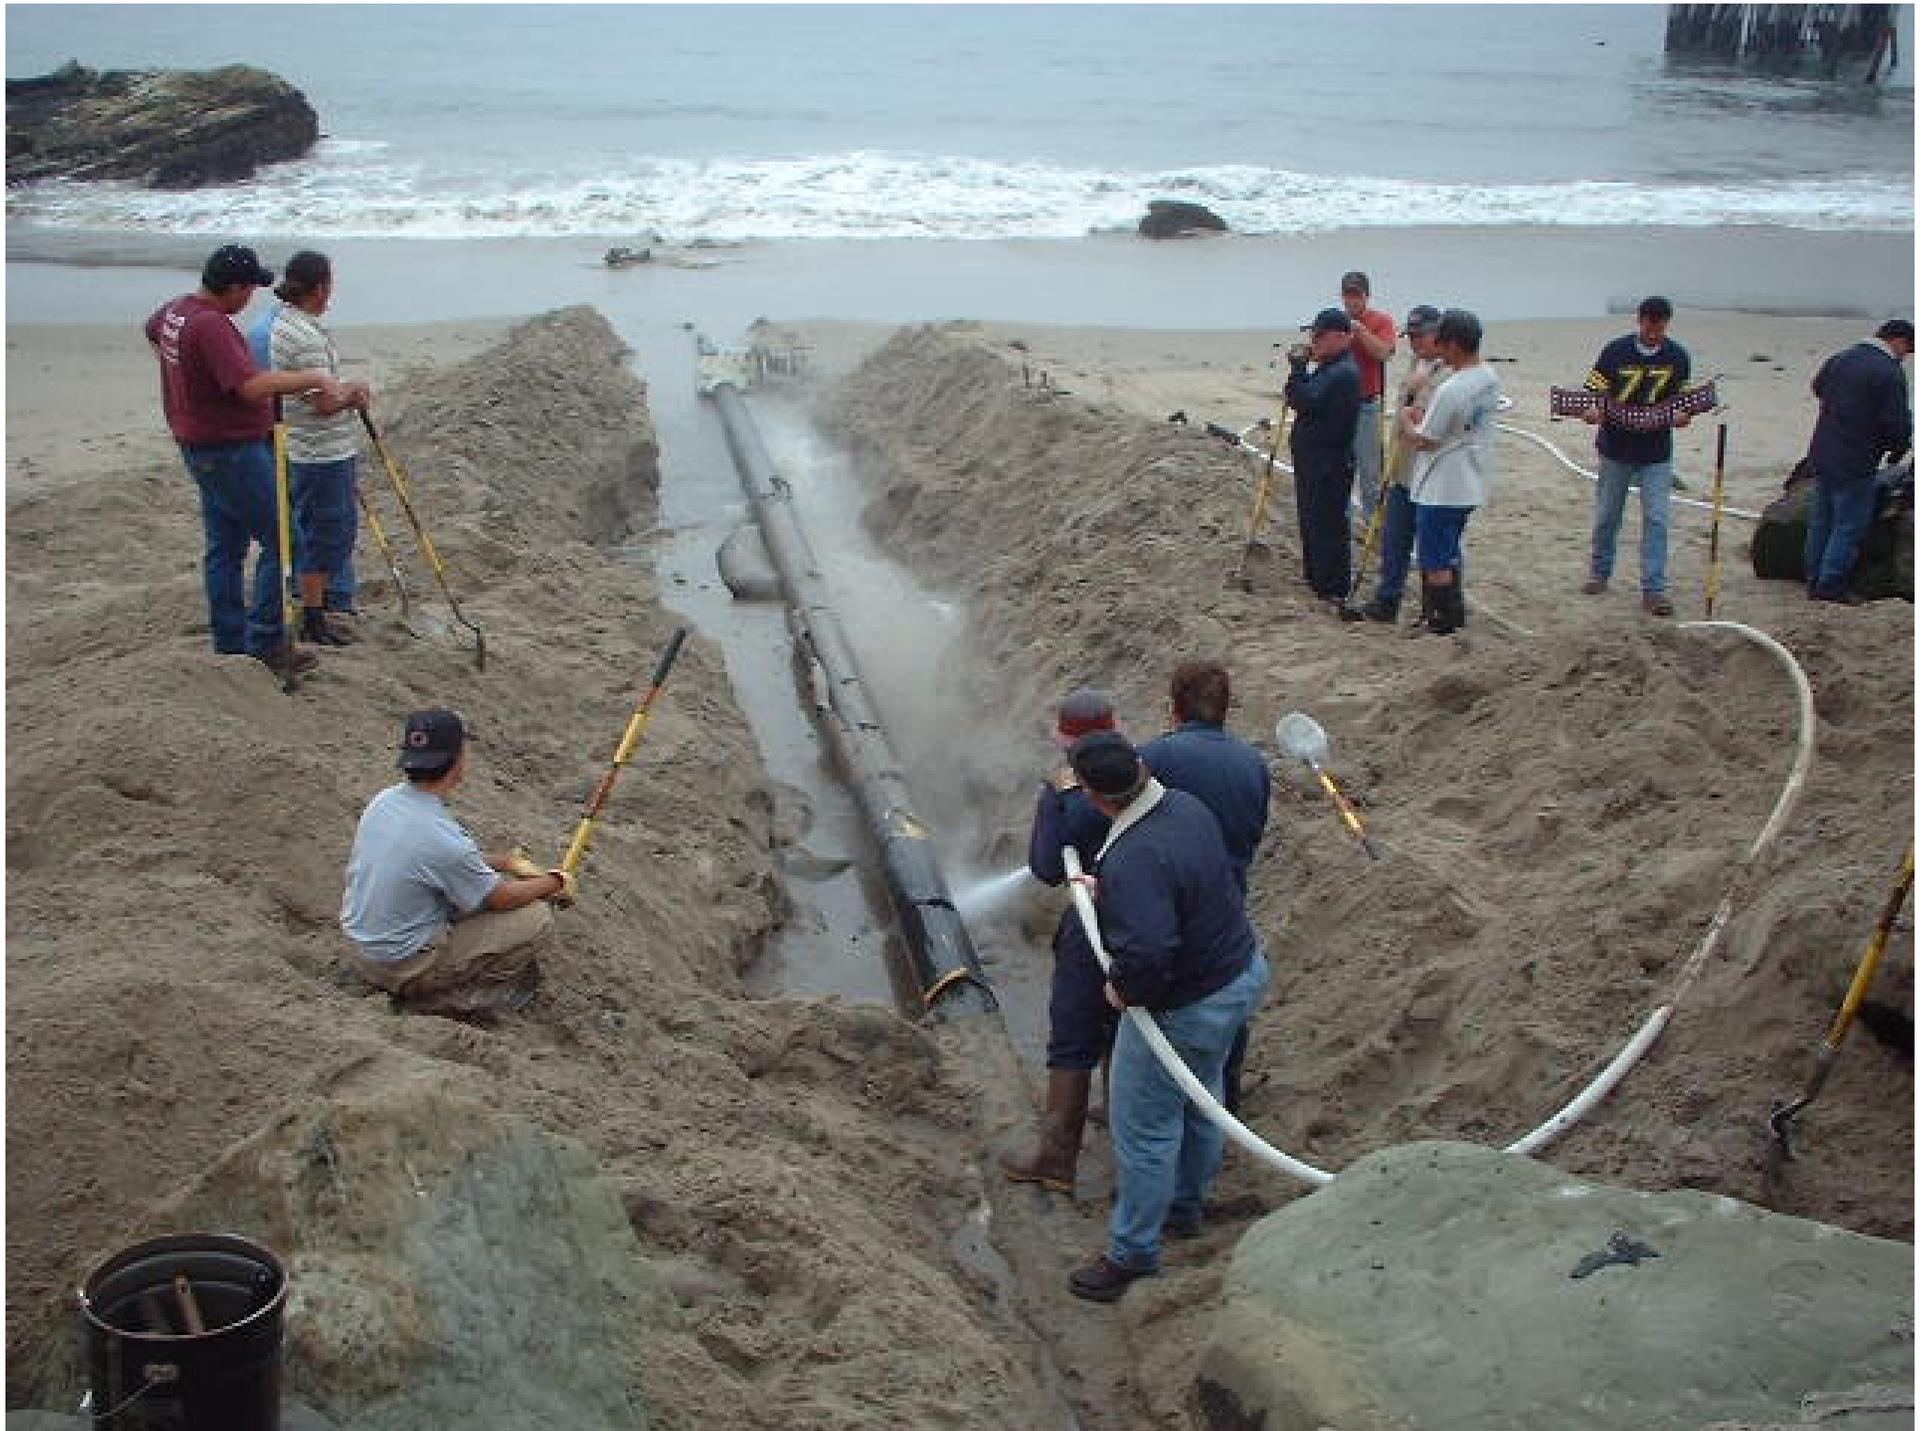
- Located two anomalies – external scouring of pipe

- Guided Wave Ultrasonic Inspection – June 21, 2004
 - Found 0.155" WT (58.6% loss) and 0.204" WT (45.6% loss)
 - Defects located within 45" of each other
 - About 12' total pipe exposed to scour
 - Subjected to RSTRENG analysis, determined true MAOP was 1188 psi, well above 740 psi
