Use of Guided Long Wave
Ultrasonic Inspection for Anomaly
Locating and Use of Composite
Repair Materials

12" x 10" M-2 Oil Pipeline

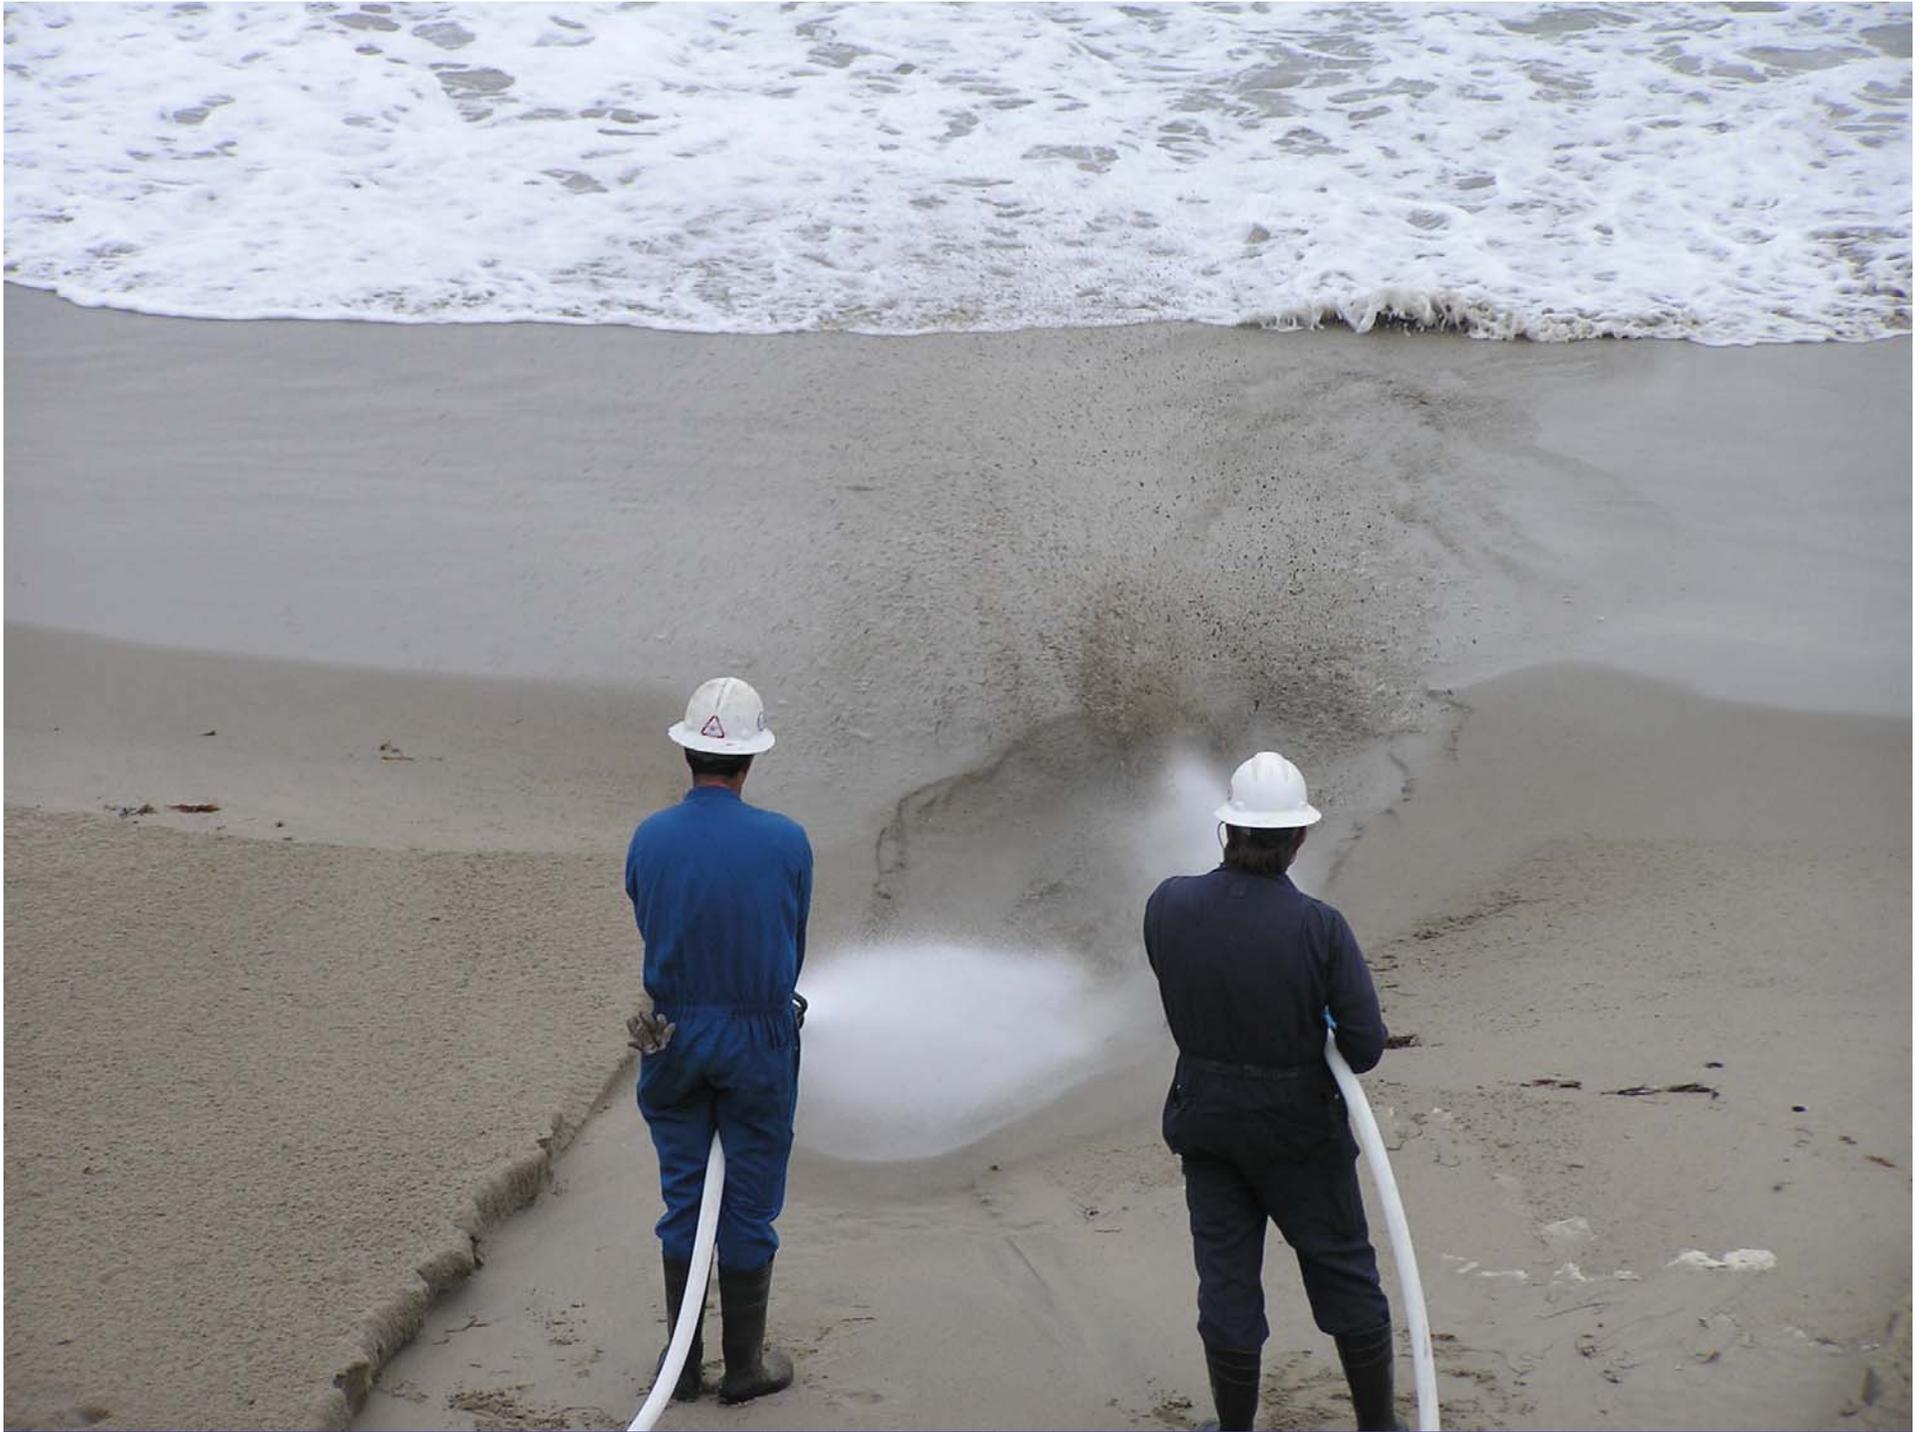
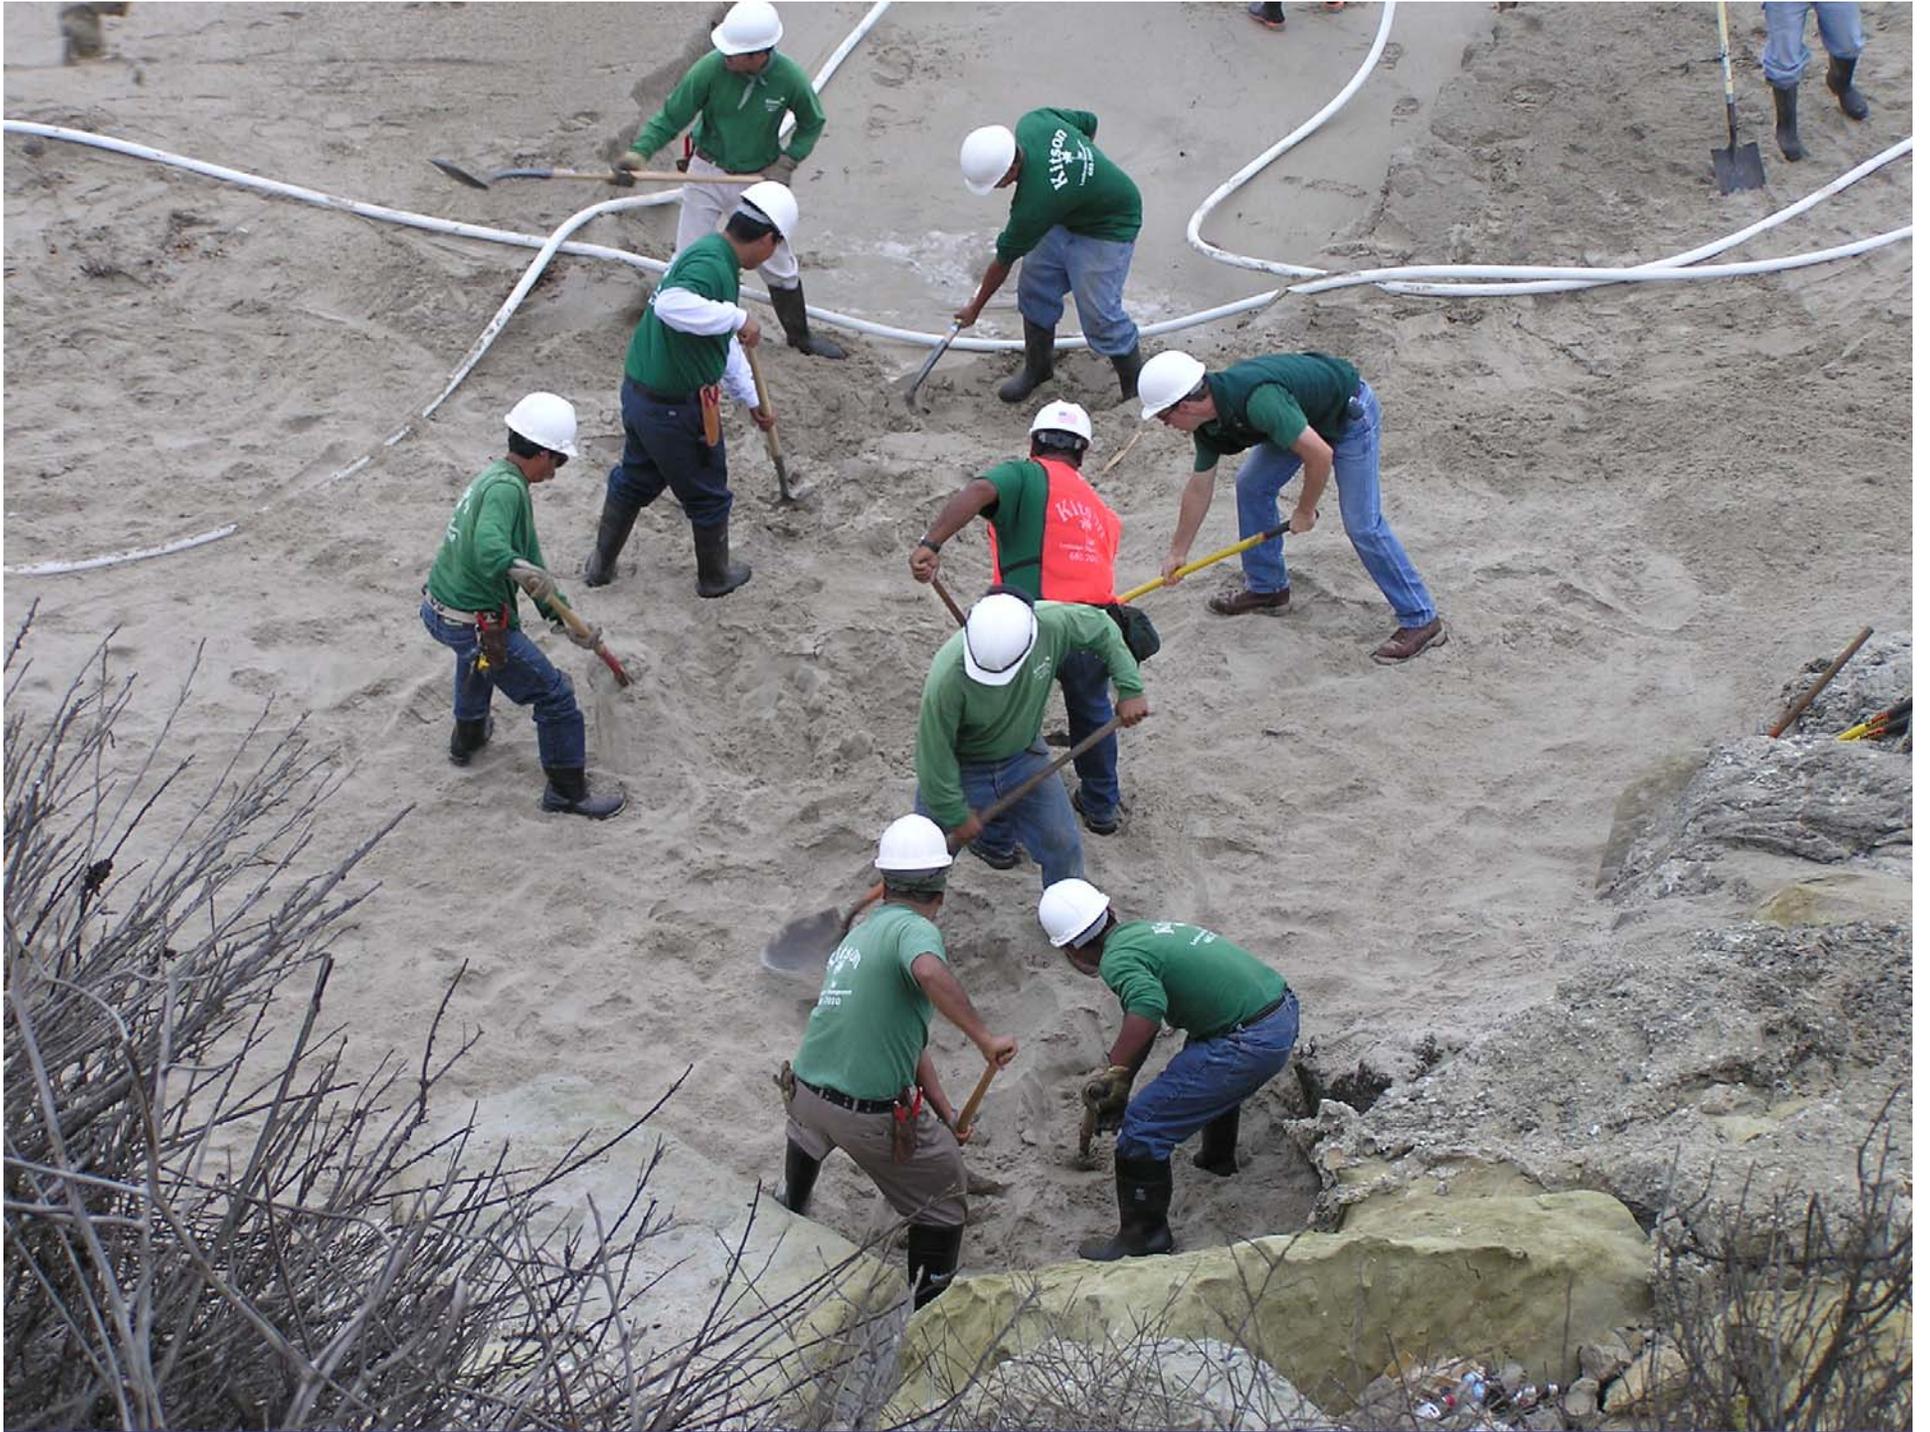
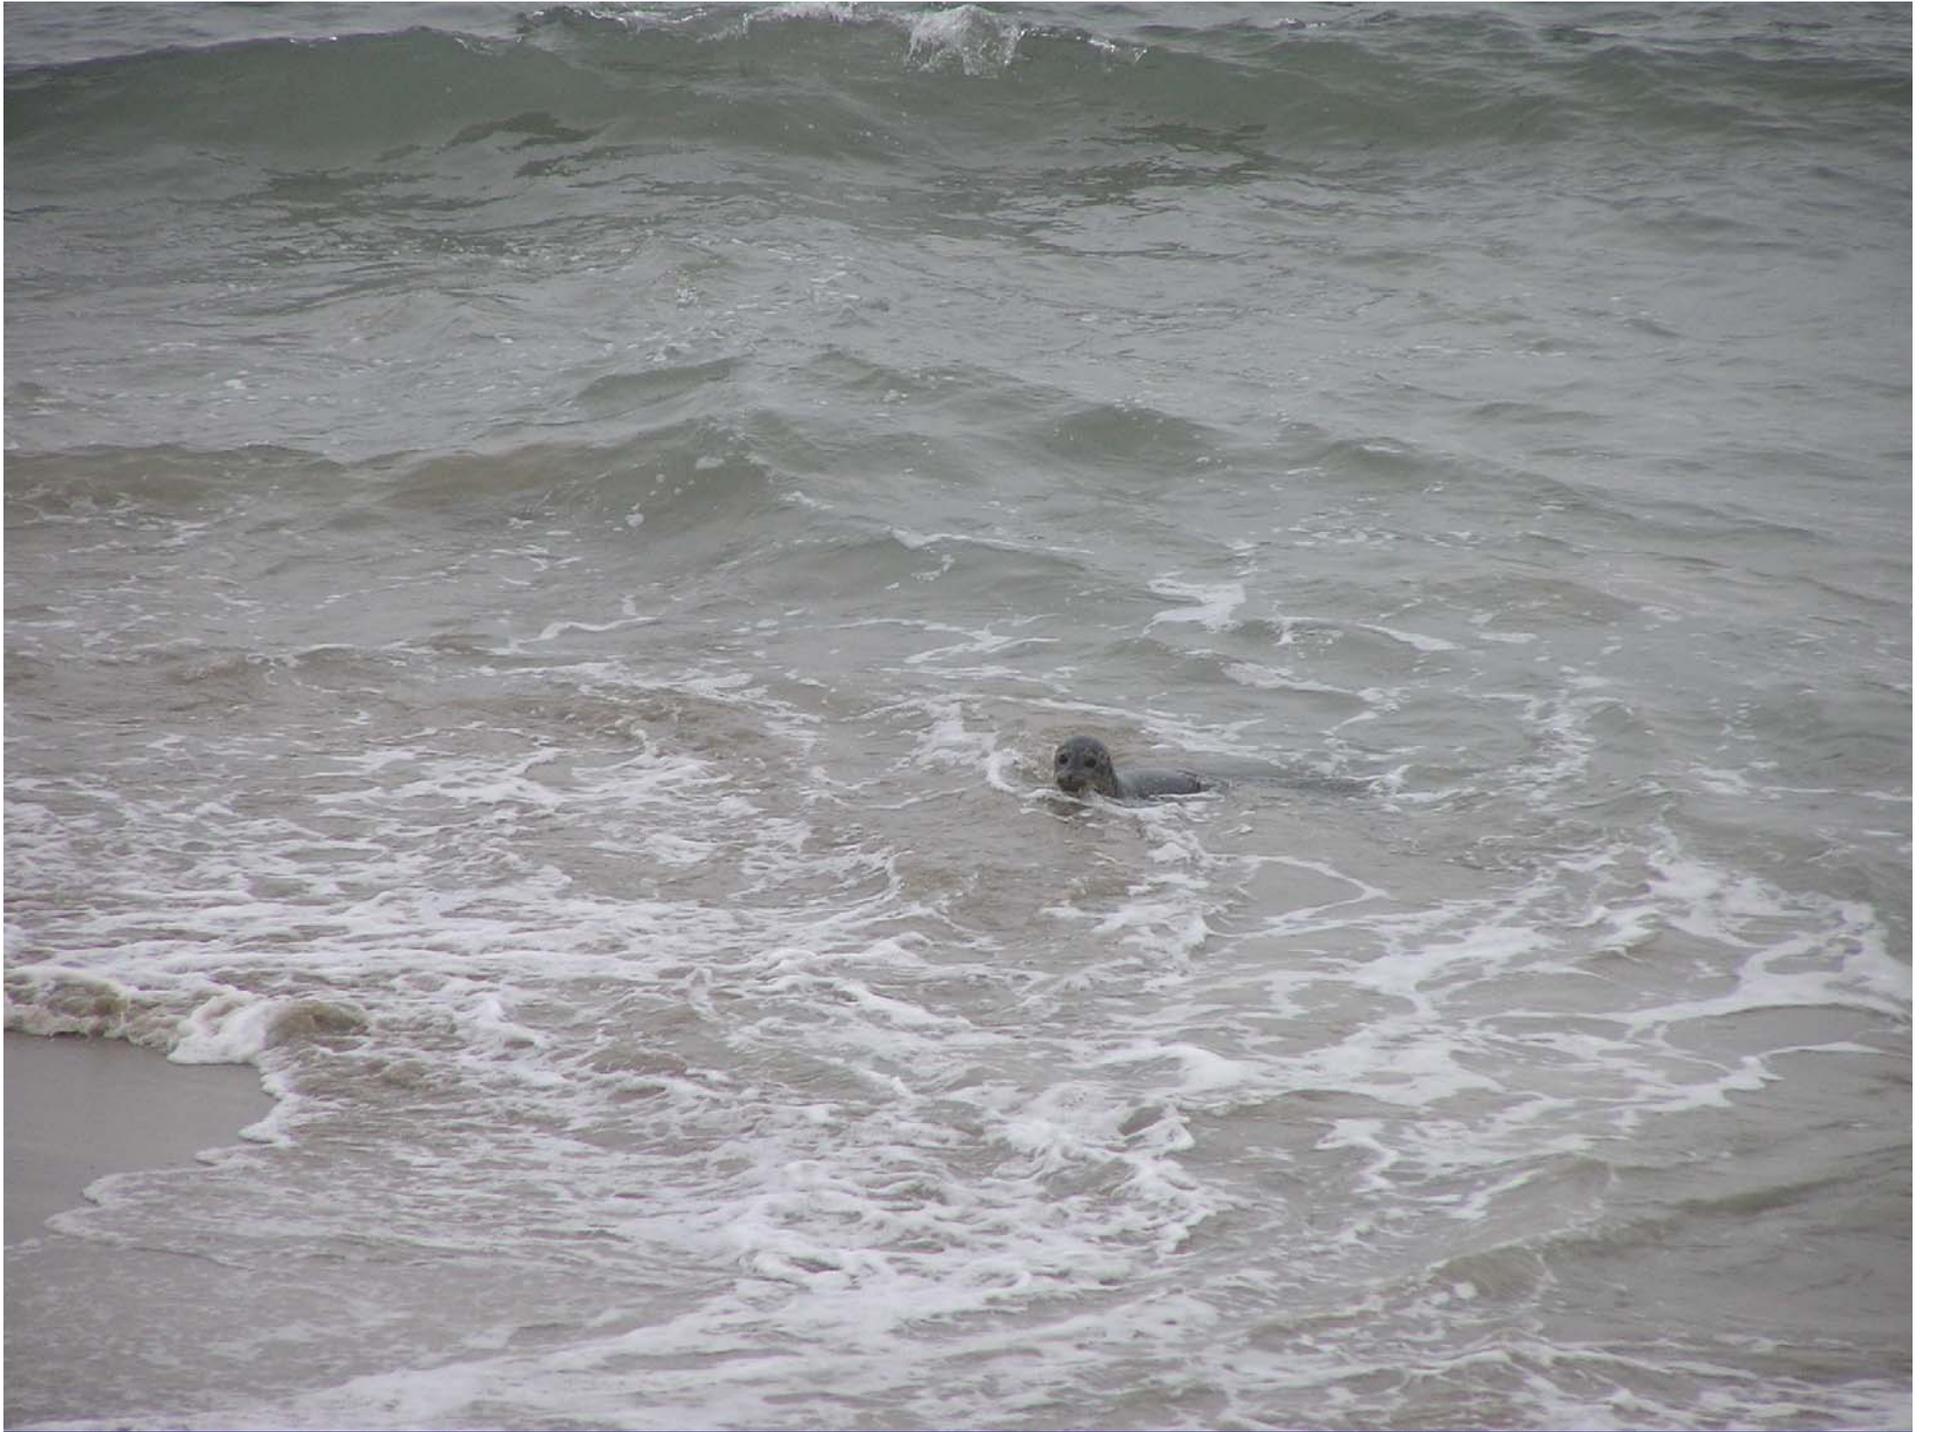
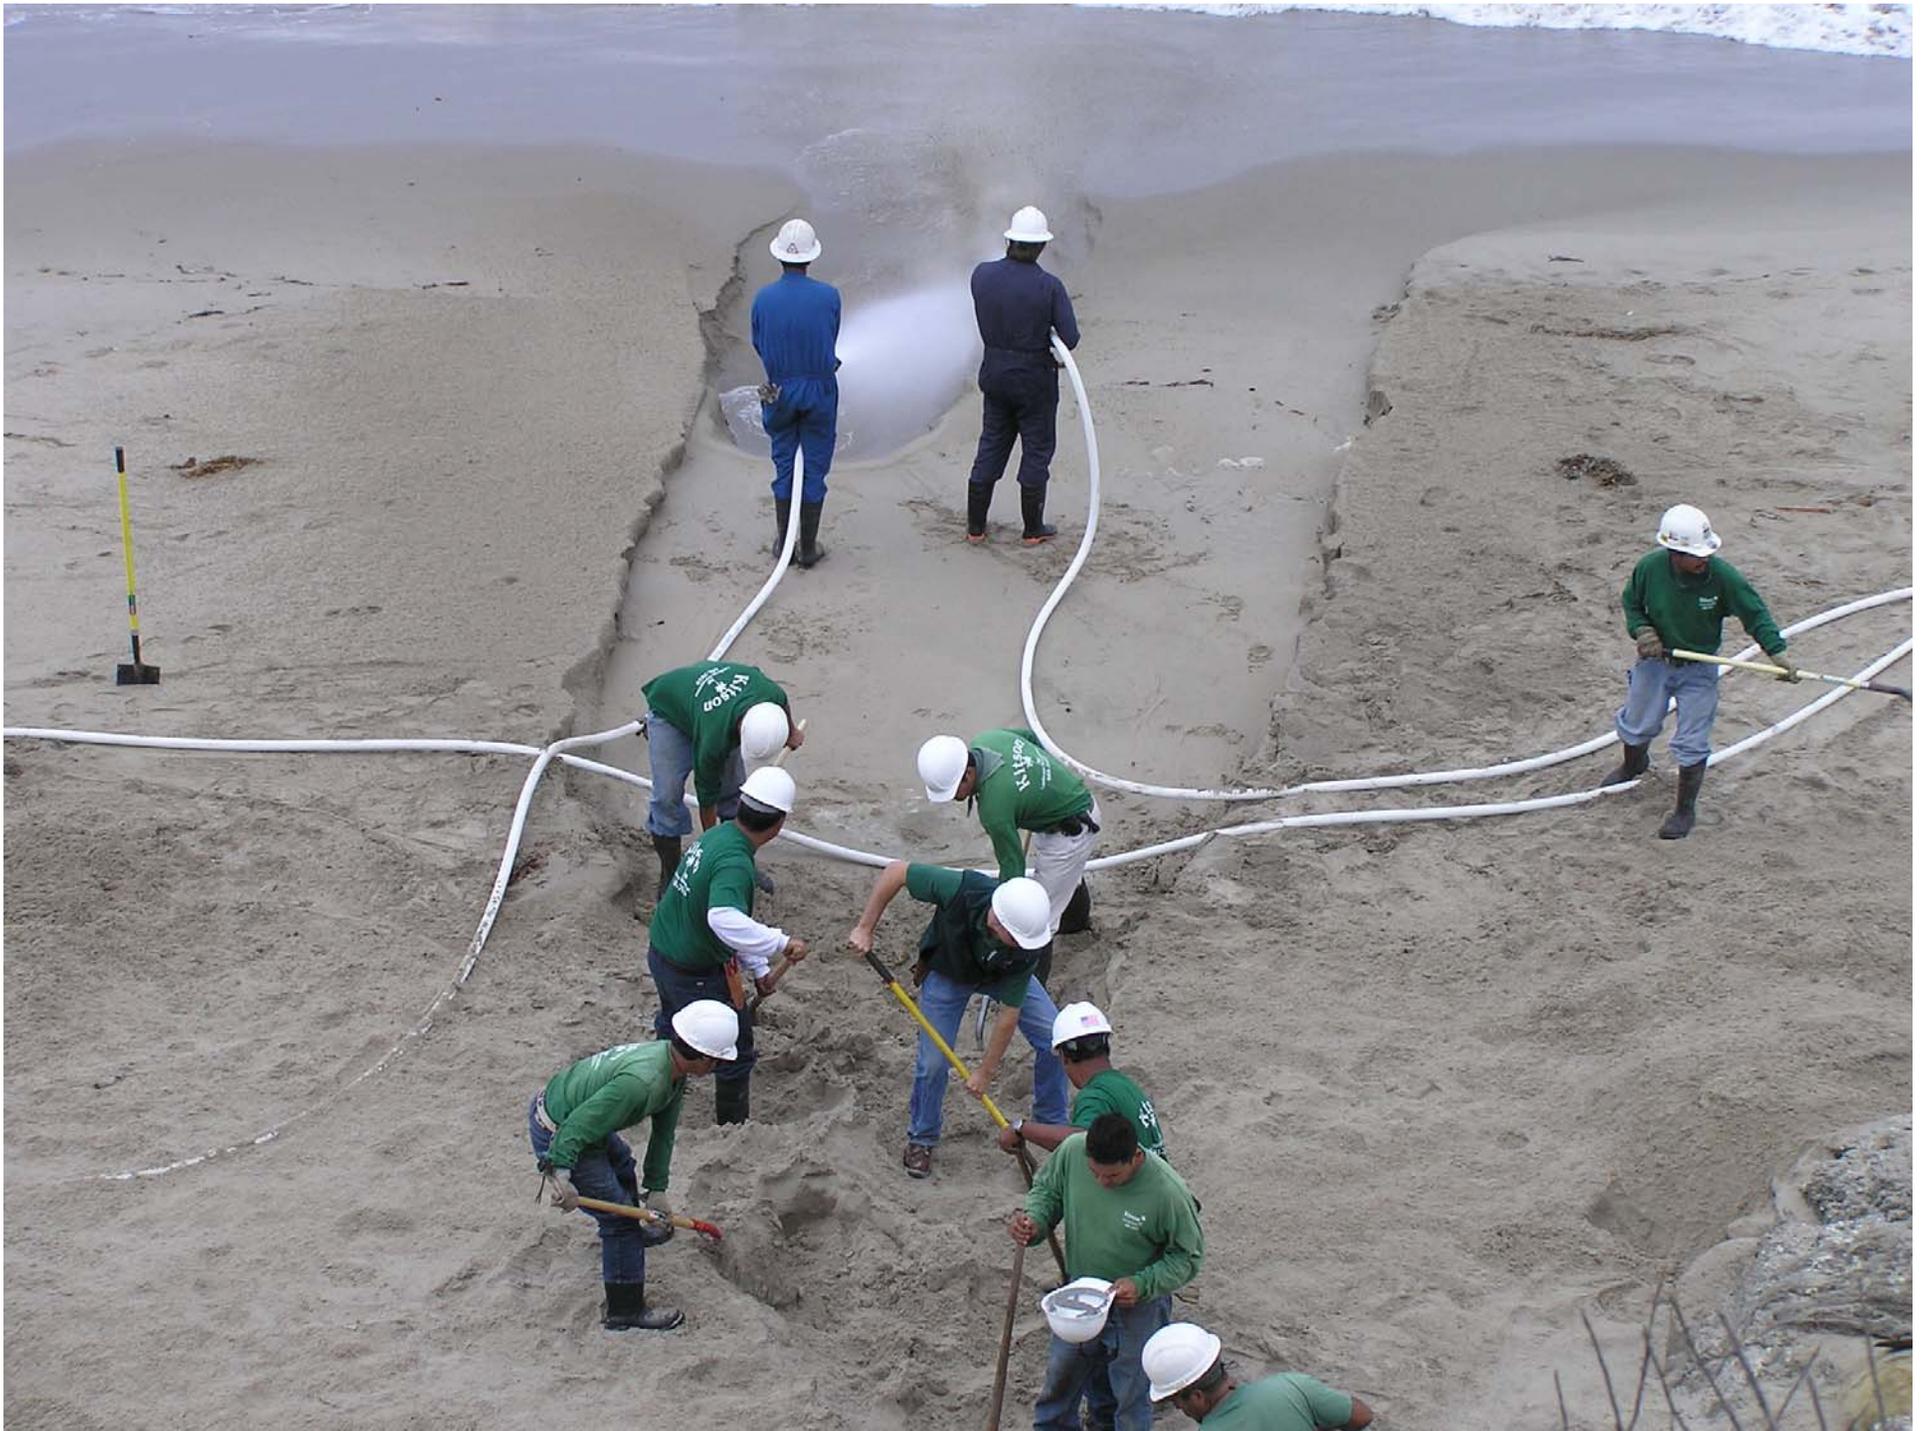
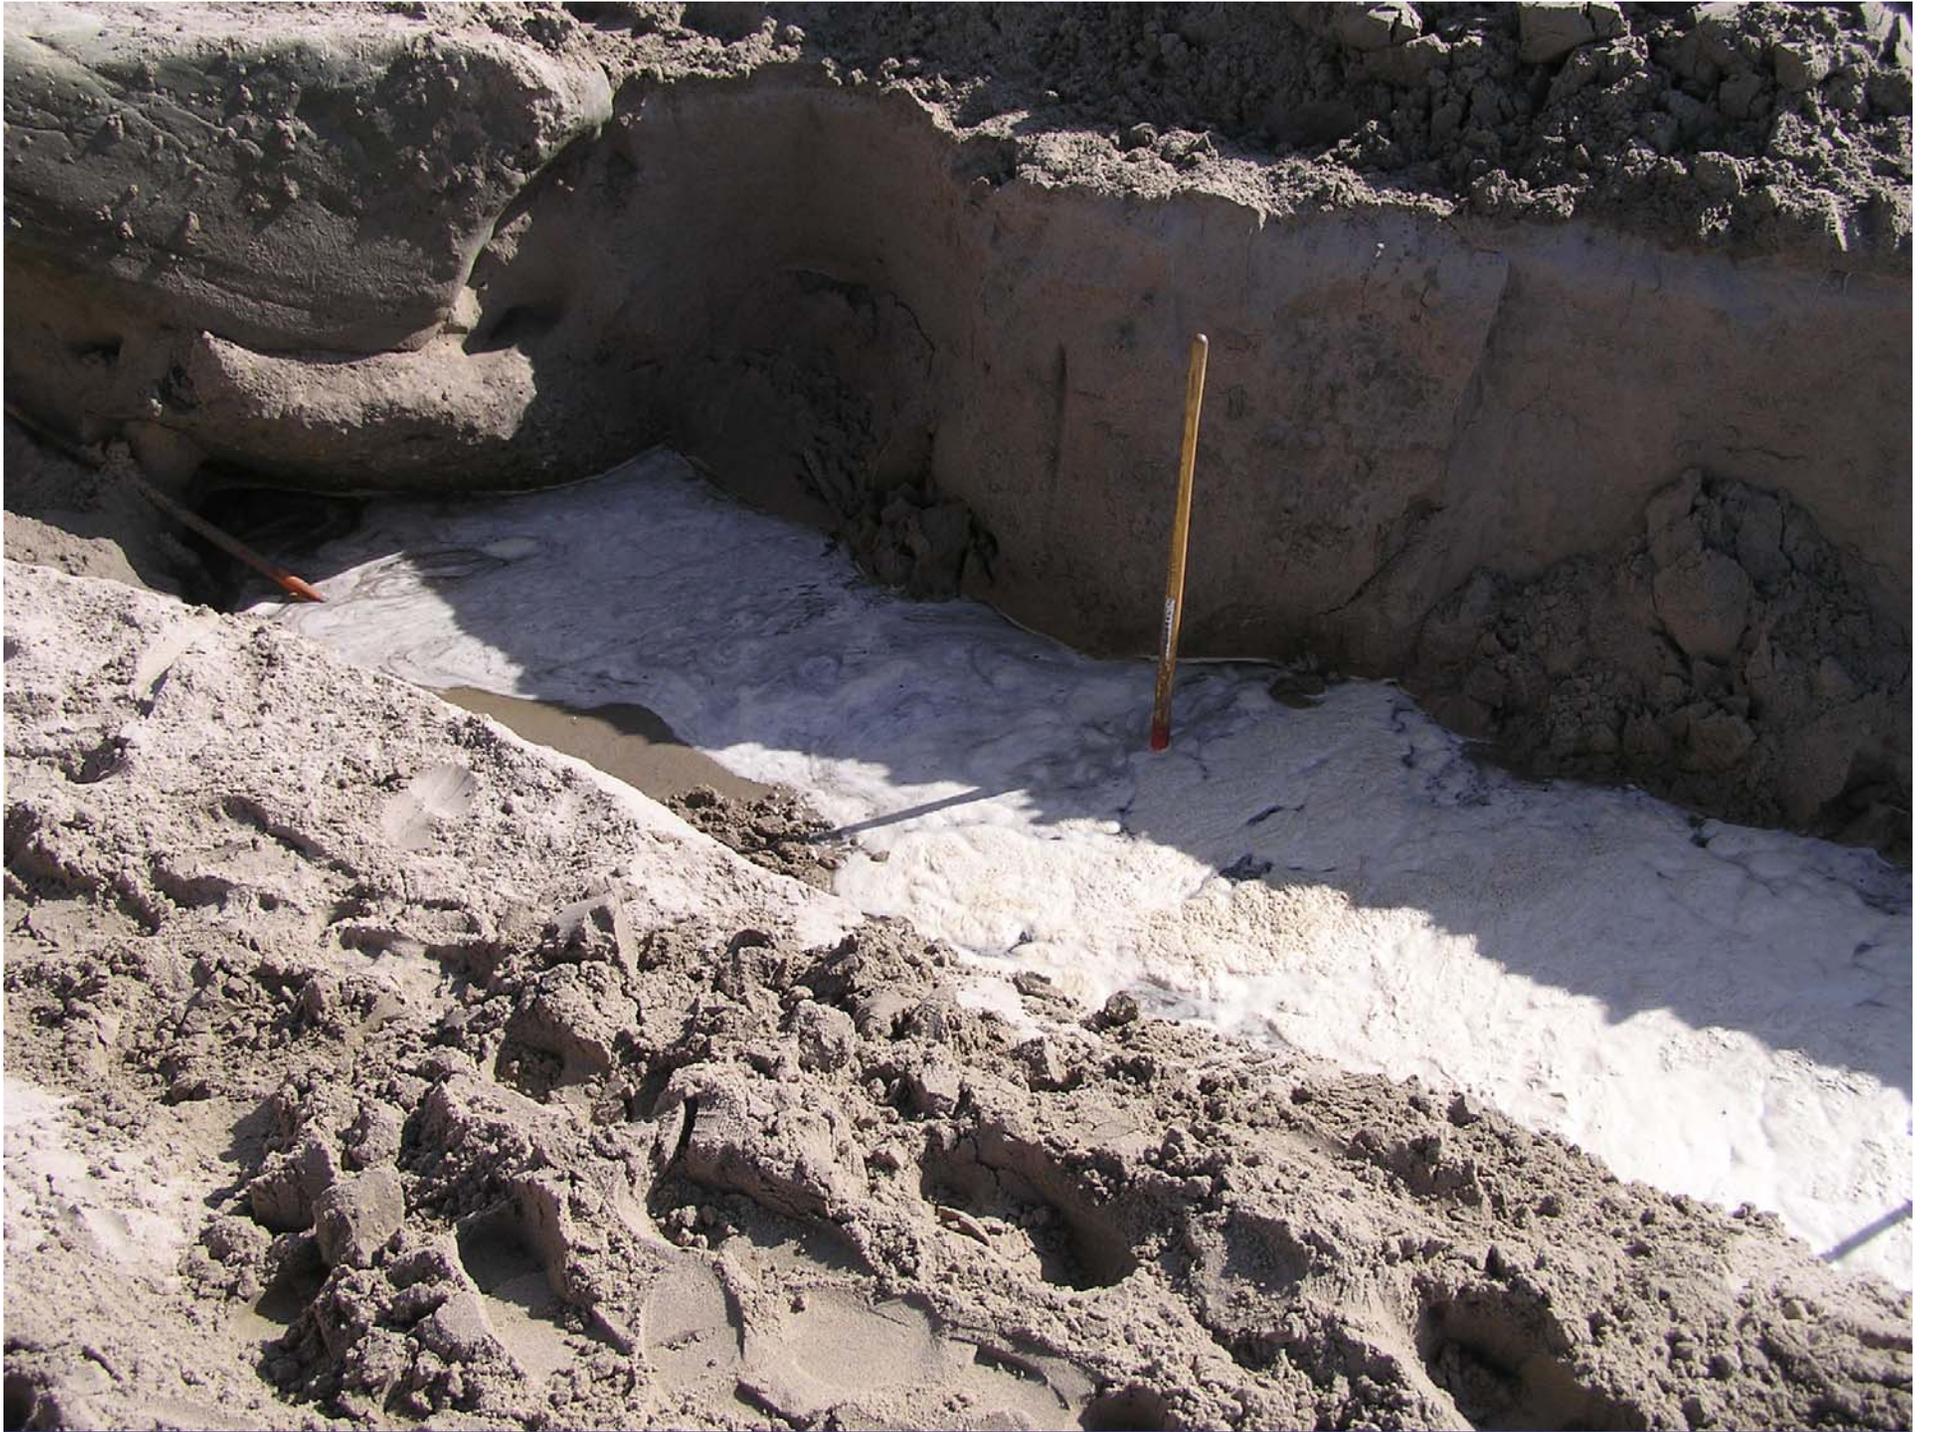
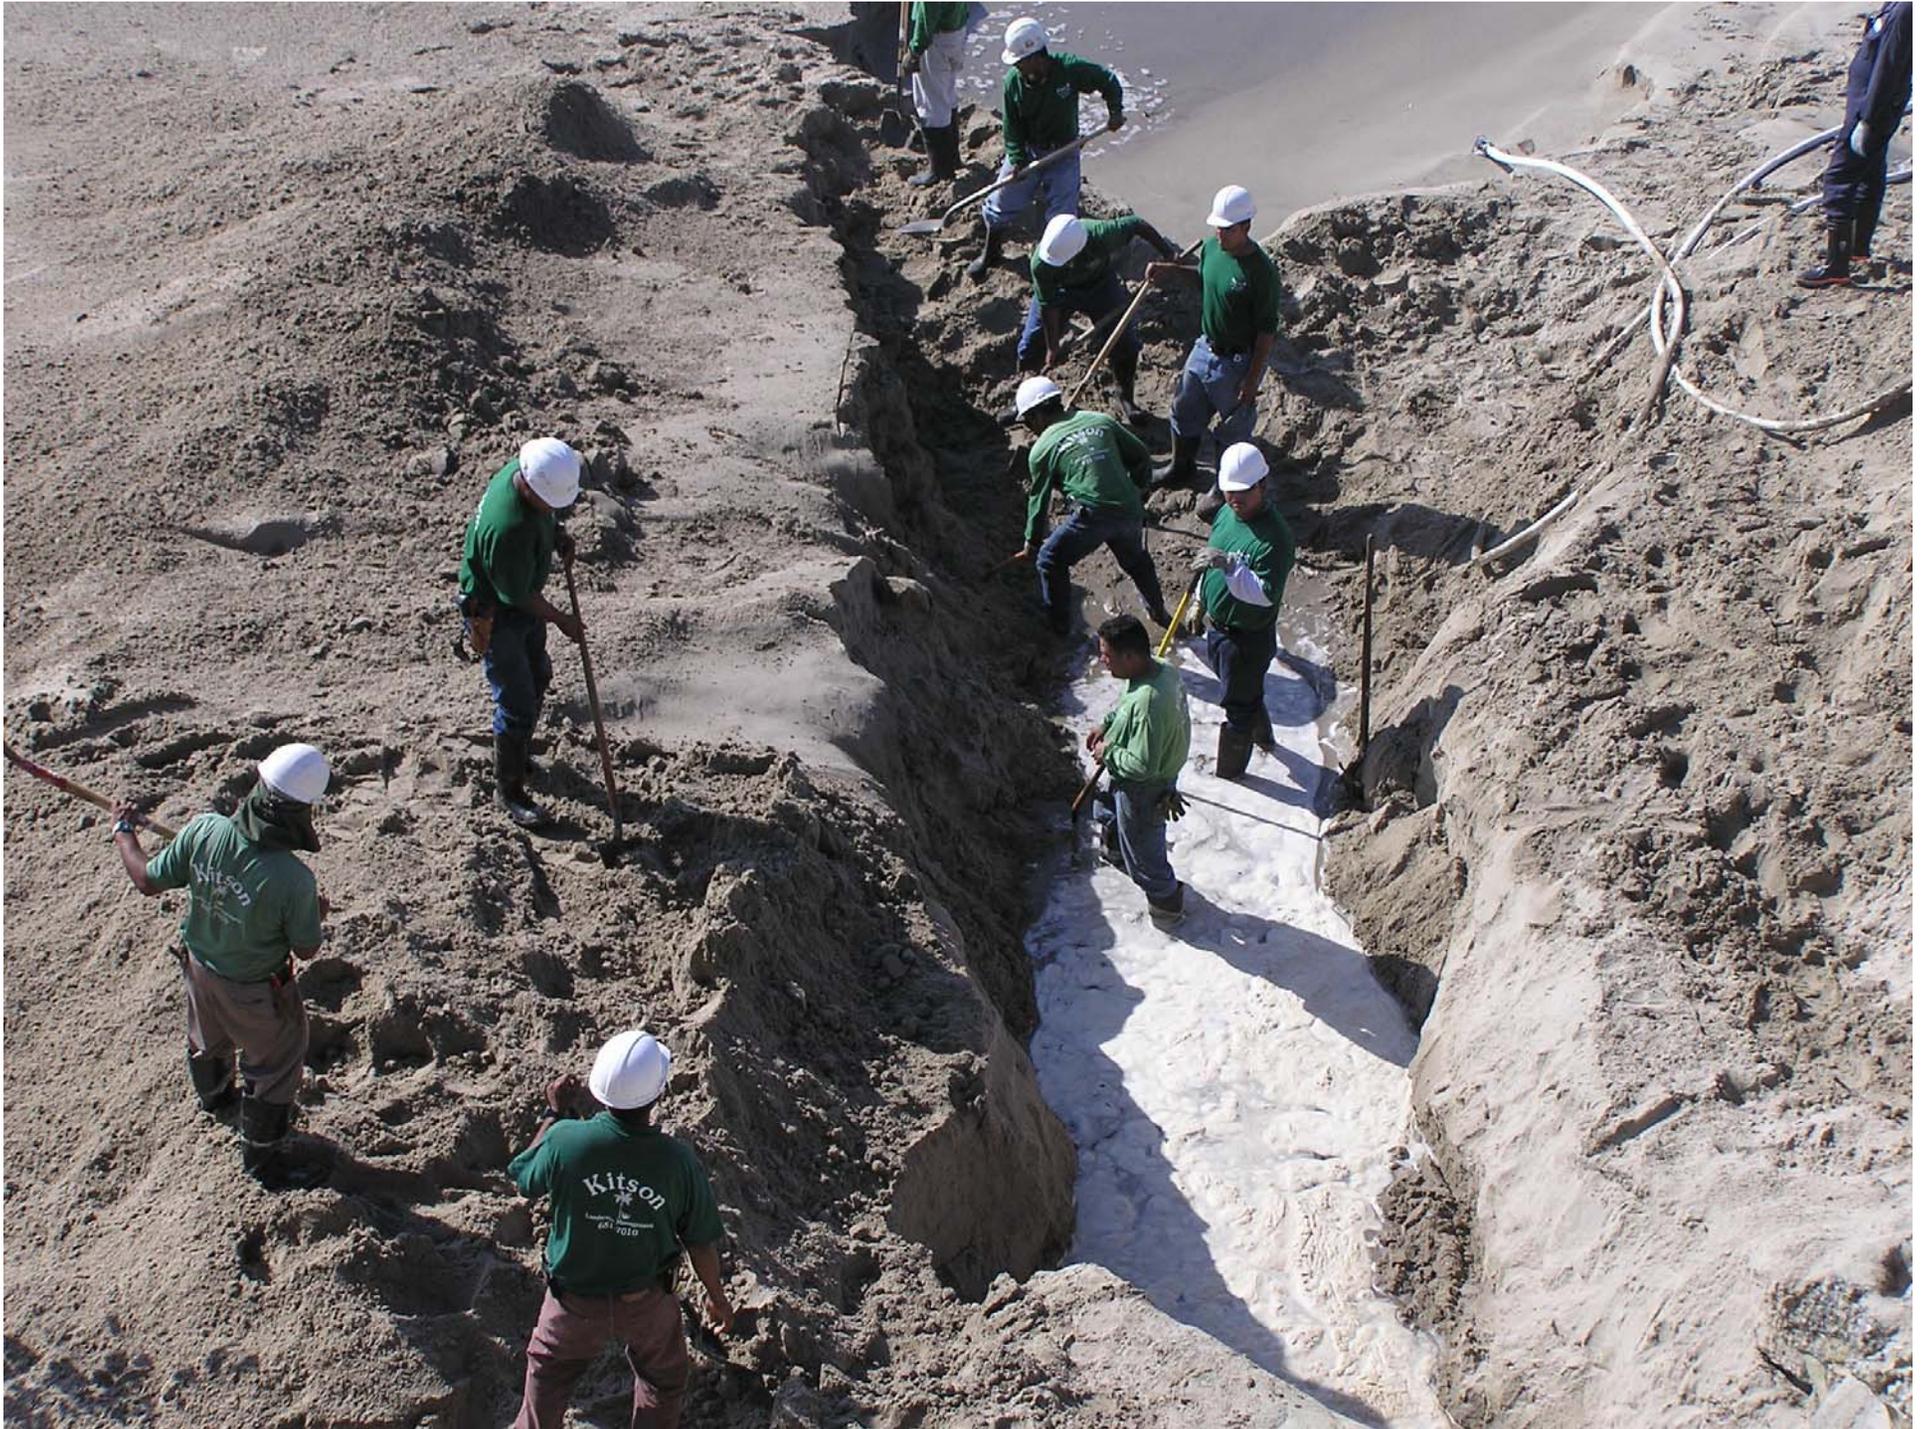
- October 14, 2004 (Day 3)
 - Pipe Exposed
 - Defects confirmed using hand held UT tool
 - Wrap applied along 17' length

- Armor Plate System Selected
 - 4-layer wrap found to restore full hoop stress
 - 2-layer wrap added for scour protection and missing coating
- Contingency Planning Included Welded Sleeves as Back-Up
