# HAITI EARTHQUAKE

## ASCE/TCLEE RECONNAISSANCE PROJECT

# Haiti Earthquake Reconnaissance

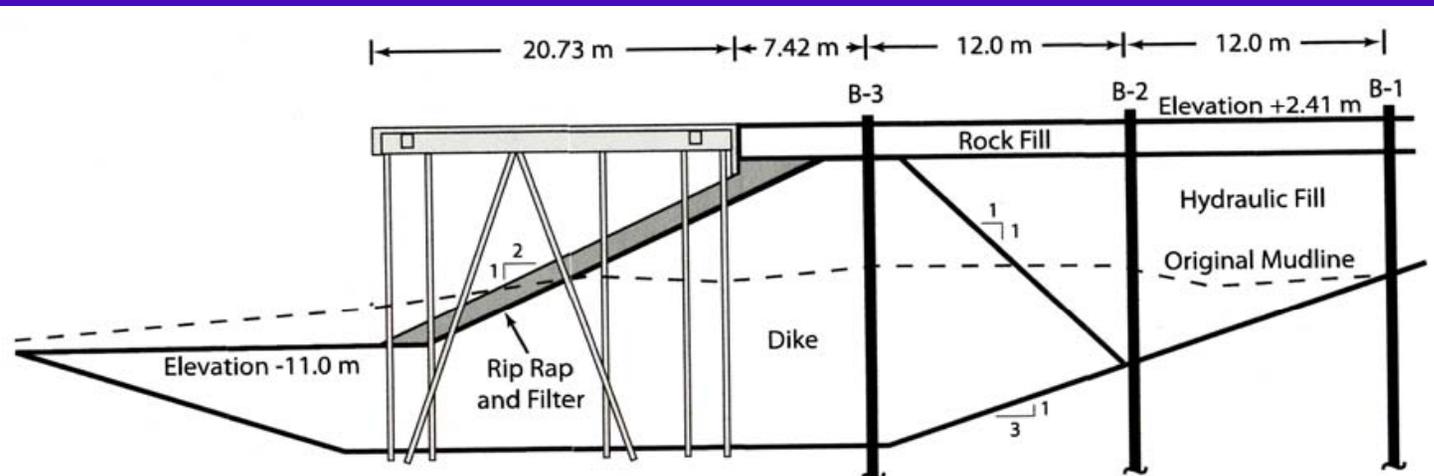
## Condition Before Earthquake

- ◆ APN in process of Retrofitting both facilities
- ◆ Actual Condition Unknown (Assumed Poor)
- ◆ 18-in. Square Pre-stressed Concrete Piles
- ◆ Balanced Battered Pile Configuration
- ◆ Supported Gantry Container Crane, 2 mobile cranes
- ◆ **Configuration Similar to U.S**

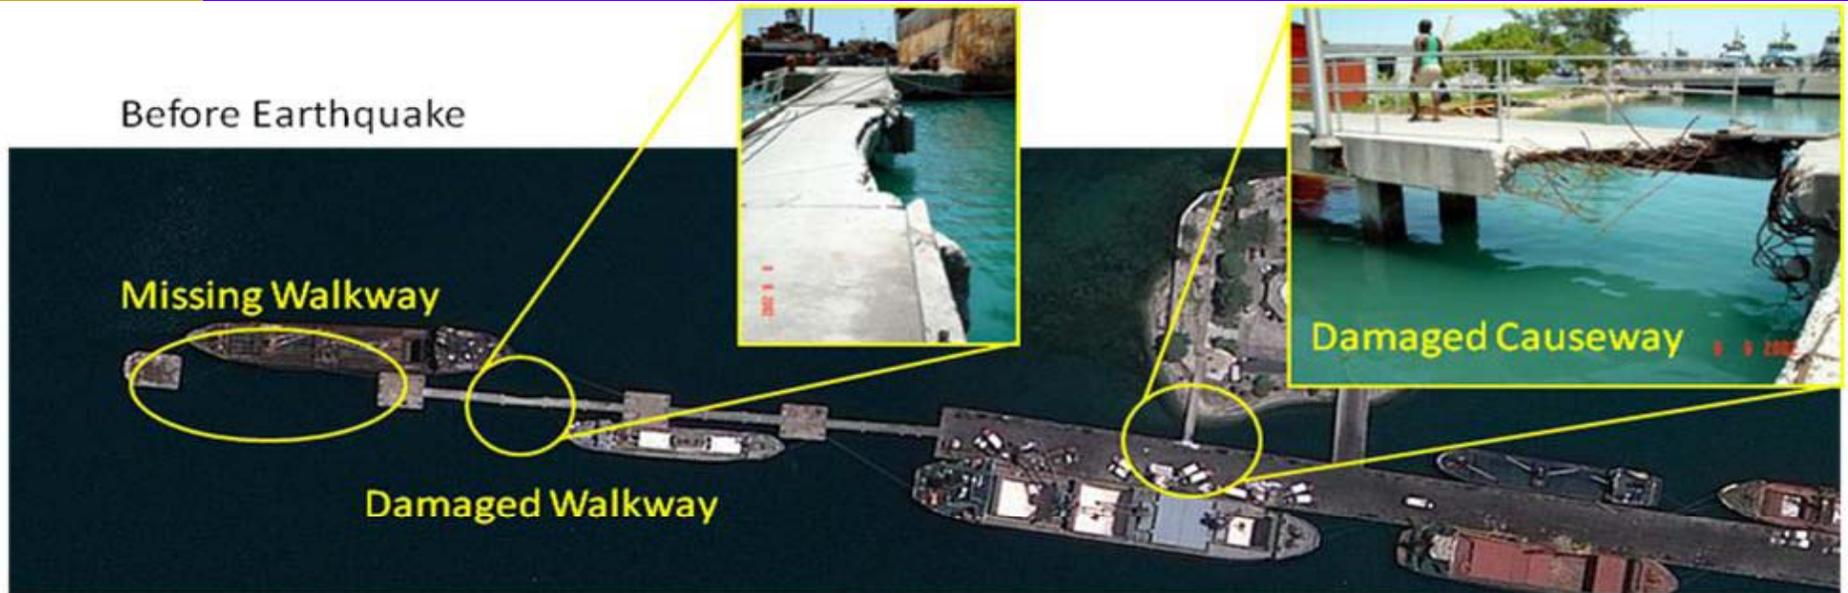
Before Earthquake

## South Pier Condition
